RECAPP Facility Evaluation Report

Grande Prairie S Dist #2357

Avondale School

B3494A

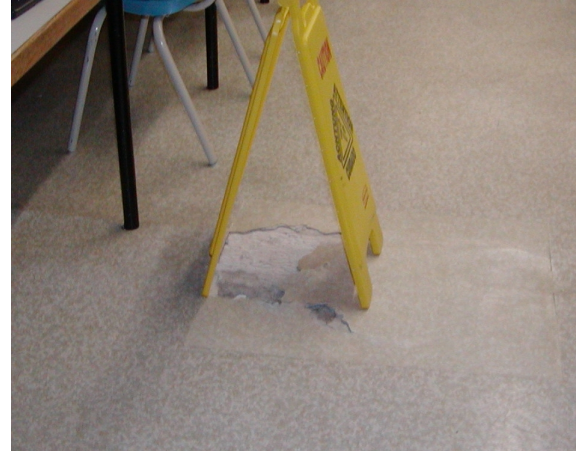
P1010080-crop.jpg

<u>Rating</u>	<u>Installed</u>	<u>Design Life</u>	<u>Updated</u>
3 - Marginal	0	20	MAR-09

Sheet flooring is torn in computer room. Rubber nosing is damaged at stairs to gymnasium.

Trip hazard and unsightly.

Repair damaged areas.

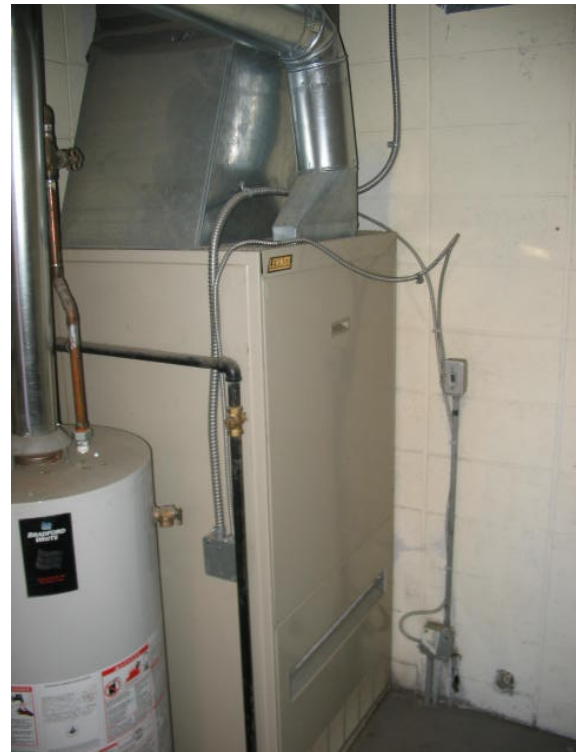
IMG_3125.JPG

Furnaces are worn and deteriorating.

No back-up capacity provided.

Flue venting leaking on each furnace.

Furnace panels rusted.

Flue vents thru the roof ice up and blocking combustion air.

Vent pipes not sealed.

Furnace room 132 appears to have problems with freezing, fresh air intake plugged.

Some furnace room have exposed combustible construction. Space temperatures varies from excessive to inadequate throughout the building.

Concern over sufficient quantities of fresh air delivered to spaces.

Replace existing furnace system with an independent central air handling system. New units should be capable to provide ventilation rates as per ASHRAE code: 62.1-2004 - Ventilation for Acceptable Indoor Air Quality.

New air distribution system should be installed throughout. Existing underslab ductwork should be abandoned.
