RECAPP Facility Evaluation Report

Leduc Composite High School

B3653A

Evaluation Company: John Murray Architectural Associates
Evaluation Date: August 15 2007
Evaluator Name: John Murray

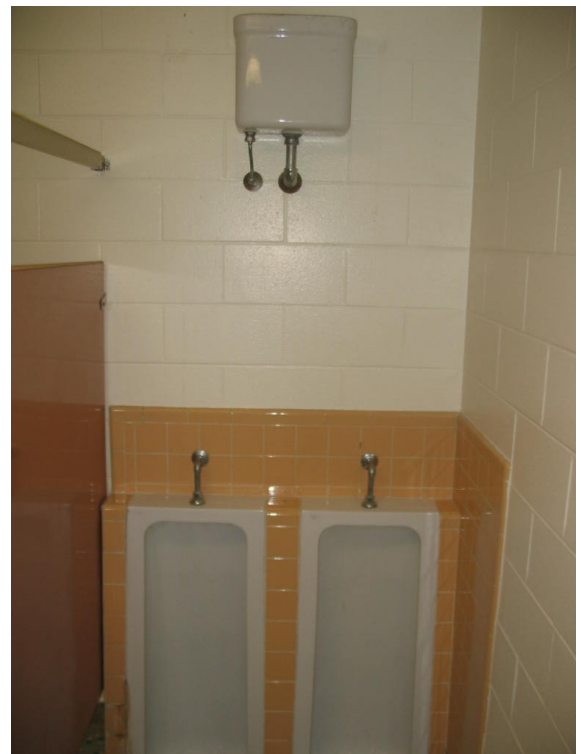
Event: Urinals Replacement**Concern:**

Some stall urinals are cracked and stained.
Flush tank urinals are inefficient and waste water when school is not occupied.

Flush tank urinals.

Replace approximately eight urinals at various locations with flush valve models.

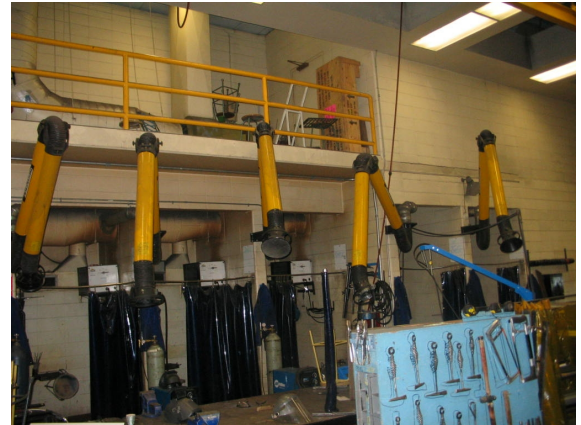
Flexible Extraction Arms in the Welding Area.

Replace five exhaust fans serving Welding area with new roof mounted units. New fans should be capable to exhaust minimum 15,000 cfm of air.

Replace existing air handling unit serving Welding area with new one. New unit should provide min. 14,000 cfm of fresh air. Replace main supply and return air ducts to accommodate new air volume.
