# **RECAPP Facility Evaluation Report**

## **Lethbridge School Dist #51**

**Lethbridge Collegiate Institute**  
B3687A  
Lethbridge

**Evaluation Company:** Stantec Consulting Ltd.  
**Evaluation Date:** December 7 2010  
**Evaluator Name:** Michael Just

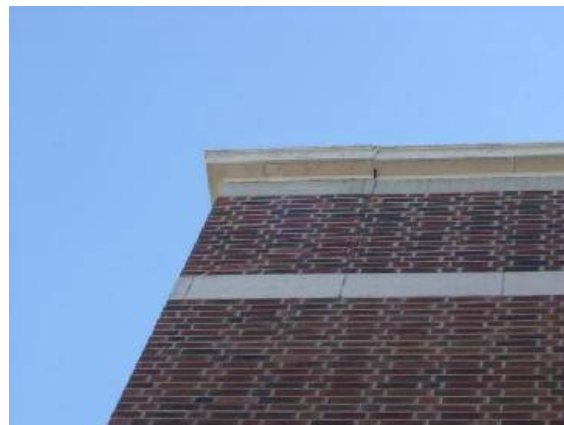
DSC00890.JPG

A large crack is present within the brick veneer at the 1949 original building's southeast corner (D-Wing). The crack extends to the roof parapet that is also separating from the adjacent section. The crack is approximately 3 meters in length on both sides of a corner.

This deficiency is understood to have been discussed on the previous 2005 facility assessment report, and no repairs are understood to have been conducted to-date.

The brick veneer appears to have separated from the adjoining portion and could pose as a danger of total separation. The cracked and separated area also presents an avenue for moisture infiltration.

Conduct repairs to the brick veneer, parapet and roof, if necessary, based on the outcome of the preliminary study. An allowance for repair is provided; however, actual repair costs can only be determined once the results of the initial study are known.
