RECAPP Facility Evaluation Report

Elk Island Cath Separate Reg Div #41

Father Kenneth Kearns School

B4011A

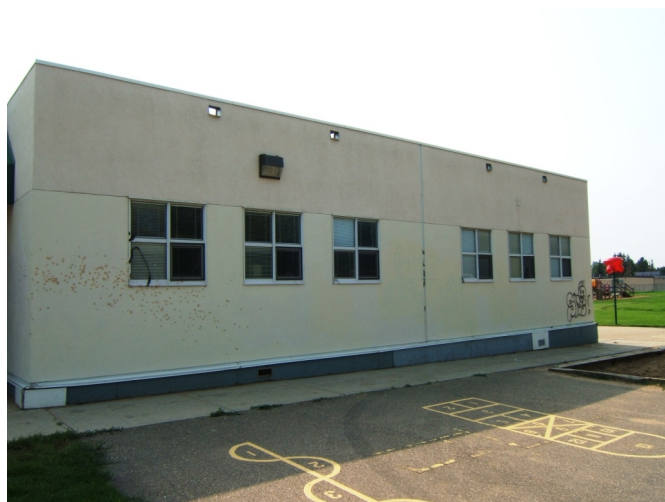
<u>Rating</u>	<u>Installed</u>	<u>Design Life</u>	<u>Updated</u>
3 - Marginal	1993	30	JAN-11

North Elevation of Portable Units

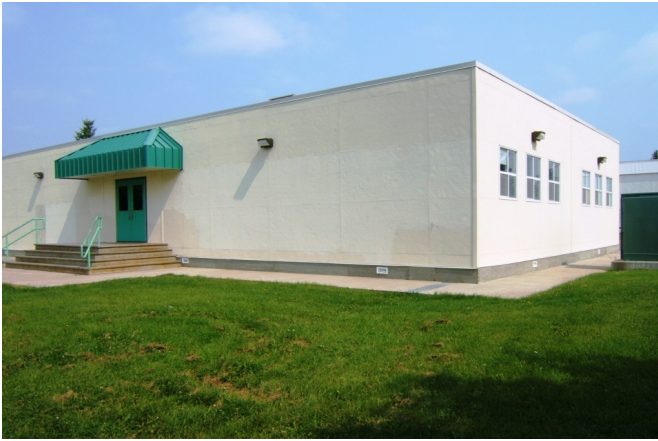
<u>Rating</u>	<u>Installed</u>	<u>Design Life</u>	<u>Updated</u>
4 - Acceptable	2004	30	JAN-11

View of 2003 Portables
