# RECAPP Facility Evaluation Report

## Elk Island Cath Separate Reg Div #41

**Jean Vanier School**

B4014A

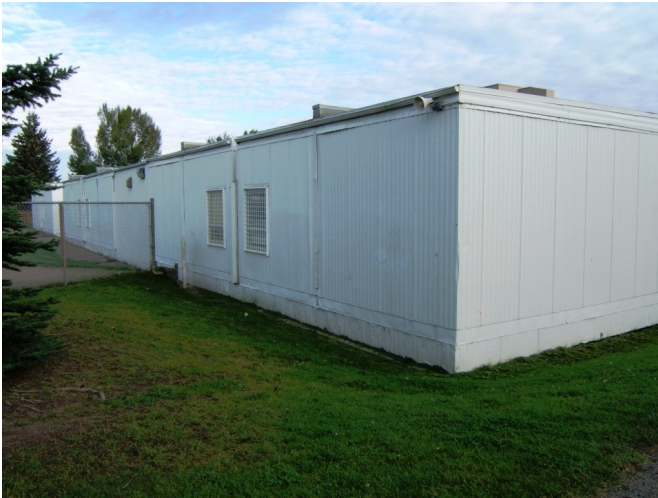
<b><u>Rating</u></b>	<b><u>Installed</u></b>	<b><u>Design Life</u></b>	<b><u>Updated</u></b>
3 - Marginal	1978	30	JAN-11

Partial view of portable units

Wall cladding faded with indentations in unreparable condition.

Wood platforms stairs and railing badly deteriorated.

Replace metal cladding, window units, gutter and downspouts and wood platforms, stairs and railings.

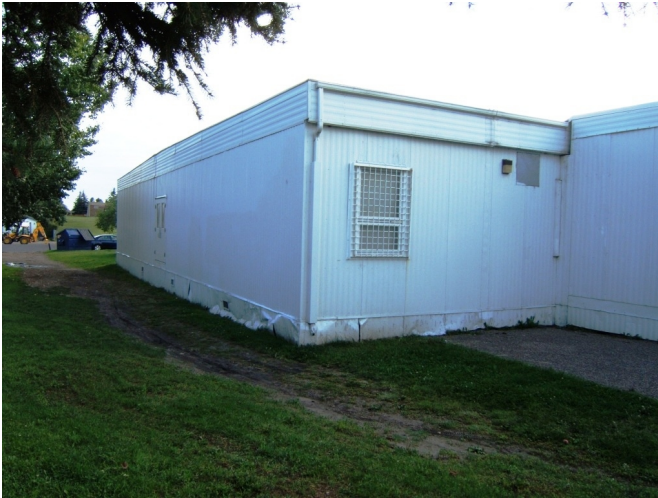
<b><u>Rating</u></b>	<b><u>Installed</u></b>	<b><u>Design Life</u></b>	<b><u>Updated</u></b>
3 - Marginal	1994	30	JAN-11

View of 1994 Portables.

Exterior cladding dented and badly faded.  
Window opening units are inoperable.  
Wood platform and stairs badly worn

Replace metal cladding, windows and exterior wood platform and stairs.
