RECAPP Facility Evaluation Report

Edmonton School District No. 7

Braemar School

B5467A
Edmonton

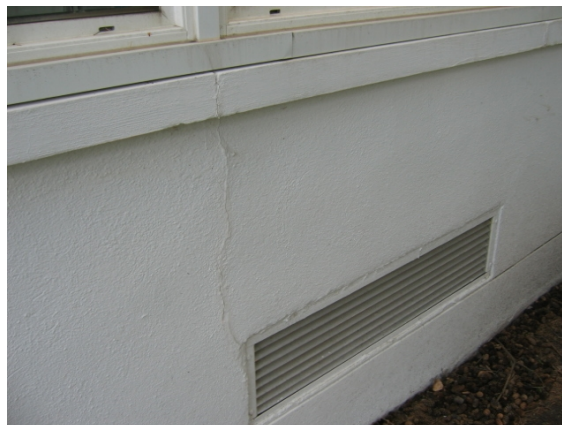
Event: Repair Cracks On Foundation Walls

Multiple hairline cracks were observed along the north and east foundation walls of the original building. The cracking on the foundation walls have progressed, causing some interior finishes to be disturbed. The interior drywall finishes are damaged with cracking which extends from the window sill to the floor level at the west elevation of the original 1959 building. See also B1010.01.

It appears that the original building is showing some early signs of differential settlement. Repairing cracks and regular monitoring of the progression of the cracks is recommended for the foundation walls of the original building.

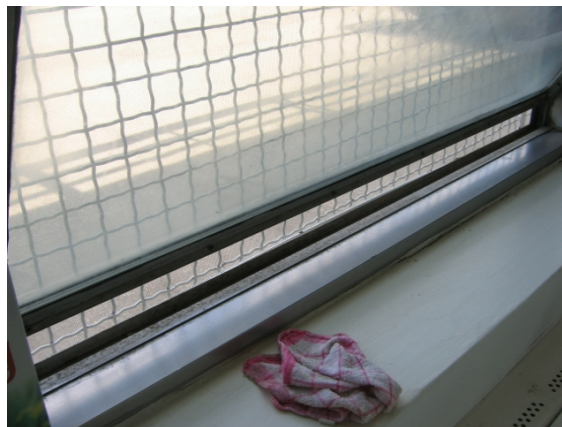
Event: Replace Original Windows**Concern:**

Existing original aluminum windows are of old design and not energy efficient. Wood sections between aluminum frames are deteriorating due to condensation. The windows have surpassed their theoretical life. Windows are old and dated. Some are difficult to open.

Replace all original windows with new vinyl window sections of an approximate area of 150 square metres to match, complete with hermetically sealed double glazing and awning sections.

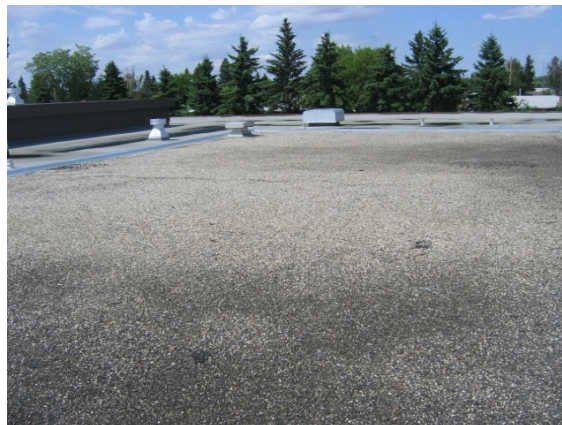
Event: Replace Roofing Assembly**Concern:**

The stained acoustic ceiling panels indicate possible roof leaks in the gymnasium. The roof of the 1972 addition has ridges and asphalt flood coat deterioration. The roof has surpassed its theoretical life.

Replace roofing of an approximate area of 1,050 square metres over the 1972 addition with two-ply SBS roofing, complete with new sloped insulation, perimeter metal cap flashing and drains.

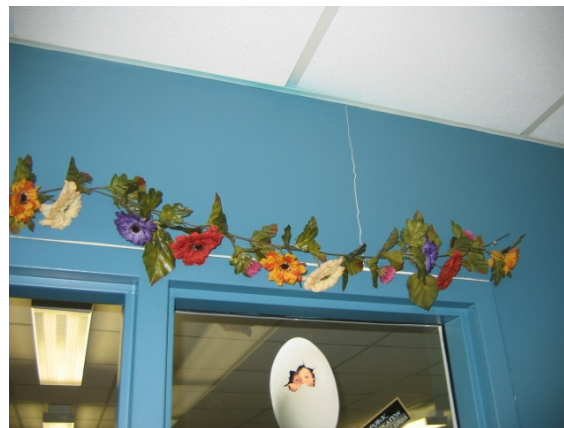
Event: Repair Damaged Drywall

Damaged wall surfaces were noted in the General Office due to movement cracking.

Repair damaged wall surfaces after structural repair. Incorporate control joints if required.

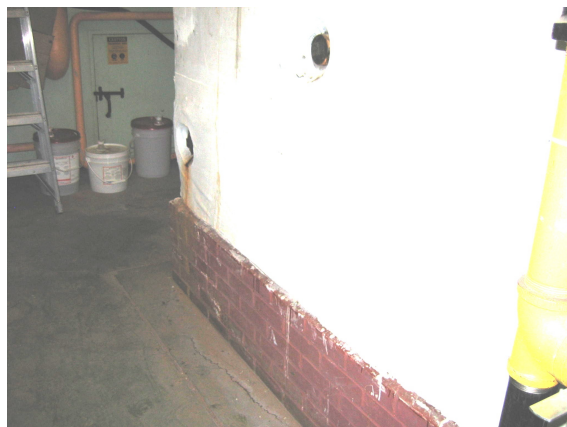
Original paint in the boiler room has deteriorated. Painted surfaces appear dated, exposing bare concrete surfaces.

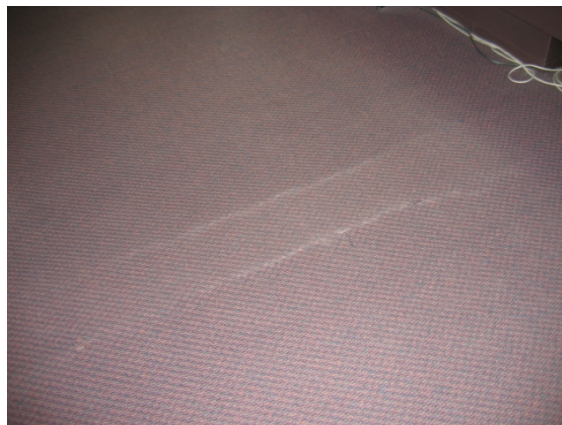
Carpet flooring of an approximate area of 240 square metres in the Administrative Area has some seam failures. Some of the carpeted area is loose. The carpet has served beyond its life expectancy.

Replace carpet in the Administrative Area.

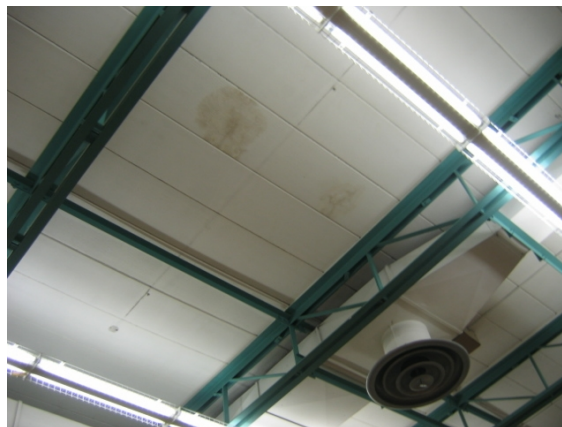
Stains were observed on the ceiling finishes of the auditorium gymnasium.

The stains appear to be caused by roof leaks. Repaint the ceiling finishes after roofing replacement.

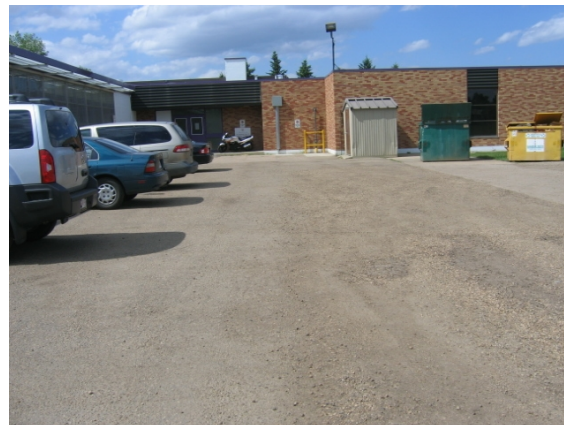
G2020.02.01 Aggregate Parking Lots (Gravel)**

A gravel paved parking lot is located west of the building.

Upgrade parking lot with asphalt pavement (approximately 1,000 square metres) and include a barrier-free parking stall. Provide markings
