RECAPP Facility Evaluation Report

Barr Colony School

B3721A

Evaluation Company: Burgess Bredo Architect Ltd.
Evaluation Date: June 8 2006
Evaluator Name: Burgess Bredo

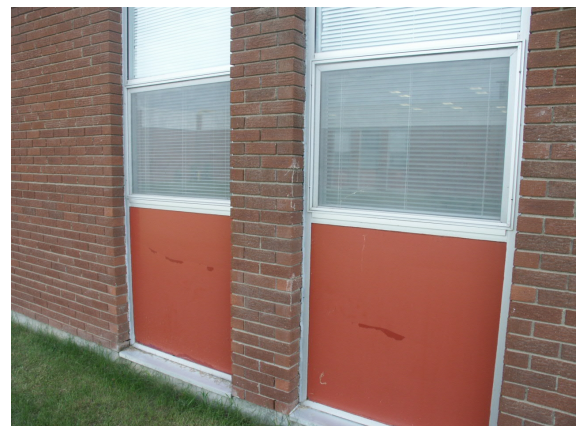
B2020.01.01.02 Aluminum Windows (Glass & Frame)**

1977, 1984: Aluminum framed windows with operable vent along the bottom. Field double glazing Opaque spandrel panels above and below vision panels.

<u>Rating</u>	<u>Installed</u>	<u>Design Life</u>	<u>Updated</u>
3 - Marginal	1977	40	JAN-07

Concern:

Windows reported to be drafty; nearing end of effective life.

Replace windows with aluminum frame double glazed sealed units (32 windows with vent - 96 sq.m.)

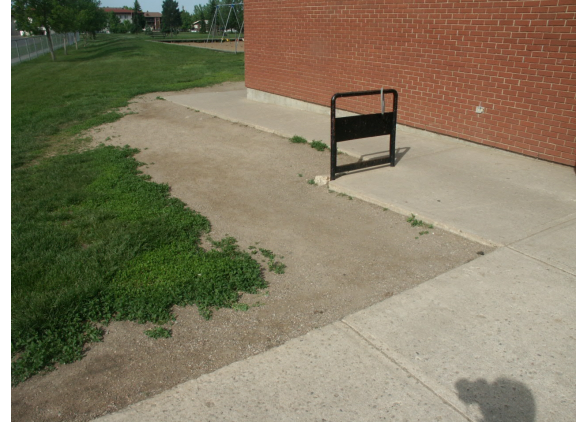
**Event: Replace damaged and cracked sidewalks****Concern:**

Sidewalks along west side of site are cracked with some displacement.

Replace damaged and cracked sidewalks (80 sq.m.)
