RECAPP Facility Evaluation Report

Broxton Park School

B9128A

Spruce Grove

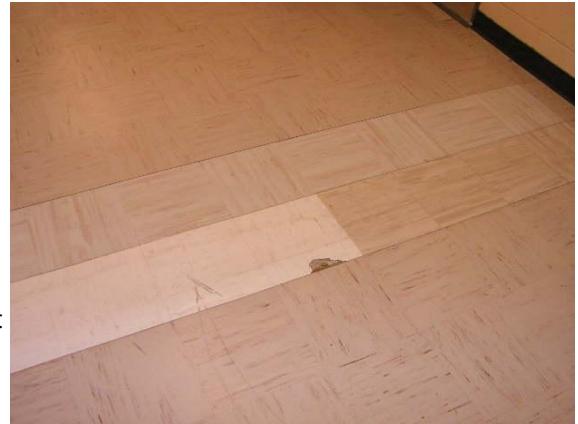
Minor settlement of concrete slab on grade in various locations throughout the building, causing cracking of floor finishes and some tripping hazards.

Differential movement of the concrete slab on grade is occurring throughout the building, causing cracking of floor finishes and in some areas creating a tripping hazard.

Event: Repair slab movement by providing cover strips / thresholds where cracking and differential movement is occurring.

Provide metal cover strips or thresholds where floor movement is causing cracking and / or differential slab movement.

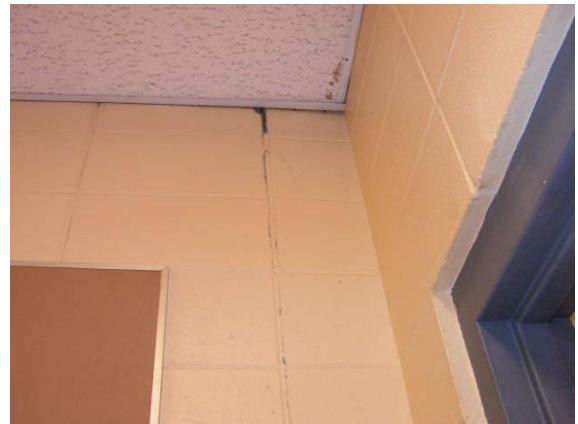
Concrete block loadbearing walls. Concrete Tees over gym, other areas open web steel joists and metal decking. Some cracking of concrete blocks and movement in vertical joints.

Caulking in concrete block movement joints is deteriorated. Some cracking in concrete block walls due to differential movement.

Event: Repair cracked concrete block and caulk vertical movement joints.

Re-caulk movement joints.

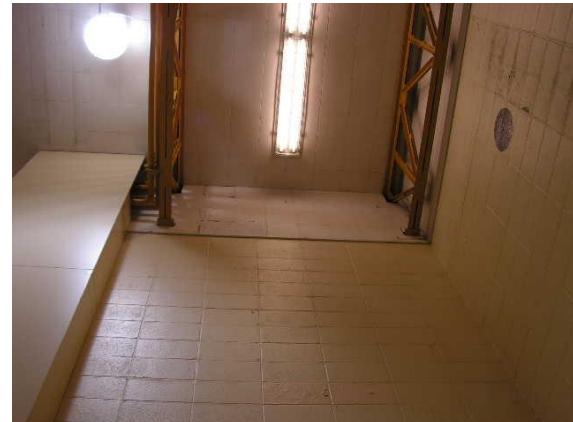
Painted single wythe concrete block. West wall of small gym shows spalling of interior finish.

Wind driven moisture is penetrating the west facing walls of the exterior of the building. (Single wythe concrete block, painted).

Event: Overcome moisture penetration through single wythe concrete block wall by providing metal siding rain screen.

Provide a rain screen by cladding the west facing walls with metal siding.

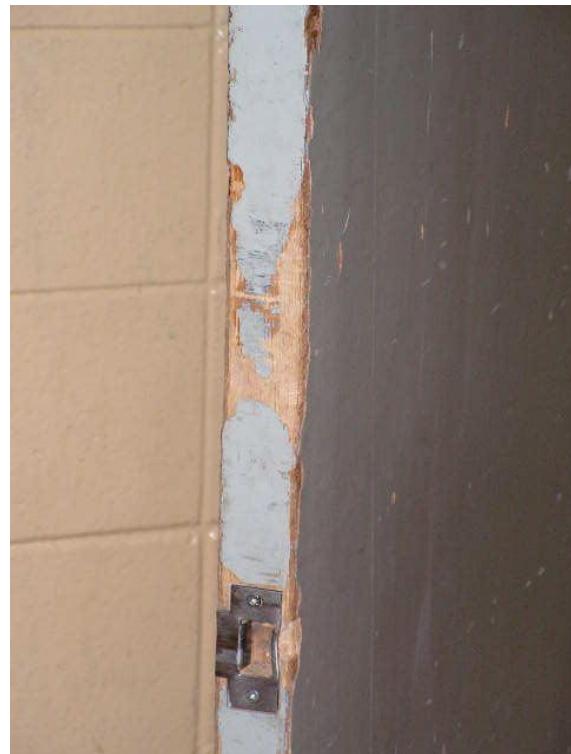
The majority of the wood doors are significantly damaged on the edges, with some surface delamination occurring.

Event: Replace solid core wood doors

Replace approximately 40 interior wood doors.

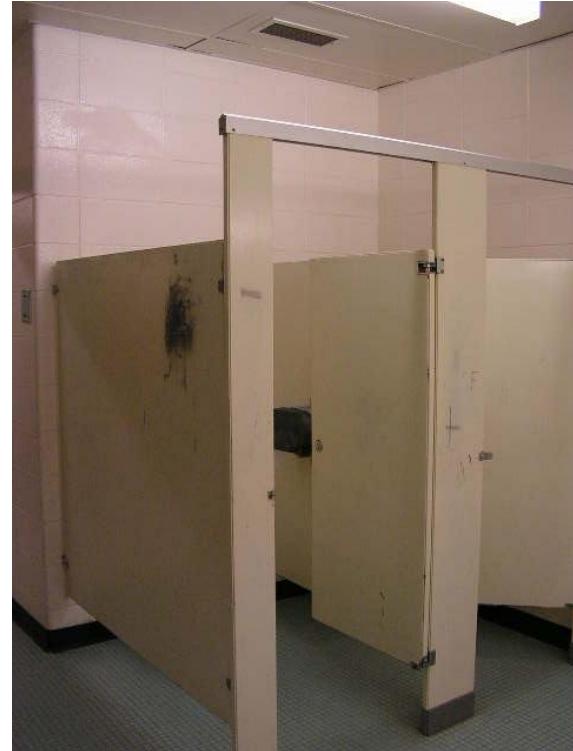
Minor functional repairs needed for on-going operation. Cosmetic repairs needed to prevent rusting and additional deterioration.

Conduct minor repairs and repaint.

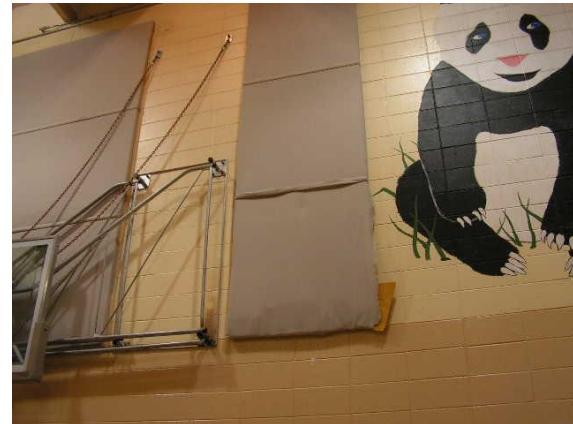
Acoustic panels are damaged due to impact with basketballs.

Event: Replace acoustic wall treatment to main gym**Concern:**

Replace panels with more durable acoustic material such as Tectum.

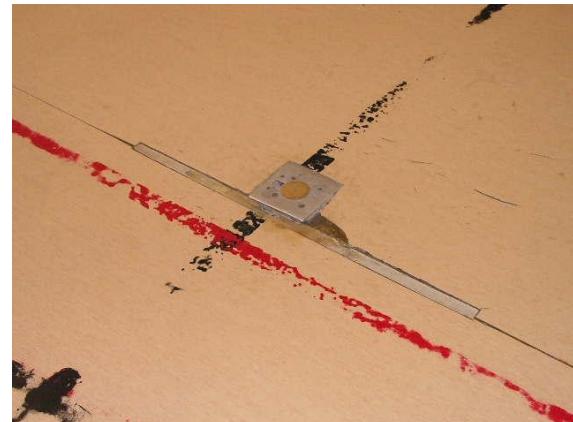
Corridor and gym flooring is deteriorated throughout, with open seams and potential for tripping hazard.

Event: Replace corridor flooring. Replace sheet flooring in small gymnasium. 1340 sq.m.

Replace deteriorated flooring in corridors and small gym.

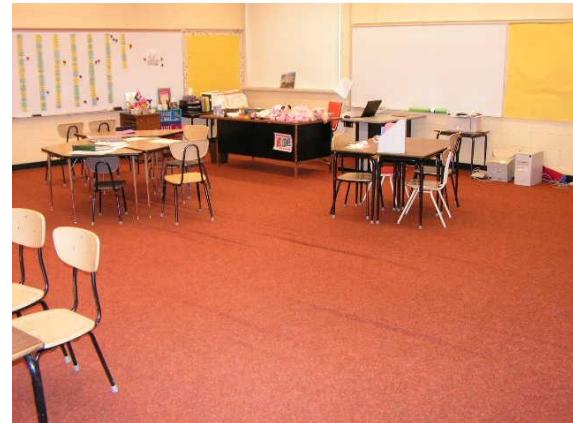
Carpet in some areas is rippling and presents a tripping hazard.

Event: Replace deteriorated carpet. 150 sq.m.

Replace deteriorated carpet.

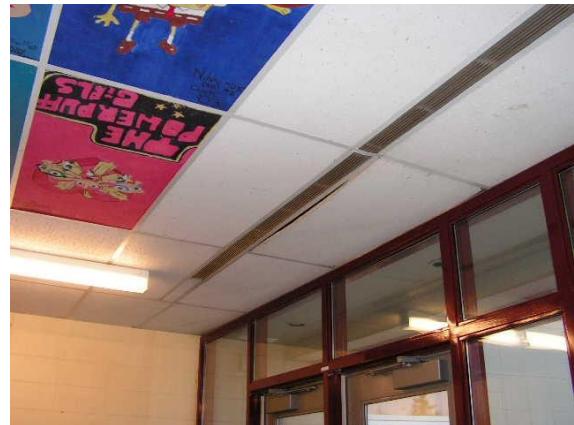
Damaged and ill-fitting ceiling tile may fall.

Event: Replace damaged and ill-fitting ceiling tile.
Approximately 5% of acoustic tile ceiling area.

Replace damaged and ill-fitting ceiling tile.

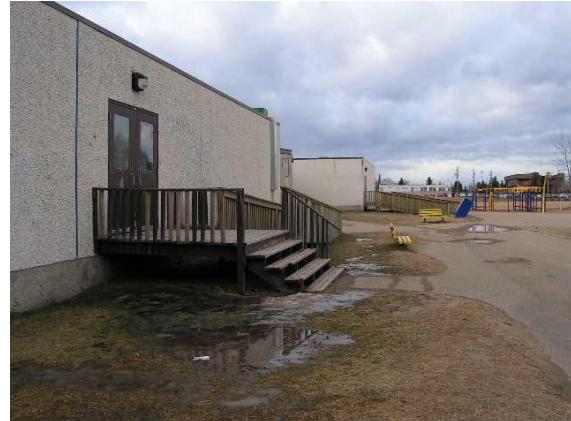
Exterior wooden platforms and stairs are deteriorated and may present a safety hazard to the occupants.

Remove exterior platform and stairs and make good the adjacent finishes and landscaping. Permanently secure the exit door leading to these platforms and remove the exit signage from the interior of the room. Provide a new steel platform and stairs to the required exit.

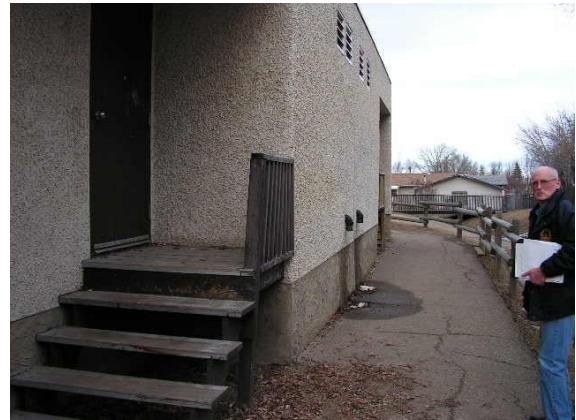
Wooden exit platforms and stairs are deteriorated.
