RECAPP Facility Evaluation Report

Medicine Hat Cs Reg Div #20

Centre for Academic and Personal Excellence Institute

B3781A
Medicine Hat

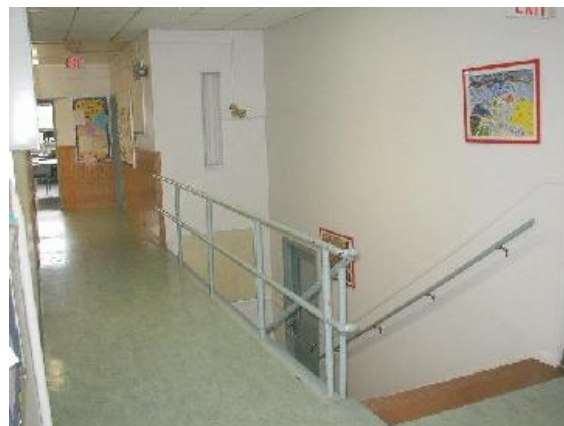
(1911) Painted steel pipe guardrails and handrails. Horizontal members only (climbing risk) spaced far apart and do not meet current code and safety concerns. Guardrails are 150mm too low. Safety concern.

Event: Stair handrails and guardrails have horizontal members spaced too far apart. Guardrails are too low.

Large objects could fall through and/or children could climb on and/or fall through to stairs and landings below.

Weld heavy gauge steel mesh with small openings to sides of railings, and a railing to the top.
