RECAPP Facility Evaluation Report

C. W. Sears Elementary School

B4181A

Evaluation Company: Wade Engineering Ltd.
Evaluation Date: December 9 2006
Evaluator Name: Ron Shannon

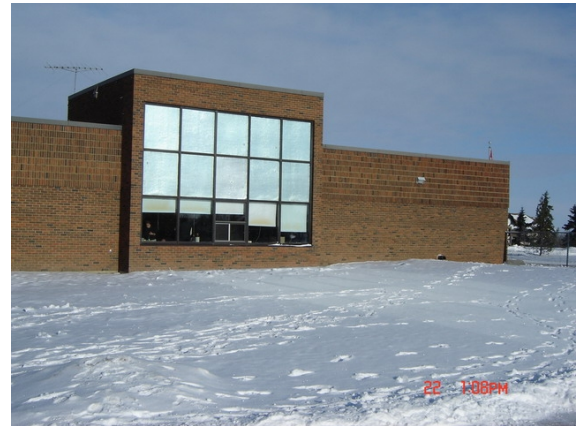
Event: Replace glazing

Full wall glazing in staff room has been modified with insulation panels behind glass to reduce heat loads. Improper design has resulted in continual glass breakage due to heat loads.

Continued heat problems and increased maintenance costs.

Replace upper glass with insulated spandrel panels and install solar reflective glass on bottom row.
