RECAPP Facility Evaluation Report

Colonel Walker Community School

B2587A

Evaluation Company: Jacques Whitford
Evaluation Date: December 1 2004
Evaluator Name: Mr. Mario Plastina

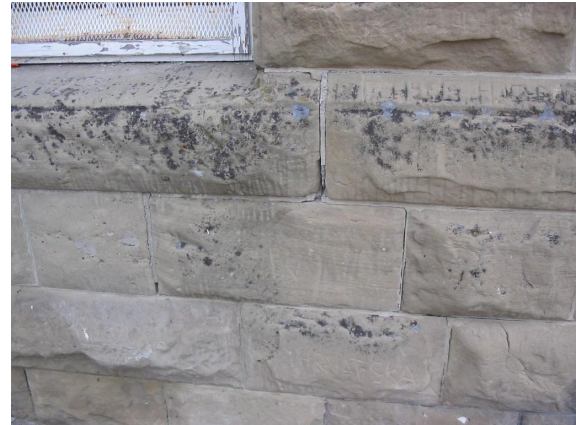
Spalling, eroded and weathered sandstone was observed around the four elevations of the 1912 building. Deficient mortar joints were also identified between the sandstone units.

Repair/replace damaged sandstone units where necessary and repoint.

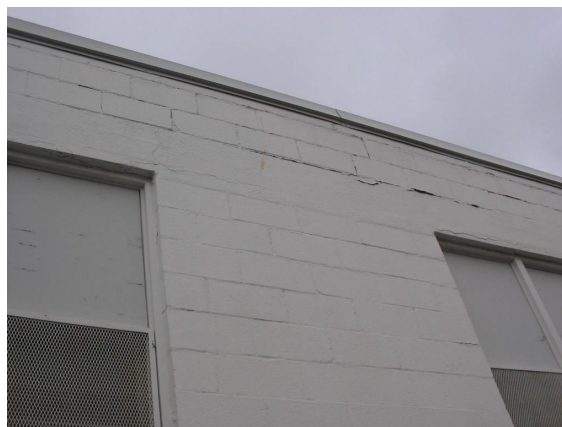
Step cracks were noted in the exterior block walls around the 1952 addition. Protruding blocks were identified above one of the window lintels on the east elevation. Diagonal cracks originating from the top of the grade level window openings were also noted in the concrete foundation wall below the concrete block structure. Mortar joints throughout the block work appeared to be deficient and the paint finish was peeling in numerous areas.

A study is recommended to determine the structural integrity of the concrete block walls.

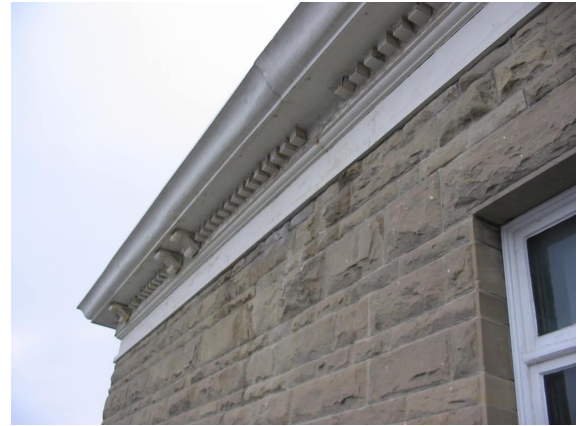
Sections of damaged and deteriorated metal soffits were identified when inspecting the ornamental metal soffits. The paint finish protecting the metal work was peeling.

Repair damaged ornamental metal work and repaint.

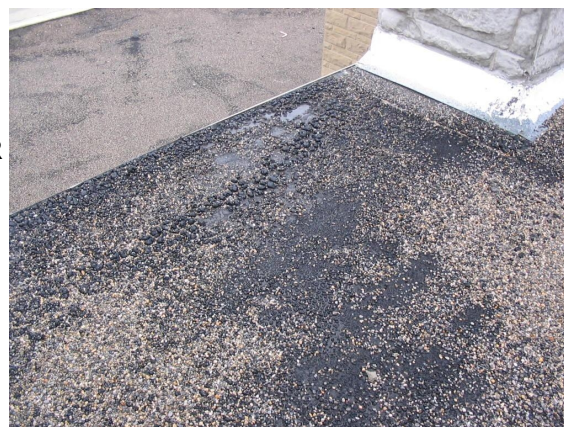
Evidence of previous repairs were observed on the BUR sections. Exposed felt membranes, bleedthrough, vegetation growth and blisters were noted. Evidence of previous roof leaks were also observed from the interior. Deficient roof flashing was also observed.

Replace roof sections D, E, and F and the roof over the shed. Replacement of all roof flashing is also recommended.

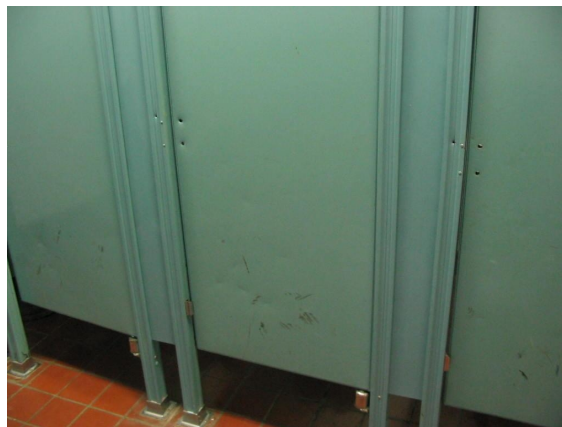
Dents, minor corrosion and deteriorated surface finishes were observed on the fabricated washroom partitions in the 1952 addition.

Replace the washroom partitions.

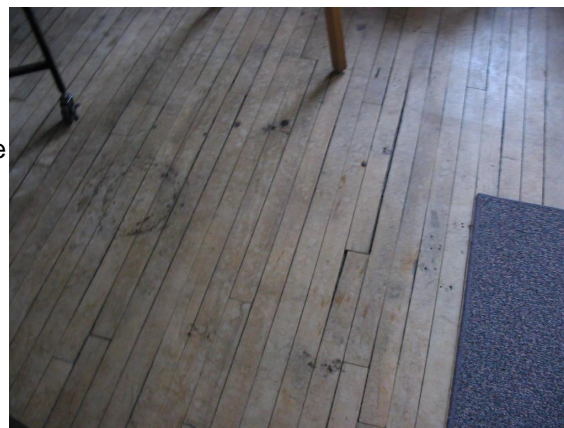
Heaved hardwood flooring was observed on the top level of the 1912 building. Joint separation and worn finishes were also identified. The floor finish on the stage also appeared to be worn.

Repair/replace hardwood flooring and re-furbish.

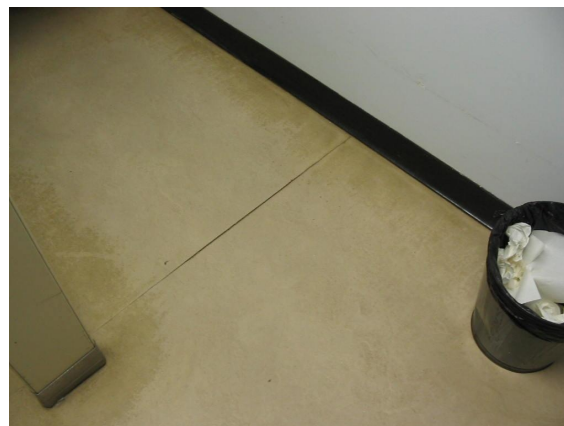
Deteriorated and raised seams were noted in the sheet vinyl flooring. Sections of the sheet vinyl appeared to be worn.

Partial replacement of the sheet vinyl within the school is recommended during the 5 year evaluation period.

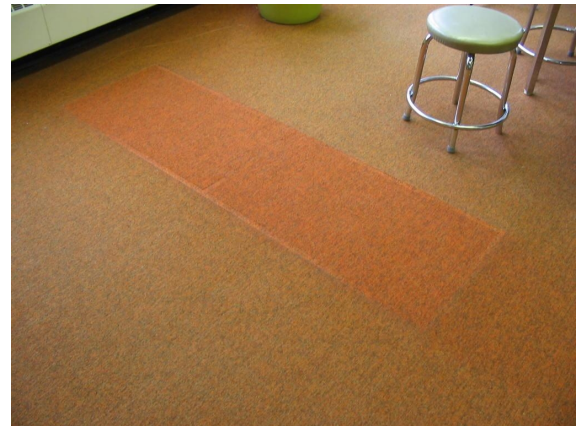
The carpeting is worn in high foot traffic areas. Stains were identified in several locations.

Replace the carpeting in the library and office areas.

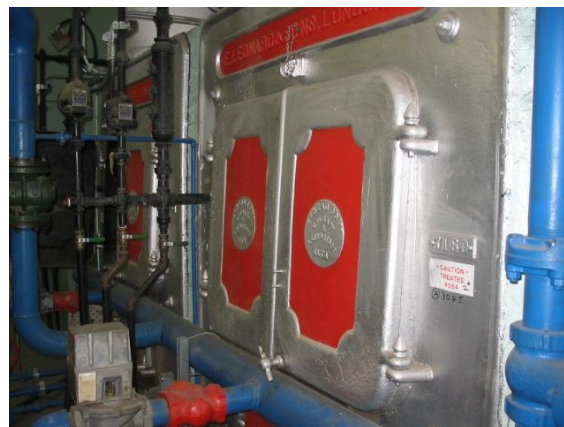
Heating for the building is supplied by three low pressure steam, natural gas-fired fire tube boilers. Two of the boilers are manufactured by E. Leonard & Sons, rated at 3.2 MBH and are original to the building. The third boiler is manufactured by Pacific, is rated at 2.9 MBH, and was installed in 1952. The steam is provided to perimeter radiators, unit ventilators, and heat exchangers. The boilers are in poor condition and require replacement.

Replace all three boilers.

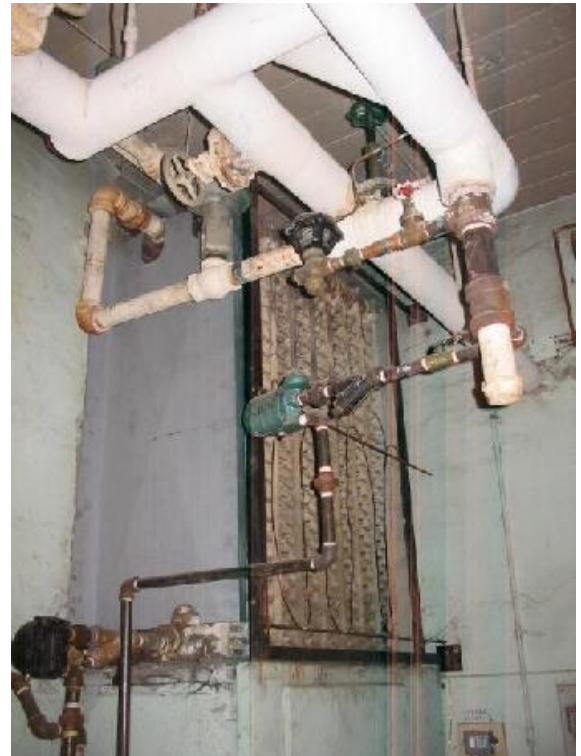
The air handling system used to ventilate the original (1912) section of the building provides poor ventilation and was observed to have corroded coils. The system is operating inefficiently and requires regular maintenance.

Replace the original (1912) air handling unit/system.

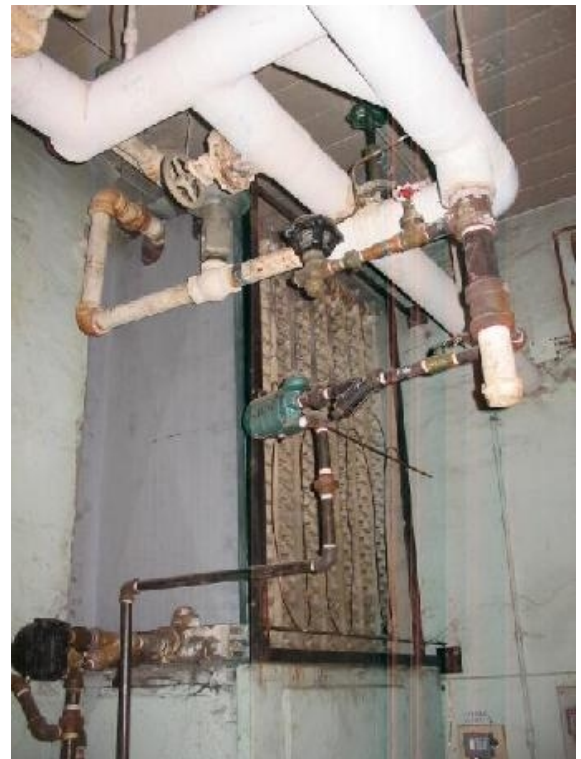
The heating piping and steam traps are corroded and should be replaced with the replacement of the boilers.

Replace all heating piping.

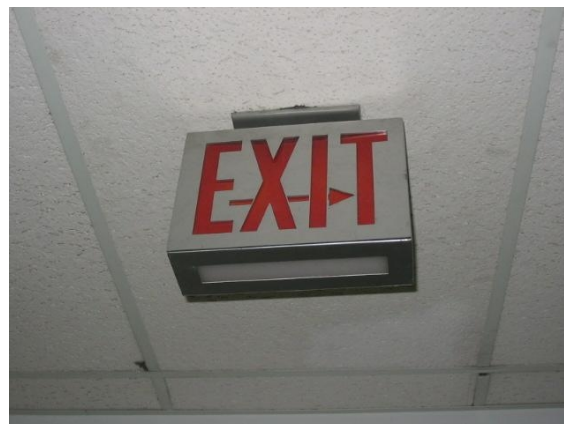
Emergency lighting in the school is provided by battery packs located throughout the school. Some fixtures have been replaced in the past five years. The exit signs are incandescent type units.

Replace all exit signs with LED type exit signs.
