RECAPP Facility Evaluation Report

County Central High School

B4219A

Evaluation Company: Arup Datta Architect Limited
Evaluation Date: September 13 2005
Evaluator Name: Mr. Arup Datta

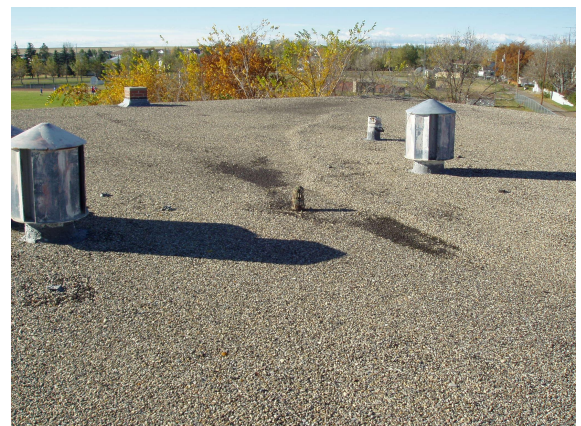
Event: 1954 original roof requires replacement

Original roof is has areas of gravel scrapped away to maintain drainage to roof drains and roof is 50 years old long past life cycle age.

Re-roof and create positive slopes to drains (approx 1250 m sq)

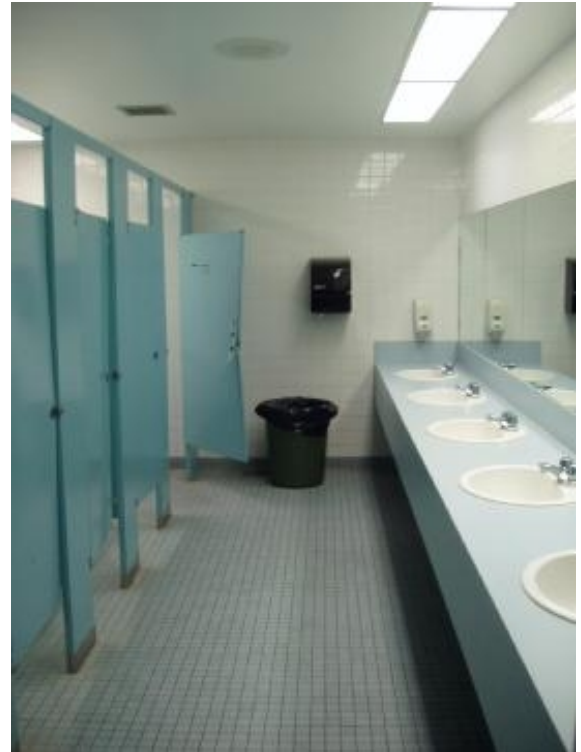
Event: 1985 Repair toilet partitions in women's washroom

1985 toilet partitions in women's washroom are seriously damaged, doors not closing

Repair all damaged toilet partition doors and other damage

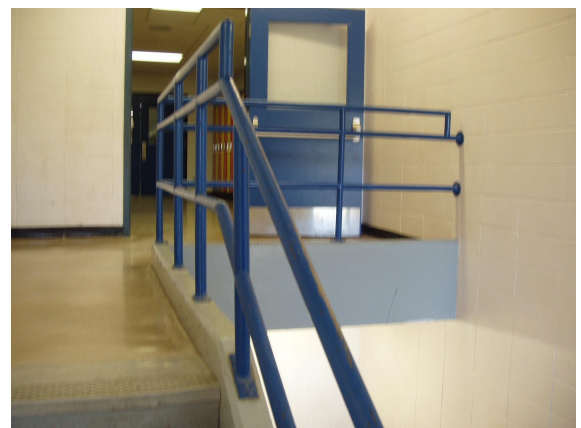
Event: Upgrade stair handrails to comply with code

Metal pipe stair handrails have openings substantially larger than permitted 100 mm

Install painted wire mesh panels to stair handrails to reduce openings to maximum 100 mm

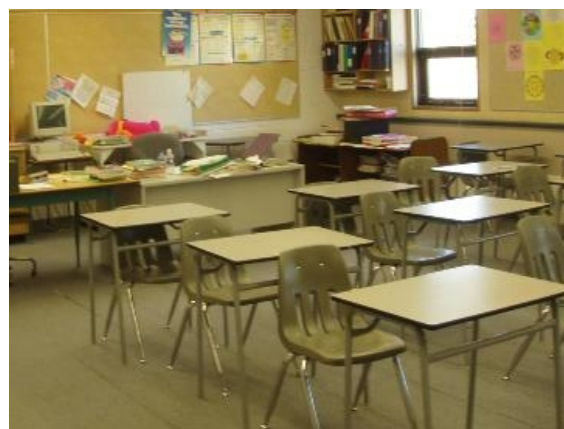
Event: 1953 section classroom and administration carpet worn

Carpet floor finish in 1953 section classrooms and administration worn and fraying

Replace 1953 section classroom and administration carpet flooring with new carpet (approx 1250 m sq)

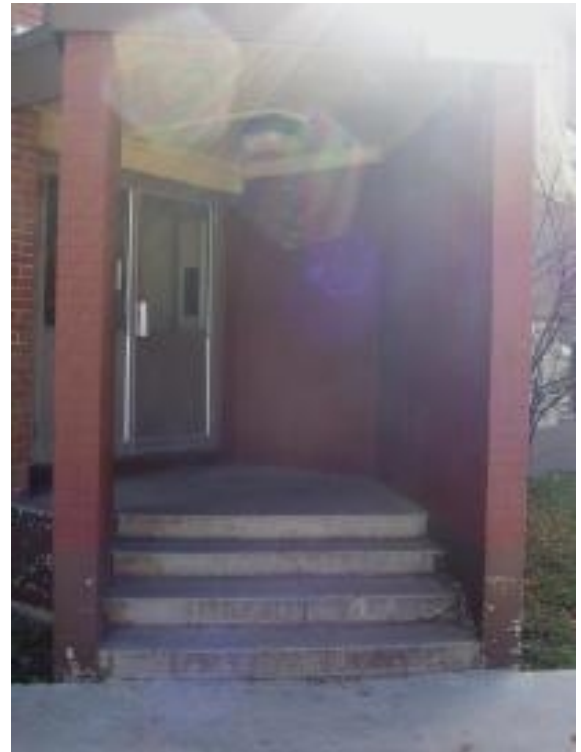
Event: Southwest exterior steps handrail missing

Southwest exterior steps handrail does not exist making the steps unsafe

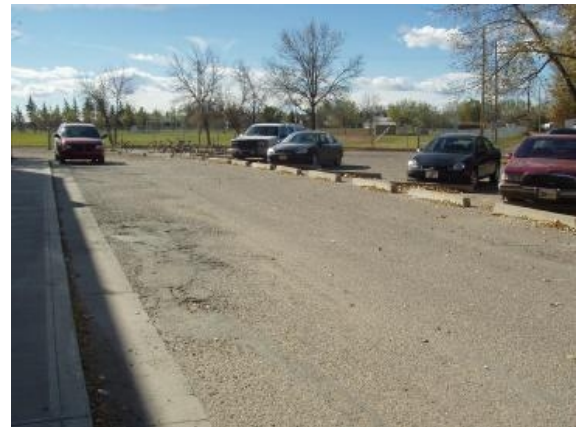
Event: Patch and repair asphalt parking lot

Areas of asphalt at bus drop off are deteriorating

Patch and make good all damaged asphalt areas in parking lot and bus drop off area
