RECAPP Facility Evaluation Report

David Thompson Junior High School

B2596A

Evaluation Details	
Evaluation Company:	Jacques Whitford
Evaluation Date:	December 1 2004
Evaluator Name:	Mr. Mario Plastina

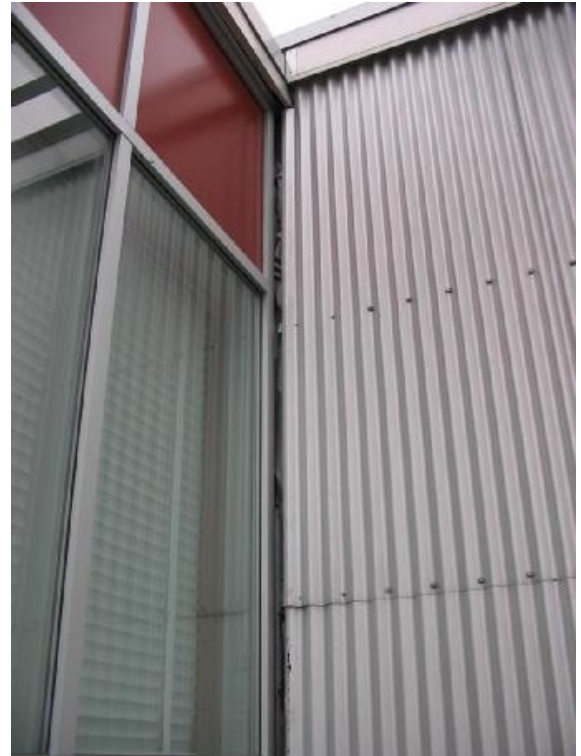
Dented corrugated metal siding panels were noted at grade level. The intersection between the curtain wall and metal siding was not properly finished above the roof level, in the southwest corner.

Replace damaged metal siding panels and repair unfinished sections.

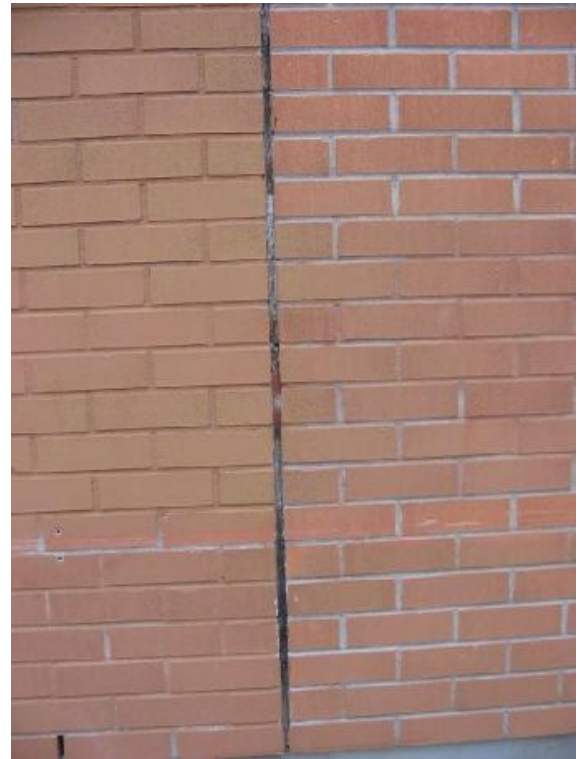
The exterior sealant was cracked and cohesive and adhesive failure was observed.

Replace exterior sealant.

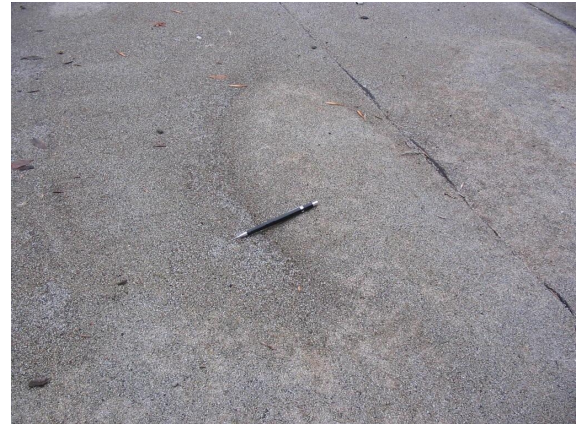
Large blisters were observed on roof sections H and G in isolated areas. Ponding water was noted around the mechanical unit on roof section G.

Repair roof sections H & G and install a roof drain in close proximity to the mechanical unit in roof G.

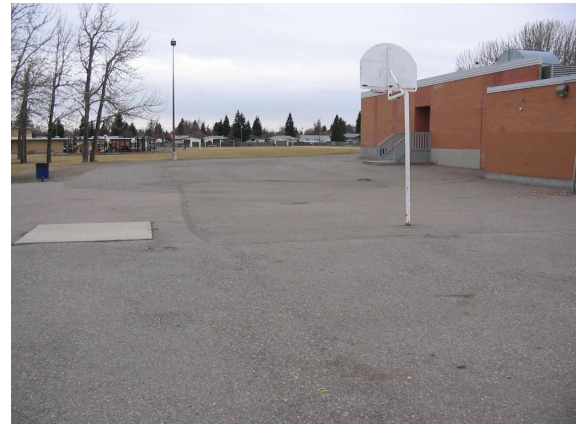
Evidence of previous asphalt repairs, longitudinal cracks, raveling asphalt and uneven surfaces were observed in the paved playground area.

Replace asphalt paved surfaces.
