# **RECAPP Facility Evaluation Report**

**Ecole Du Sommet School**

B4089A

Evaluation Company: Burgess Bredo Architect

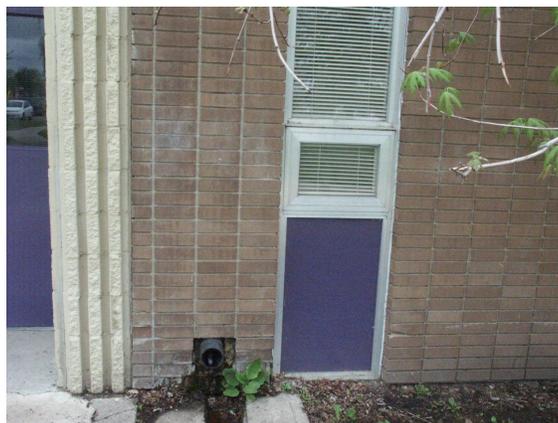
**Event: Replace aluminum windows**

Replace aluminum windows (30 sq.m.)

<u>Type</u>	<u>Year</u>	<u>Cost</u>	<u>Priority</u>
Lifecycle Replacement	2007	\$15,000	Low

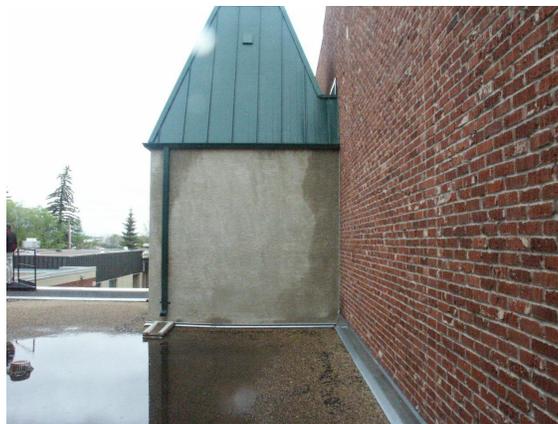
**Event: Repair cupola eaves trough**

**Concern:**  
Eaves trough appears to be leaking or sloping the wrong way. Stucco is wet below.

**Recommendation:**  
Engage roofer to investigate cause of leakage and repair.

<u>Type</u>	<u>Year</u>	<u>Cost</u>	<u>Priority</u>
Repair	2004	\$1,000	Low

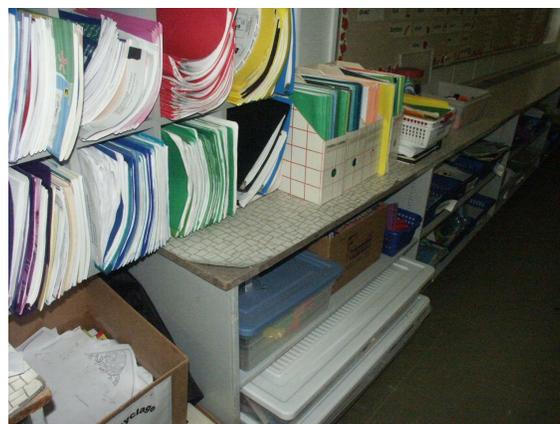
#### Event: Replace selected millwork

Replace millwork in 2 classrooms (23 m.).

<u>Type</u>	<u>Year</u>	<u>Cost</u>	<u>Priority</u>
Lifecycle Replacement	2005	\$12,000	Low

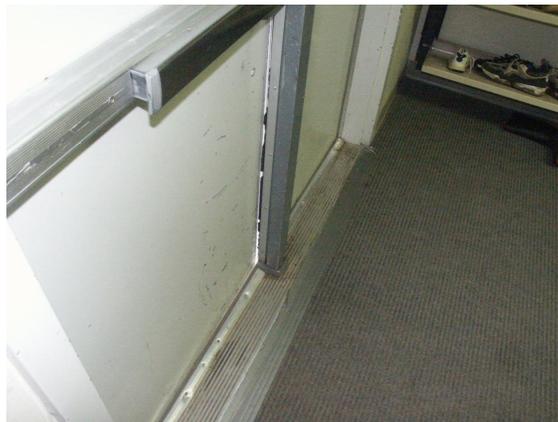
**Event: Replace warped door**

Replace exterior warped door

<u>Type</u>	<u>Year</u>	<u>Cost</u>	<u>Priority</u>
Failure Replacement	2007	\$500	Low

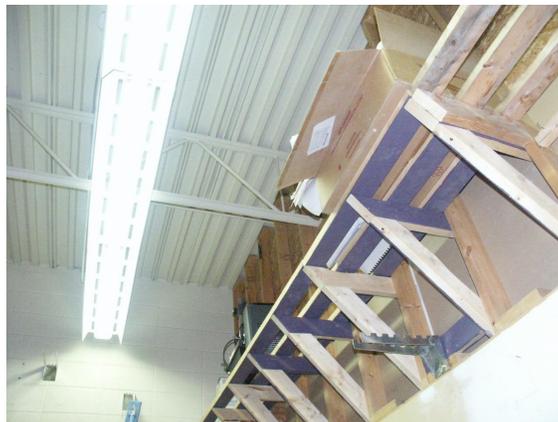
**Event:** Repair fire separations

<u>Type</u>	<u>Year</u>	<u>Cost</u>	<u>Priority</u>
Code Repair	2004	\$2,500	Medium

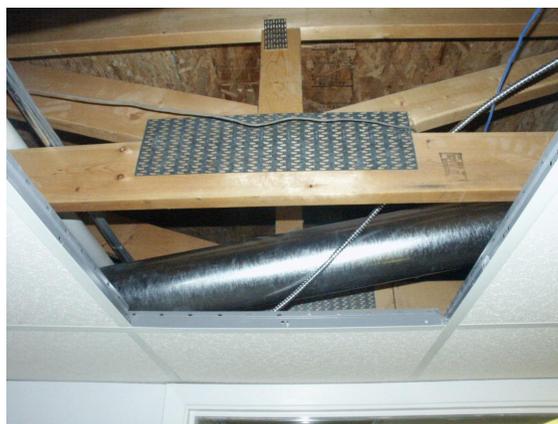
**Event:** Study wood in return air plenum

Undertake study to review extent of wood in return air plenums, devise remedial action and make recommendations as to most cost effective repair.

<u>Type</u>	<u>Year</u>	<u>Cost</u>	<u>Priority</u>
Study	2004	\$2,000	Low

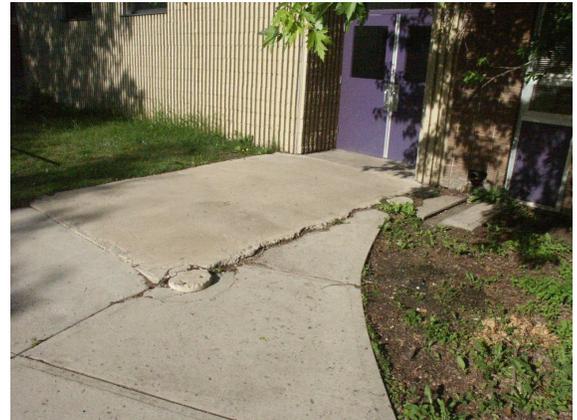
#### **Event: Replace concrete sidewalks in two locations**

Cracking of sidewalks throughout is relatively normal. Cracking which produces displacement creates tripping hazard.

Replace concrete sidewalks in two locations to eliminate tripping hazards.

<u>Type</u>	<u>Year</u>	<u>Cost</u>	<u>Priority</u>
Repair	2005	\$3,000	Low

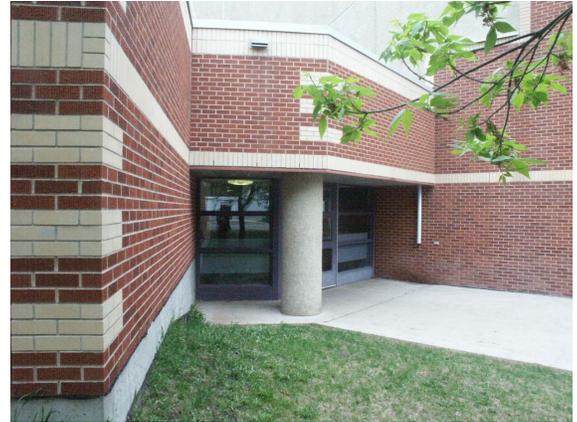
Surface drainage conditions. Roof drainage to grade. No catch basins.

<u>Type</u>	<u>Year</u>	<u>Cost</u>	<u>Priority</u>
Maintenance	2005	\$15,000	Low
