School Name						
ochool Marrie	: Earl Gre	У			School Code:	9118
Location:	845 Hillo	rest Ave.	S.W., Calgary		Facility Code:	1444
Region:	Calgary				Superindendent:	Dr Donna Michaels
Jurisdiction:	School D	istrict No	p. 19		Contact Person:	Leanne Soligo
					Telephone:	(403) 214-1123
Grades:	K-6				School Capacity:	350
Building Section	Year of Compl.	No. of Floors	Gross Bldg Area (Sq.M.)	Type of Construction (i.e., structure, roof, cladding)	Description of Mechanical Systems (incl. major upgrades)	Comments/Notes
Original Building  Additions/	1953	1	1894.7	Steel columns and steel trusses with flat wood deck roof. Horizontal "rusted steel " siding. See 8.1.1 for photo illustration of this siding .  Steel columns and steel trusses with	Gym heated by hot water heating system and ventilation provided by multiple furnaces. Heat and ventilation for basement is by multiple furnaces. Three roof top multizone units provide heat and ventilation for classrooms.  Gym heated by hot water heating

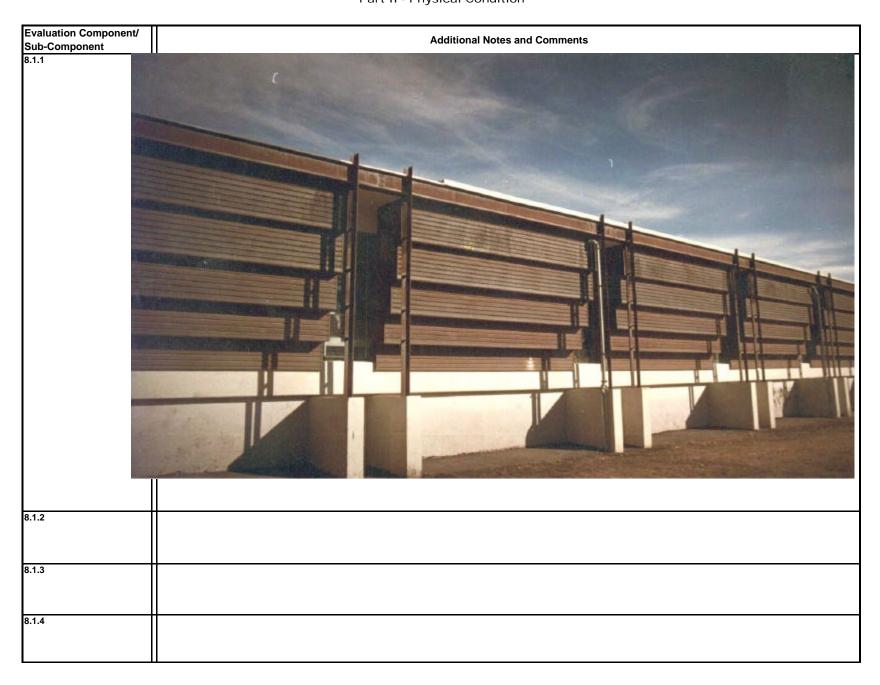
Expansions				flat wood deck roof. Horizontal "rusted steel " siding. See 8.1.1 for photo illustration of this siding .		
			1			<u> </u>
