RECAPP Facility Evaluation Report

Edwin Parr Composite Community School

B2418A
Athabasca

Evaluation Company: Francis Ng Architect Ltd.
Evaluation Date: September 26 2006
Evaluator Name: Francis Ng

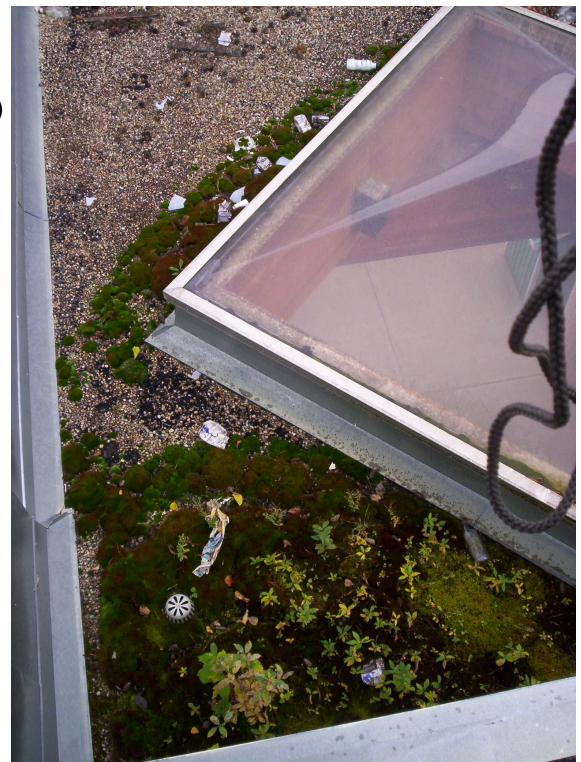
(1949) Original building, (1950) Addition, (1955) Addition, (1958) Addition, (1968) (gymnasium), (1984) Addition - (Flat Built-up Roof) has blisters, ponding, fish boning, worn out and cracked roofing.

Replace with SBS roofing. (approx. 700 square metres)

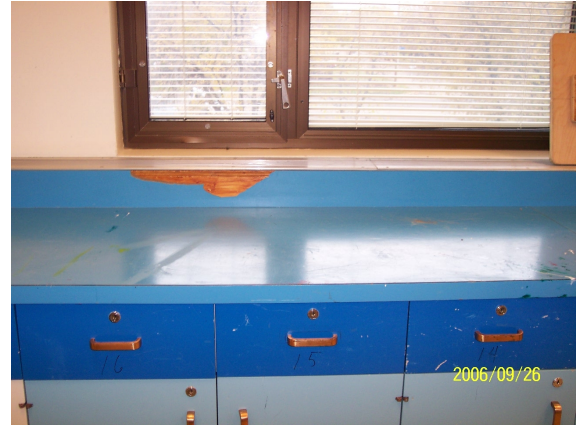
(1955) Addition - (VED 203) has damaged millwork.

Repair millwork. (approx. 20 metres)

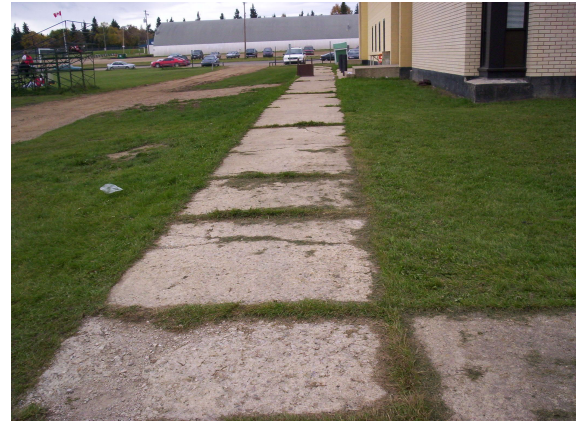
(1968) Addition - has unlevelled and worn out concrete sidewalk on the South side.

Replace concrete sidewalk.(approx. 100 metres long)
