RECAPP Facility Evaluation Report

Calgary School District #19

Ernest Manning High School

B2625A

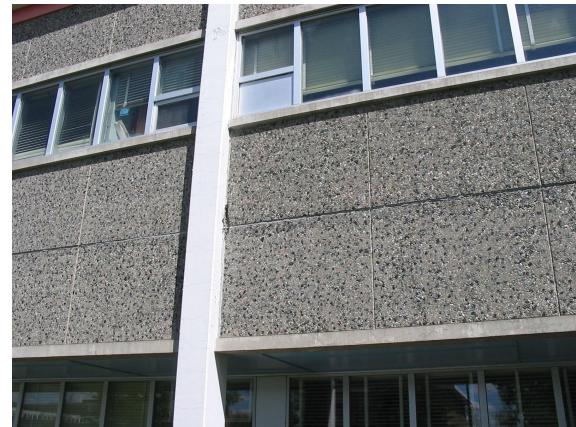
Event: Movement of precast concrete panels should be studied.

Movement of precast concrete panels up to 50 mm is noted. This indicates potential failure of anchors.

Study problem of precast panel movement, and provide recommendations for remediation.
