# RECAPP Facility Evaluation Report

## Fort McKay School

B3418A  
Fort Mackay

**Evaluation Company:** Denzil Lobo Architect  
**Evaluation Date:** December 1 2004  
**Evaluator Name:** Mr. Denzil Lobo

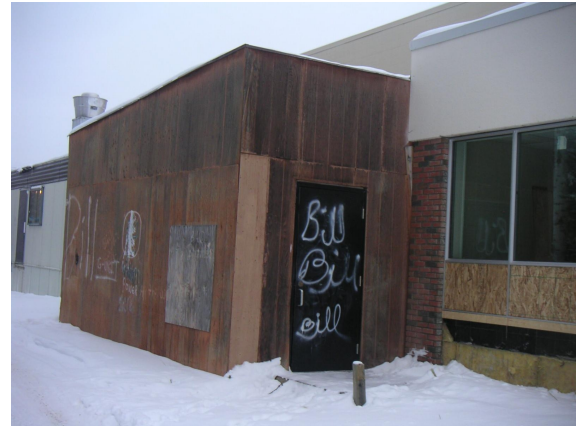
**B2010.01.99 Other Exterior Wall Skin\***

(1991) Wood Siding on back entry vestibule to Kitchen Trailer

| <u>Rating</u> | <u>Installed</u> | <u>Design Life</u> | <u>Updated</u> |
|---|---|---|---|
| 3 - Marginal | 0 | 0 | DEC-04 |

Back entry vestibule was added in 1991 and is wood framed with wood siding on exterior. Siding is warped, rotting, discoloured, deteriorating and unsightly.

**Event:** **Provide new siding on back entry vestibule addition**

Remove existing wood siding and reclad with new metal siding or stucco finish.

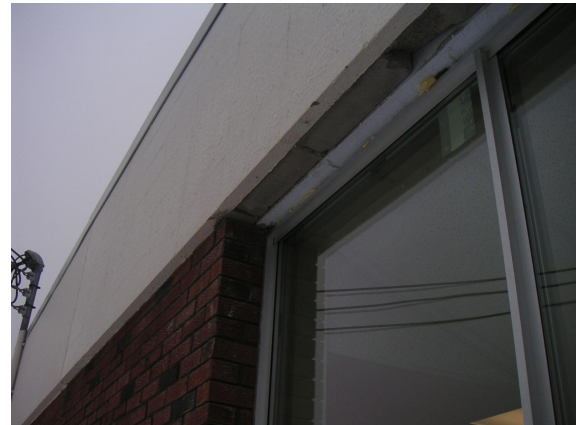
**B2010.02.03 Masonry Units: Ext. Wall Const.\***

100mm wide Concrete block backing for stucco fascia over exterior brick facing.

| <u>Rating</u> | <u>Installed</u> | <u>Design Life</u> | <u>Updated</u> |
|---|---|---|---|
| 3 - Marginal | 0 | 100 | DEC-04 |

New window installed in exterior wall at front of building. Concrete block for stucco banding was not supported on steel angle lintel and presently remains in place due to mortar.

**Event:** **Install lintel for blockwork at new window location on front of school.**

Provide steel angle lintel at new window location prior to finishing off opening and installation.

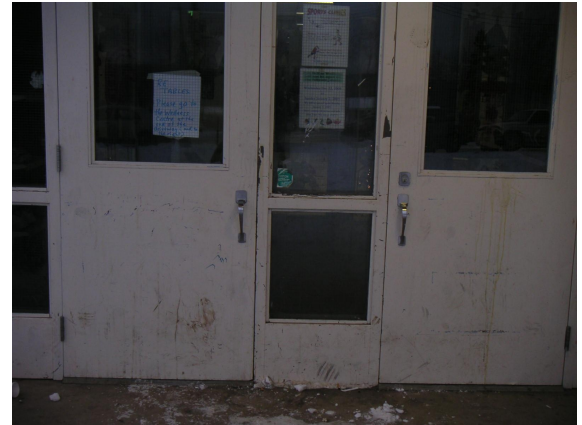
**B2030.01.02 Steel-Framed Storefronts\***

(1976) Main Entrance door frames are hollow metal frames with glazed sidelights.

| <u>Rating</u> | <u>Installed</u> | <u>Design Life</u> | <u>Updated</u> |
|---|---|---|---|
| 3 - Marginal | 0 | 30 | DEC-04 |

Main entrance door frames are warped, damaged, dented and unsightly. Replace hardware as well

**Event: Replace Main Entry Door Frame**

Replace main entry door frames with new frames and sidelights.
