# RECAPP Facility Evaluation Report

## Fort McMurray Composite High School

B3427A  
Fort McMurray

**Evaluation Company:** Denzil Lobo Architect  
**Evaluation Date:** December 1 2004  
**Evaluator Name:** Mr. Denzil Lobo

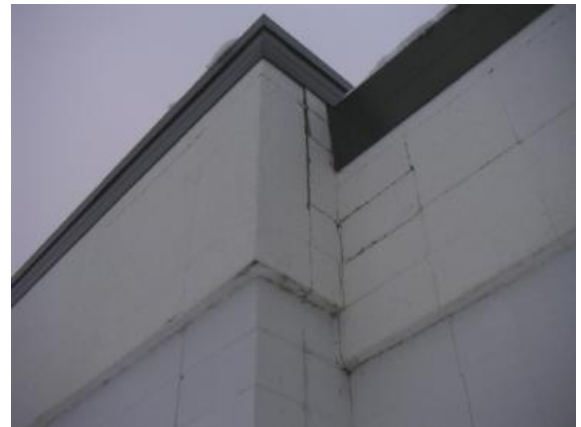
The block walls on the south walls have a lot of cracks in the walls and along the parapets. It appears that there is a lot of movement of the walls in this area. The cracks do not pose any structural safety concerns.

The causes and remedies for this cracking of the blockwork needs further study. The cracks appear on the inside of the walls and floors in this South wing and are not solved by patching or covering up the conditions. A soil investigation in the area along with a Structural stability study of this area is recommended.

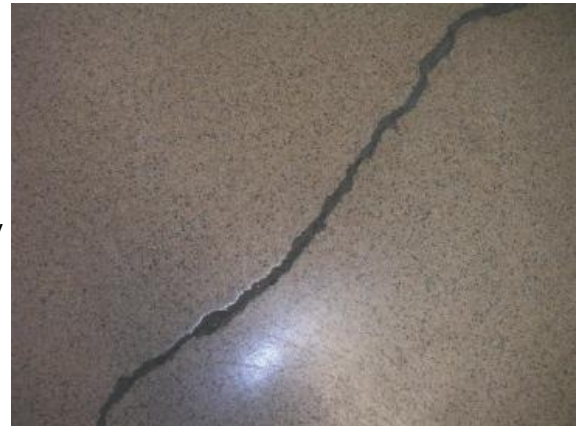
The epoxy floors are cracked, stained, discoloured, and dirty looking. Cracked floors create a tripping hazzard.

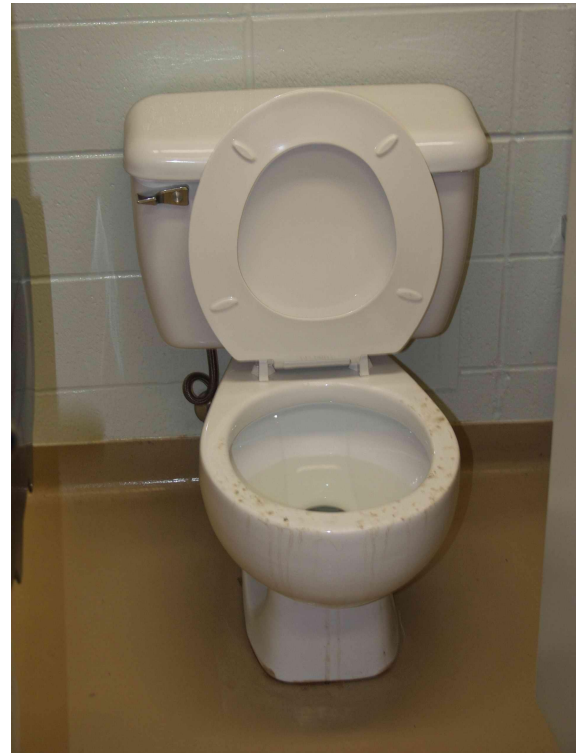
Toilets are not efficient, they are old and there are a number that are cracked. Maintenance requirements are considerable. Most have round bowls with closed front seats which do not meet current codes.

Replace approximately 35 toilets with ULF toilets with elongated bowls and open front seats

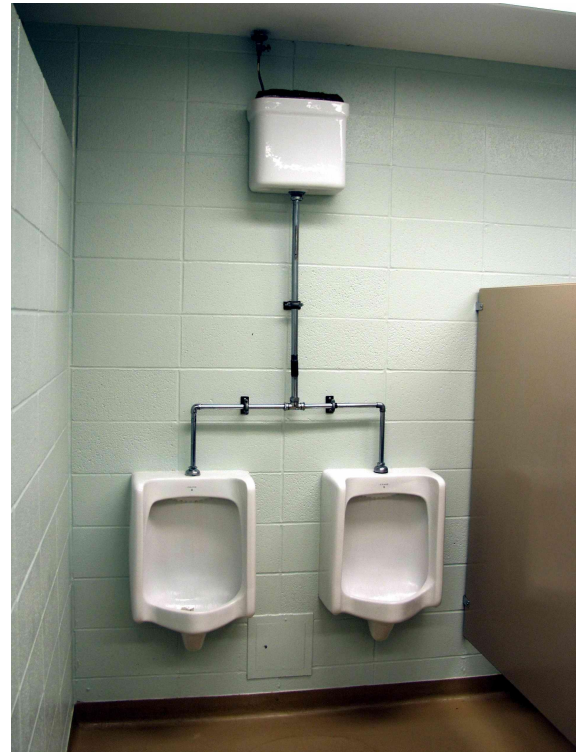
High water consumption. Fixtures and flush systems are old and in poor condition.

Replace flush systems with approximately 18 electronic flush valves. Replace selected cracked urinals.

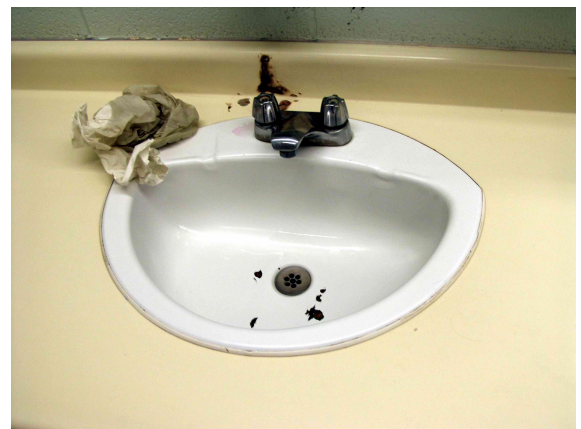
(1976) Vanity mounted lavatories. Most are pocolain enamel steel with ribbed handle faucets. Many lav's are chipped.

Replace 20 lavatories and faucets throughout.

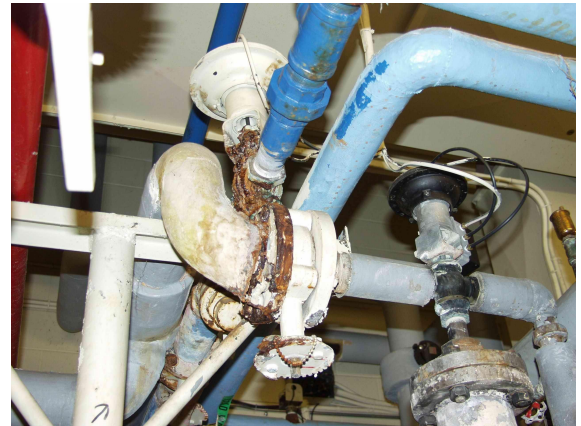
Valves and actuators are in poor condition, require significant repairs, and do not provided consistant control.

Replace 40 valves and actuators. Tie into existing BMCS.
