RECAPP Facility Evaluation Report

Graminia School

B4051A
Spruce Grove

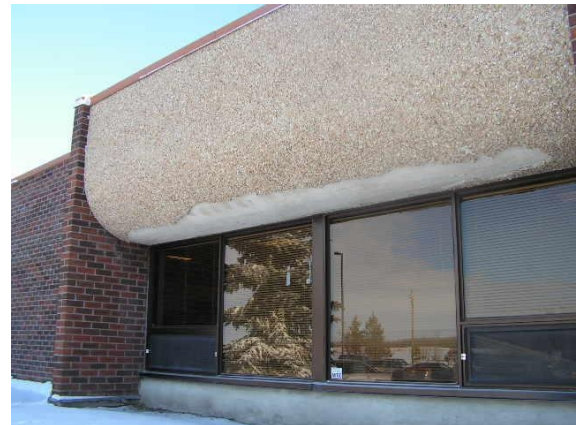
B2010.01.08 Portland Cement Plaster: Ext. Wall*

<u>Rating</u>	<u>Installed</u>	<u>Design Life</u>	<u>Updated</u>
3 - Marginal	0	75	DEC-04

Lower portion of stucco fascia has spalled off in one location

Event: Replace stucco finish to one section of fascia

Rectify cause, probably moisture freeze / thaw action, and replace stucco finish to match existing. Approximately 10 sq.m. of new stucco is required.

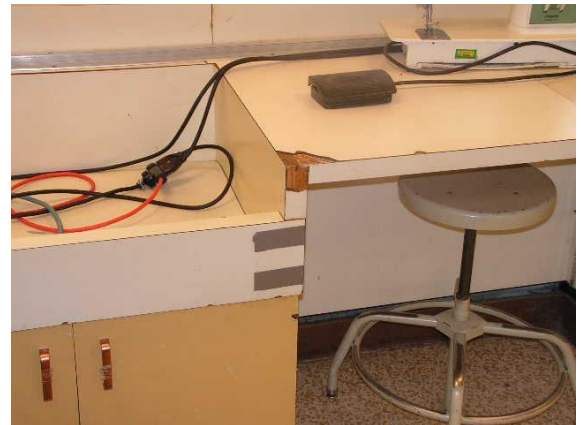
Considerable number of counters have damaged plastic laminate edges, making them difficult to keep clean and potentially a safety hazard to students due to loose and broken edging.

Event: Replace plastic laminate edging to counters

Replace broken edging with new plastic laminate.

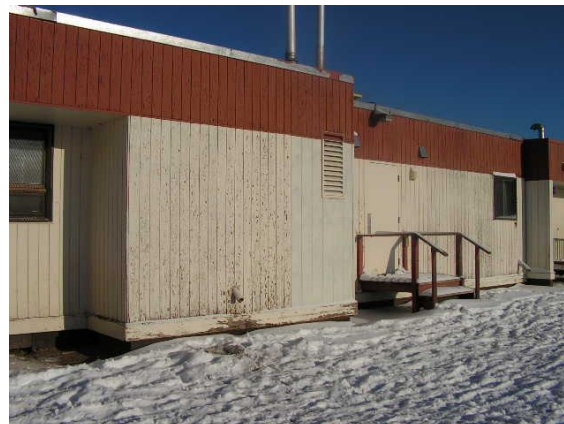
Wood siding is deteriorated and in need of replacement. Localized areas of rot at window penetrations and downspout locations.

Event: Wood siding is deteriorated and in need of replacement with a low-maintenance siding.

Replace with low maintenance metal siding. Approximately 90 sq.m.
