RECAPP Facility Evaluation Report

Edmonton School Dist #7

Grandview Heights Elementary / Junior High School

B3136A
Edmonton

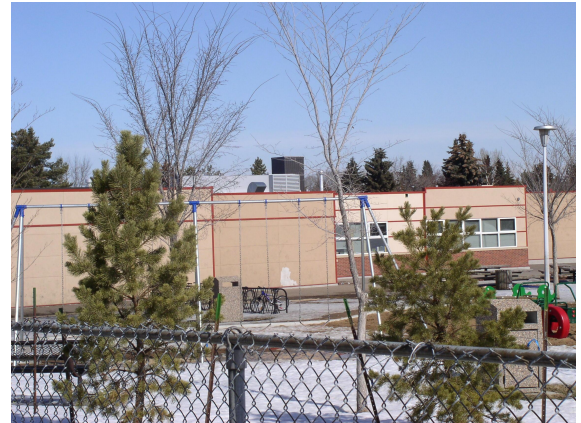
2002 Exterior wall is 70% Stucco. Stucco top coat is spalling in two areas.

Event: **Investigate why stucco is spalling.**

Stucco is 2 years old and isolated spalling noted in two areas. Each area approximately 1/2 sq. m.

Conduct further investigation to determine cause of this spalling.
