RECAPP Facility Evaluation Report

Edmonton School District No. 7

High Park Elementary School

B3148A
Edmonton

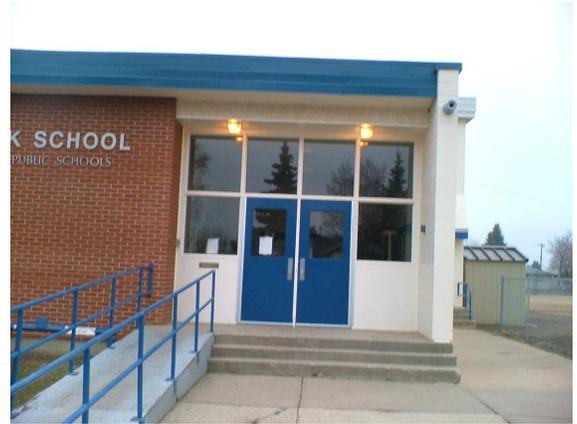
B1010.06 Ramps: Exterior**

<u>Rating</u>	<u>Installed</u>	<u>Design Life</u>	<u>Updated</u>
3 - Marginal	0	40	NOV-05

Event: Replace the wood ramp at the main entrance with a new concrete ramp.

Concern:

The wood ramp is not in good condition and needs frequent maintenance.

Replace the wood ramp with a new concrete ramp.

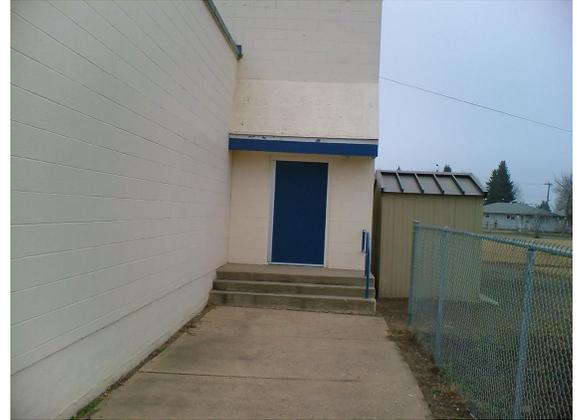
1960 - A small wood frame canopy above the east exterior entrance to the gymnasium. The wood frame canopy above the west exterior entrance to the gymnasium is not in good condition.

Event: **Replace the canopy above the west exterior entrance to the gymnasium with a new canopy.**

The existing canopy above the west exterior entrance to the gymnasium is not in good condition and is not properly designed. Ice, snow and water falling directly onto the exterior exit stairs and cause hazardous situation.

Replace the canopy with a new canopy of proper design.

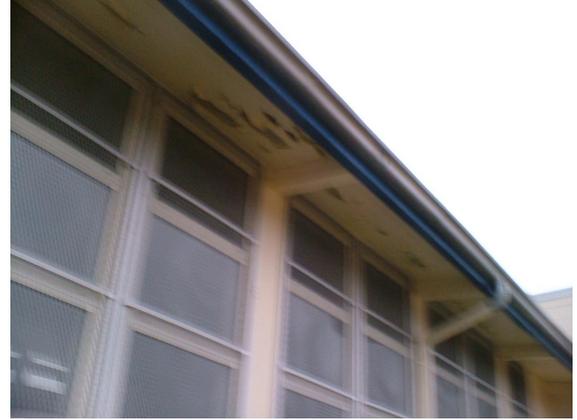
1954, 1960 - Painted plywood soffit for all phases.
 1954 - Painted wood panel soffit at the north end of the building.

<u>Rating</u>	<u>Installed</u>	<u>Design Life</u>	<u>Updated</u>
3 - Marginal	0	20	NOV-05

Event: Repaint the wood panel soffit at the north end of the 1954 original building.

Paint peels off from the wood panel soffit at the north end of the 1954 original building.

Repaint the wood panel soffit.

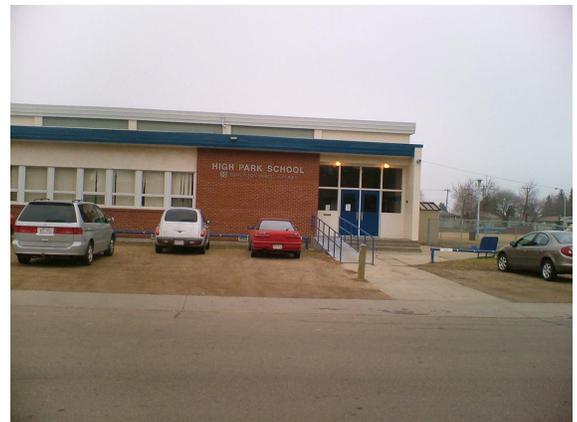
Bus loading/unloading on street blocking staff parking lot. Congested condition on street during drop-off and pick-up times. 10 staff parking stalls. No visitor or handicap-only stalls.

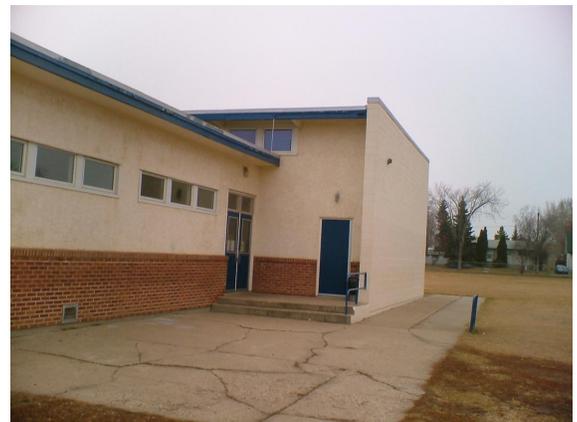
1954 - Concrete sidewalks on the east, west and north sides of the building to the entrances. The concrete pavement on the east side of the building and the concrete sidewalk to the south entrance entrance on the west side of the building are not in good condition.

1960 - Concrete sidewalks on the west side and east side of the building to the entrances. The concrete sidewalk to the main entrance on the west side of the building is not in good condition.

Event: **1954 - Replace the concrete pavement on the east side of the building. Replace the concrete sidewalk at the south entrance on the west side of building.**
1960 - Replace the concrete sidewalk to the main entrance on the west side of the building.

1954 - The concrete pavement on the east side of the building and the concrete sidewalk at the south entrance on the west side of the building are not in good condition.

1960 - The concrete sidewalk to the main entrance on the west side of the building is not in good condition. People can trip and fall down.

Replace the concrete pavement and concrete sidewalk at these locations (280 sq.m.).
