School Name:	Holy Cross			School Code:	203	
Location:	15120 - 104 avenue Edmonton, Alberta T5P 0R5			Facility Code:	2007	
Region:	Central			Superintendent:	Dr. Dale W. Ripley	
Jurisdiction:	Edmonton RCSSD No. 40			Contact Person:	Mr. Garnet McKee	
				Telephone:	(780) 453-4500 (Garnet)	
Grades:	K-IX			School Capacity:	Total 880	
Building Section	Year of Compl.	No. of Floors	Gross Bldg Area (Sq.M.)	Type of Construction (i.e., structure, roof, cladding)	Description of Mechanical Systems (incl. major upgrades)	Comments/Notes
Original Building	1963	2	3351.8	Masonry/B.U.R.	Perimeter hot water heating; separate ventilation systems; gas-fired furnaces serve heating & ventilation for 1972 Gymnasium.	
Additions/ Expansions	1968 1972	1 2	2312.9 1500.0	Masonry/B.U.R. Masonry/B.U.R.		
					Evaluator's Name:	George Brandt
					& Company:	Henderson Inglis Partridge

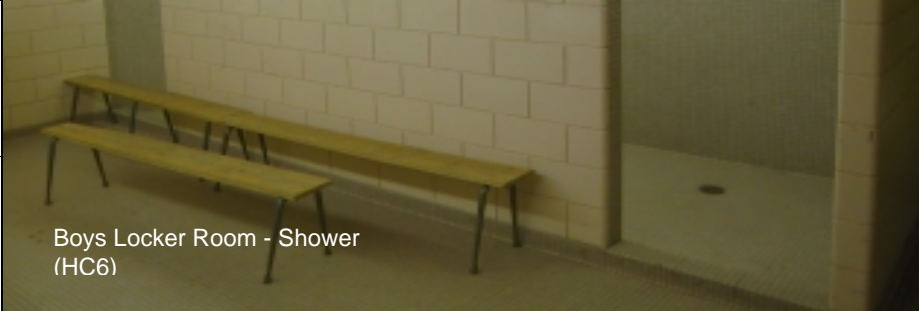
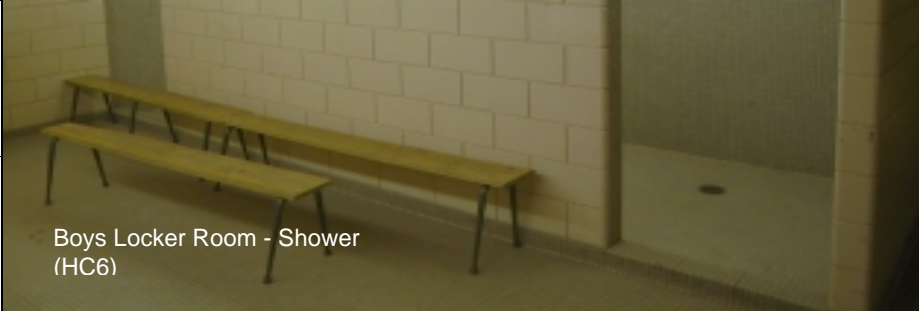
Boys Locker Room - Shower (HC6)

3.2.8	Washroom materials and finishes.	2	63/68/72	Painted concrete block with tooled joints appear dirty and unsuitable for age of users. Ceramic tile finishes are broken, chipped, cracked and mis-matched in colour. Water leakage from past plumbing problems have stained ceilings and ceramic tile grout. Washroom finishes should be replaced with new commercial grade tile that meet current standards.	\$42,000
	Other

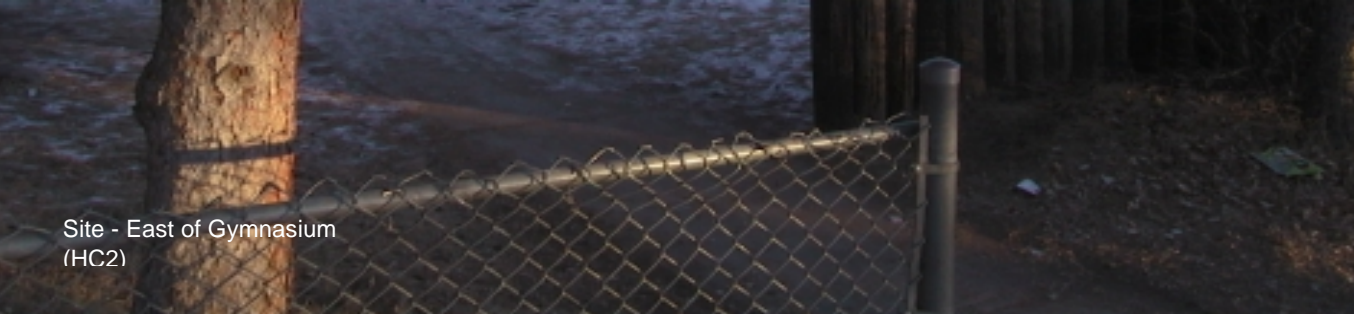
<p>Site - East of Gymnasium (HC2)</p>
Site landscaping.	<p>Community funding has allowed for landscaping over and above any normal standards for schools. Landscaping is parklike and acts as a buffer between the school building and neighbouring residences.</p>

1.1.4	Site landscaping.	5	Community funding has allowed for landscaping over and above any normal standards for schools. Landscaping is parklike and acts as a buffer between the school building and neighbouring residences.
