RECAPP Facility Evaluation Report

Edmonton School District No. 7

Holyrood Elementary School

B3156A
Edmonton

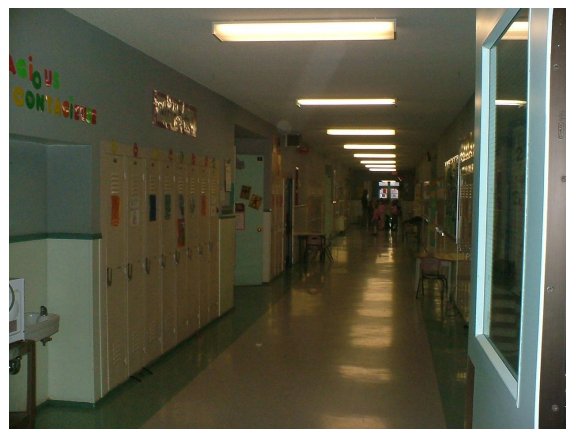
Concern:

The school has 414 students and has less than 200 lockers. These lockers are located in the 1957 addition. It is inconvenient for the students in the 1955 original building to use these lockers.

Recommendation:

Install 200 new single tier metal lockers in the 1955 original building.

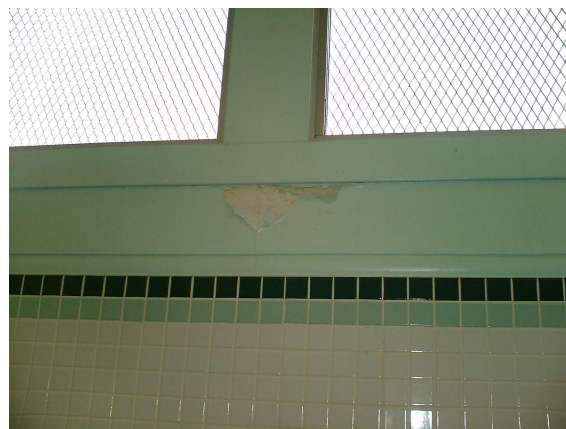
Concern:

Paint peeling off, chipped and stained in various rooms.

Recommendation:

Paint damaged surfaces in the building.

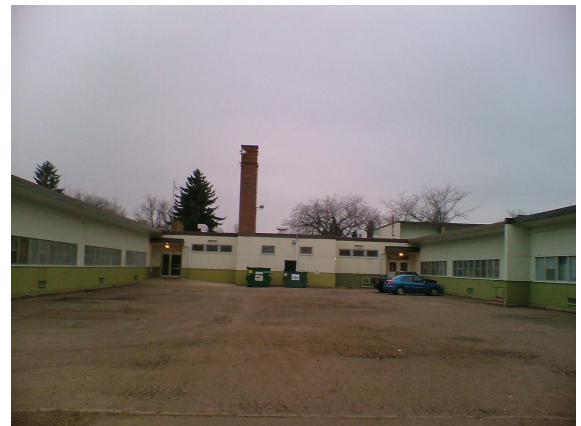
There is a central parking lot (asphalt) between the 1955 original building and the 1957 addition. The asphalt pavement of the parking lot is not in good condition.

There is a central parking lot (asphalt) between the 1955 original building and the 1957 addition. The asphalt pavement is not in good condition.
