Upgrading/ Modernization (identify whether minor or major)	1991					-Minor Modernization create new Science Rm. in open area. -Minor Modernization create C.R. within I.A. area with windows. Upgrade Locker Rm. Hooks, doors, benches, construct 3/4 length wall to separate C.R. from corridor. -Minor Modernization add door window to 2 Offices on 1st floor & install door window into 2nd floor Counselors Office. -Minor Modernization subdivide I.A. area & create a C.T.S. Lab. -Minor Modernization create an exit corridor on 2nd floor to Code requirements.
	1993					
	1995					
	1996					
	1998					
Portable Struct. (identify whether attached/perman. or free-standing/ relocatable)						
List of Reports/ Supplementary Information	See Section 8 for complete list.

Evaluation Components	Summary Assessment	Estim. Cost
1	Site Conditions	Generally good, perimeter walkways require some attention.	\$12,000
2	Building Exterior	Generally good attention required on a number of exterior elements.	\$16,500
3	Building Interior	Floors, Ceilings and lack of elevator for second storey access are the primary deficient areas. School has only been painted once since completion and it shows.	\$296,000
4	Mechanic

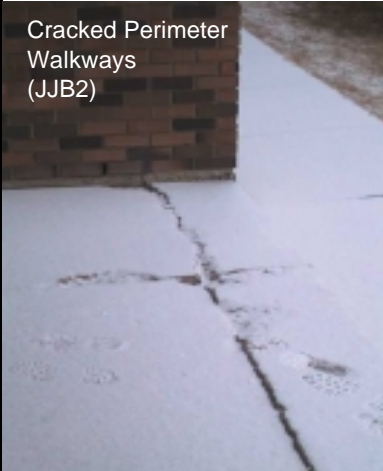
1.1.6	Surface drainage conditions (i.e., drains away from building, signs of ponding).	3	Perimeter walkway shows signs of settlement leading to back slope to school in a number of areas.	\$10,000

1.3.4	Layout and safety of sidewalks.	4		
1.3.5	Surfacing and drainage of sidewalks (note type of material).	3	Slab at north entrance settled with back slope to school. Perimeter walkway shows signs of movement from school and back slopes.	Cost is identified as part of 1.1.6

(JJB2)	Perimeter concrete walkways show signs of cracking and backslope.		
(JJB3)	Screens on North side of school require repainting.

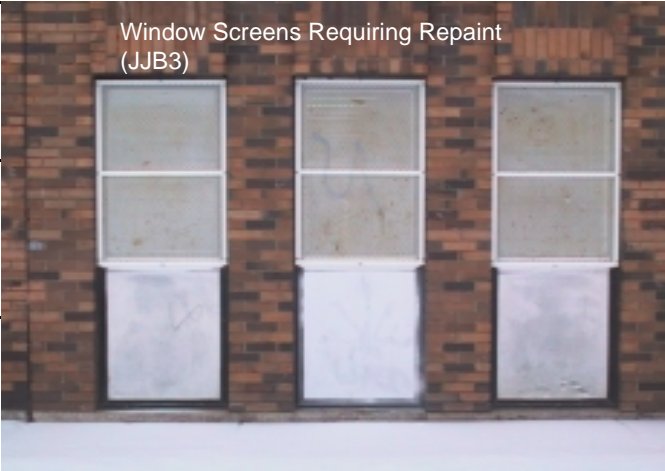
2.4.5	Window accessories (i.e., latches, hardware, screens, locks, alarms, holders, closers, security devices).	3	Metal screens on windows rusting. Repaint on north side of school.	\$2,000

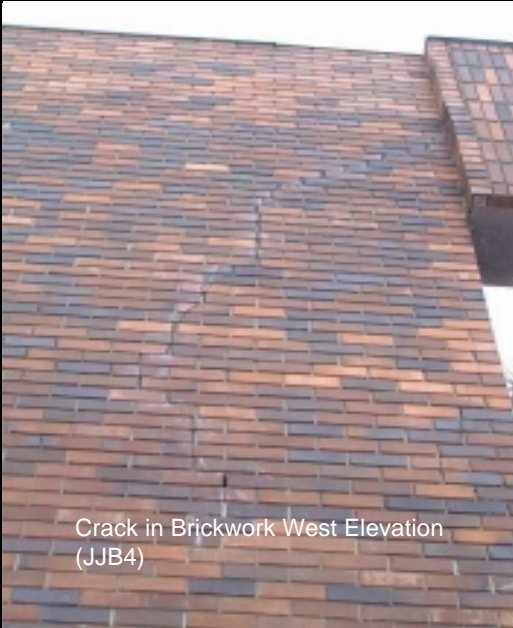
Section 2	Building Exterior	Rating	Comments/Concerns		Estim. Cost
2.3	Exterior Walls/Building Envelope		Bldg. Section	Description/Condition	\$7,000
2.3.1	Exterior wall finishes (i.e., signs of deterioration, cracks, brick spalling, effluorescence, water stains).	3		Brick expansion joints require re-caulk. Graffiti / paint on brick north side. Some damaged brick corner conditions cracking at wall defining open court. See 2.1.2	\$5,000

Crack in Brickwork West Elevation (JJB4)	Exit Stair Floor Finish Requiring Replacement (JJB5)
(JJB4)	Cracking in exterior wall near entrance.	
(JJB5)	Flooring in stair enclosures looks soiled and unattractive.

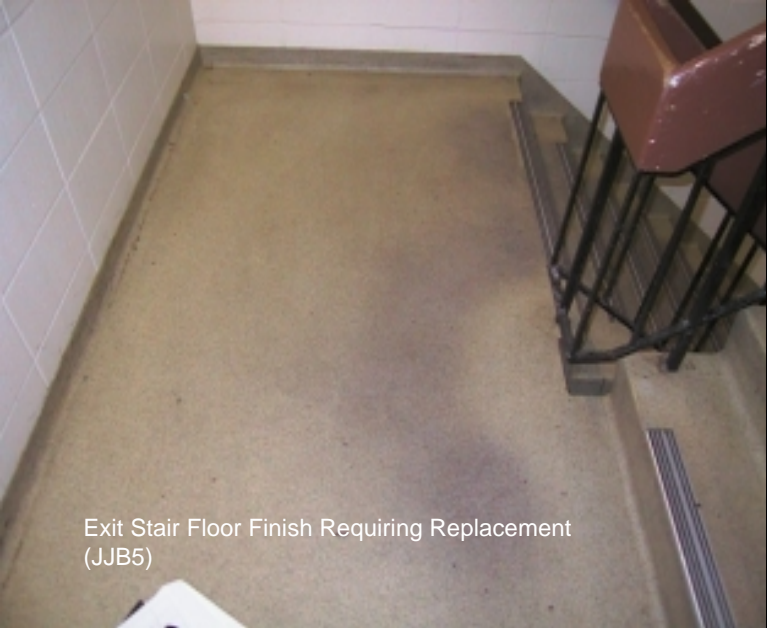
3.2	Materials and Finishes		<u>Bldg. Section</u>	<u>Description/Condition</u>	\$211,000
3.2.1	Floor materials and finishes.	3		Washrooms / stairwells cracking - looks very dirty in stairs due to age. Replace. 100 S.M. VCT typically in good condition throughout. Original carpet dated and coming apart at seams. Should be replaced. 600 SM. Wood floor in gym good condition.	\$26,500

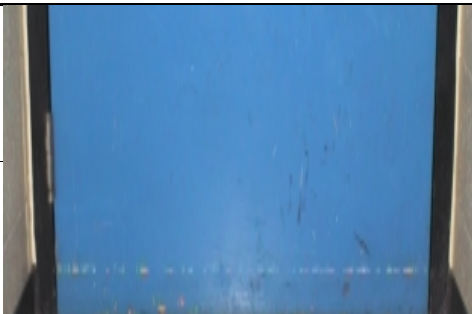
Dated/Worn Carpet Requiring Replacement (JJB6)	Typ. Door/Frame Requiring Painting (JJB7)
(JJB6)	Original carpet in some classrooms is torn at seams, worn, and dated in appearance.	
(JJB7)	Paint chipping evident in doors/frames throughout school.

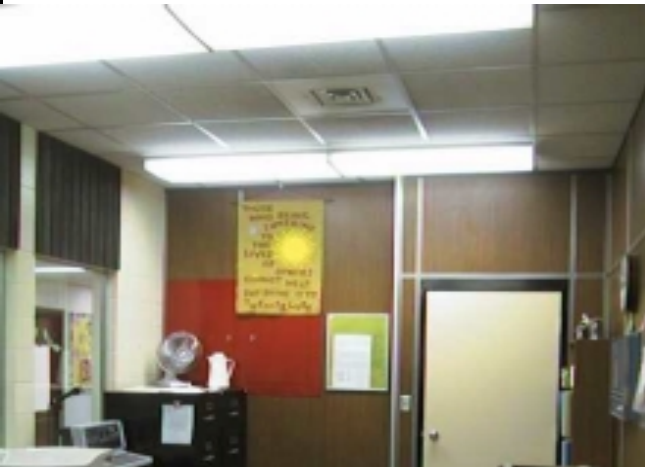
Typical Soiled /Damaged Ceiling Tile (JJB9)

3.2.3	Ceiling materials and finishes.	3		Wood slats corridor painted white. Requires painting in stairwells. Suspended acoustic tile in classrooms is original and generally very badly soiled (Note: All air system). Rusted suspended "T" in second floor janitor room with roof access.	\$95,000

Dated/Dark Interior Finish (JJB8)	
(JJB8)	Wall finishes in a number of locations are dark, unattractive, dated and inflexible due to material selection.	
(JJB9)	Ceiling tiles are damaged/soiled throughout school. All air system may contribute to soiling of tiles.
