RECAPP Facility Evaluation Report

Edmonton School Dist #7

John A. McDougall Elementary / Junior High School

B3210A
Edmonton

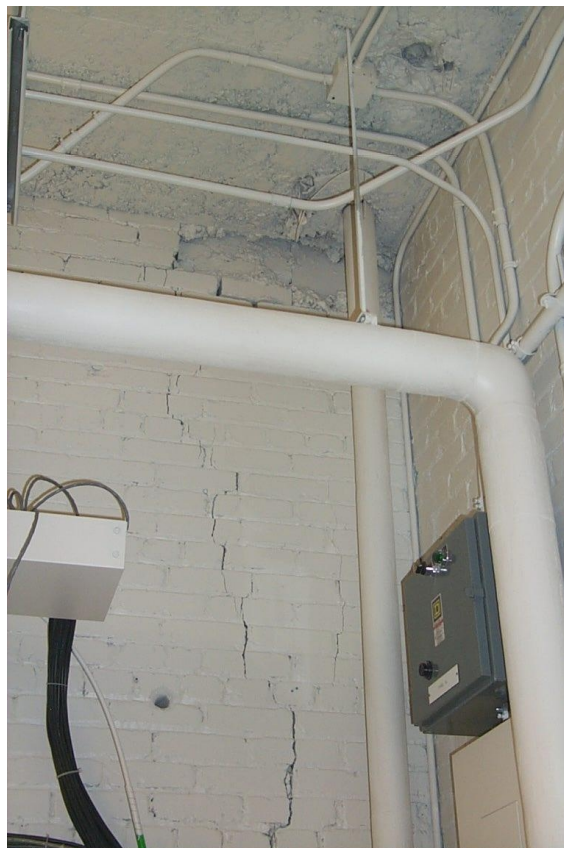
B1010.10 Floor Construction Firestopping*

1913/30 building -unsealed penetrations (conduit, pipe, raceway) through floors / walls / ceilings in the electrical room 008, custodian room 013, music room 015, storage room 031 and 1972 gymnasium building.

Unsealed penetrations (conduit, pipe, raceway) through the floors, walls and ceilings compromise the buildings fire separations.

Event: Fill and seal the floor/wall/ceiling penetrations with firestopping material.

Fill and seal the floor/wall/ceiling penetrations with firestopping material to meet code.

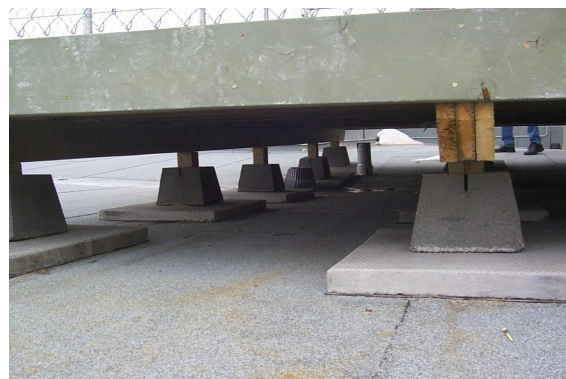
B3010.01 Deck Vapor Retarder and Insulation*

2002- Wood observatory deck on roof of 1930 building.

Wood deck has untreated wood connections and ends.

Seal exposed natural wood as appropriate (eg. stain, preservation, paint)

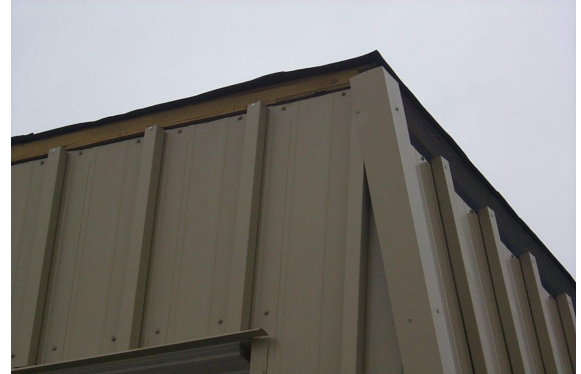
B3010.08 Flashing and Sheet Metal

New building link between the 1913/30 and 1972 buildings as well as the roof top observatory.

Both areas are without required flashing; wall and roof construction exposed to elements.

Install flashing.

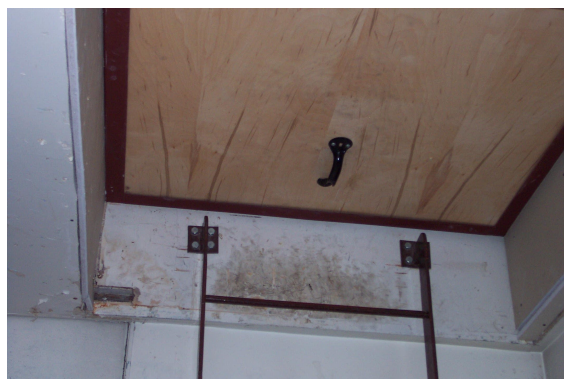
C1020.07.01 Access Doors and Panels

The 1972 building's storage room 039 and mechanical space 046 (mech space in mezzanine above storage room 039) both have plywood access doors.

Access doors are both single sheet plywood doors, which compromise the integrity of the fire separations.

Event: Replace both plywood doors with ULC labeled hatch doors.

Install fire rated hatch doors.

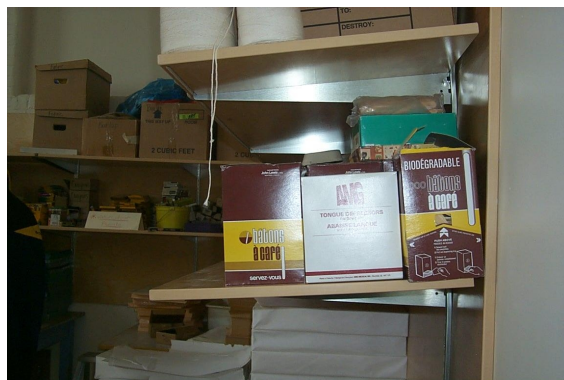
C1030.12 Storage Shelving*

1930 building -Basement Art storage room 021.

Shelves are binding and pulling out the wall supports due to overloading.

Remove weight, repair shelves and wall, remount supports and display warning signs about weight restrictions.

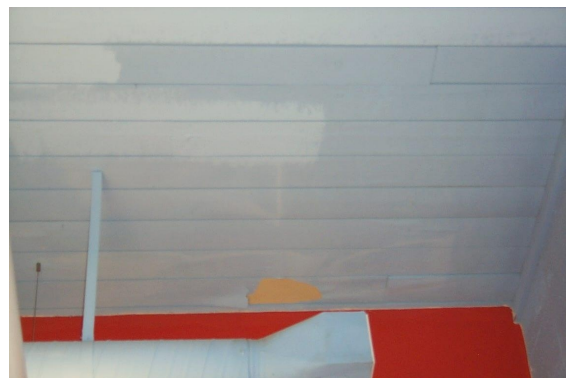
C3030.07 Interior Ceiling Painting*

2000- 1955 building

Paint is peeling and bubbling badly.

Futher investigation to determine the reason for the paint problems.

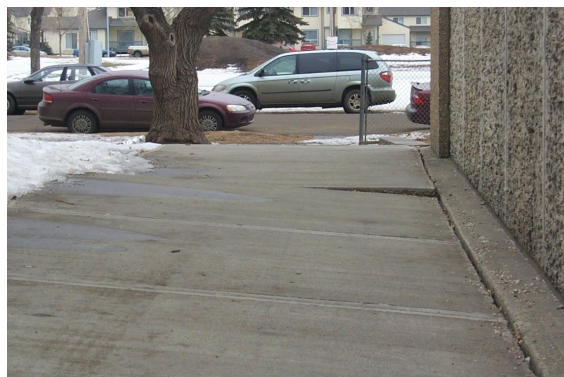
Sidewalk (front entrance to gym) is sloping towards building creating water pooling problems; large cracks and settling/lifting of sidewalk.

Re-level ground and replace existing sidewalk. (72 m²)

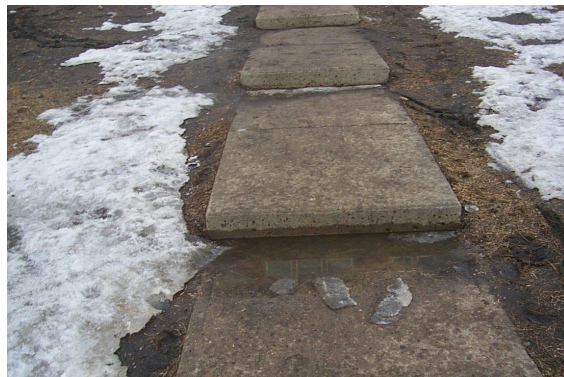
**G2030.06 Exterior Steps and Ramps***

Front entrance stairs to building

Remove existing sloping stairs, relevel ground and replace with new concrete stairs.

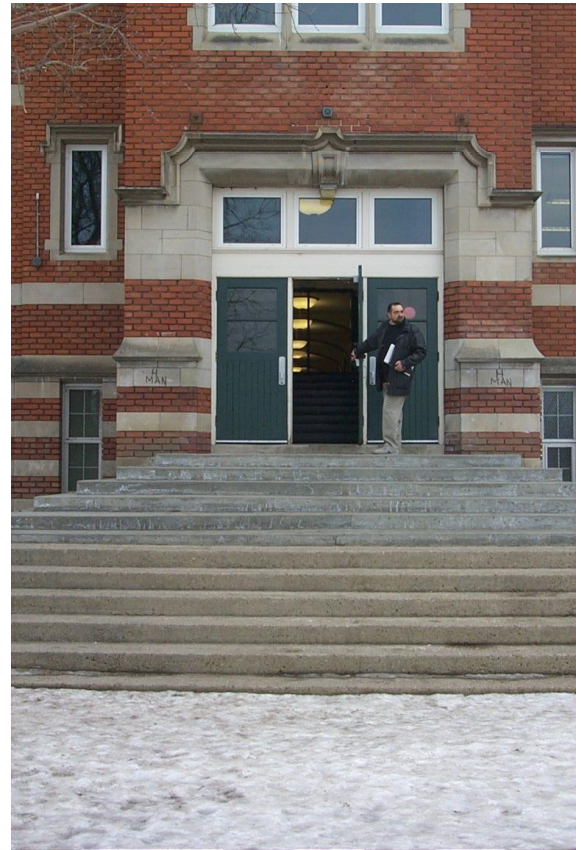
G2030.06.05 Metal Handrails and Railings

Exterior stairs in need of metal handrails.
