RECAPP Facility Evaluation Report

Kildare Elementary School

B3182A
Edmonton

Evaluation Company: Lotus Architecture
Evaluation Date: December 1 2004
Evaluator Name: Mr. Tonu Mitra

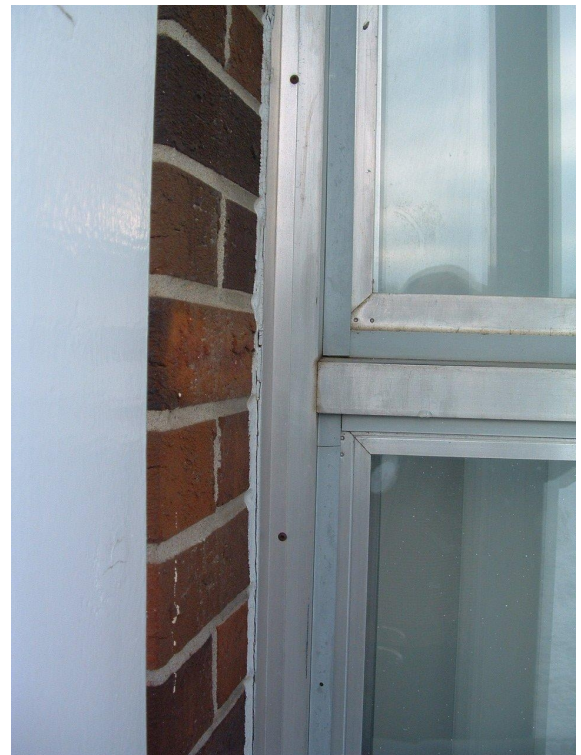
(1968) Original aluminum windows, consisting of two separated aluminum sections with field glazing. Wood framing sections in between. Bottom slider sections. Painted wood sills.

<u>Rating</u>	<u>Installed</u>	<u>Design Life</u>	<u>Updated</u>
3 - Marginal	0	35	DEC-04

Original windows are not energy efficient, there is no effective weather seal. Wood sections between panes have rotted due to condensation and cannot be repaired. Interior surfaces of frames also condensate. Painted wood sills have cracked and starting to rot.

Replace existing windows with new windows, similar to the ones used in the new addition, complete with new sills. (16 windows). Includes cost of demolition of transite panel walls below 14 windows and rebuilding of exterior walls.
