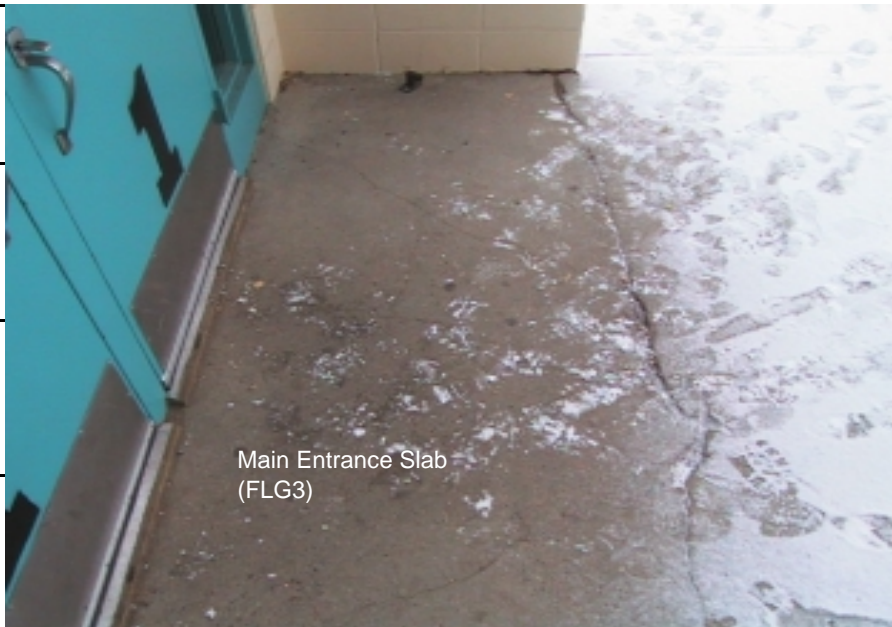
<p>Main Entrance Slab (FLG3)</p>

(FLG3)	Exterior concrete walkways show signs of settlement and cracking.

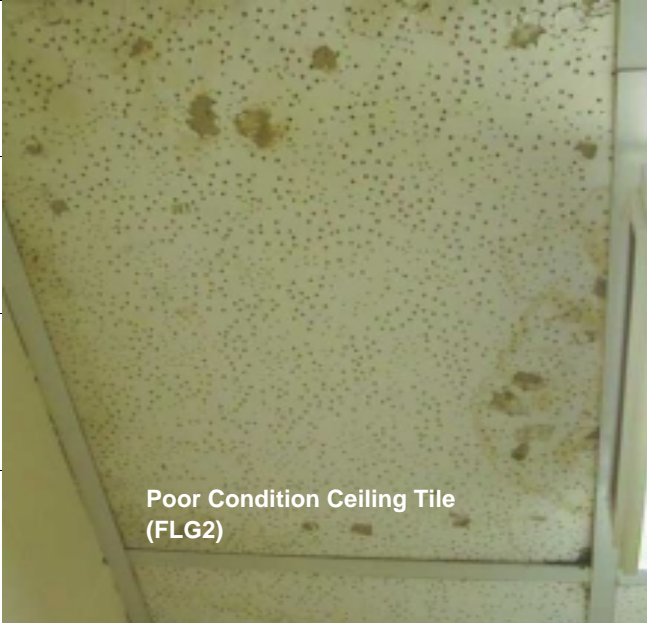
<p>Poor Condition Ceiling Tile (FLG2)</p>

<p>Poor Condition Slab and Stucco (FLG4)</p>
(FLG2)	Original ceiling tile is in need of replacement.	
(FLG4)	Stucco is in need of repair some areas and concrete shows signs of settlement/cracking.
