# **RECAPP Facility Evaluation Report**

**Wild Rose School Div #66**

**Maintenance / Transportation Shops**

**B5779A**

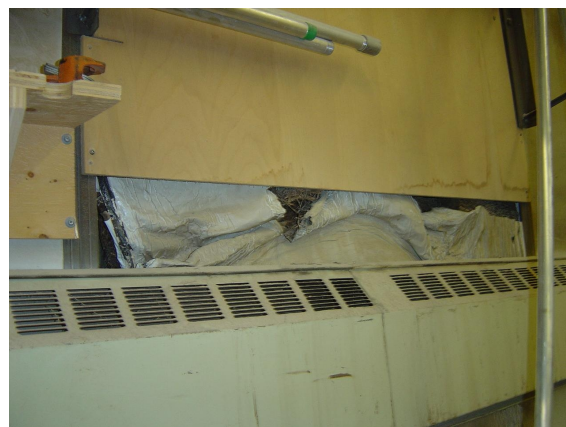
**B2010.03 Exterior Wall Vapor Retarders, Air Barriers, and Insulation\***

(1976 & 1982) The inner wall is vinyl wrapped stramit (straw) panels, approximately 50-60mm thick. The thermal resistance may be about an R10. The vapour barrier is the vinyl.

There are a number of locations where the insulation panels have been compromised or failed. The thermal resistance values are poor.

Repair specific locations, and implement phased upgrading of the interior wall layer. Remove and replace panels with 38 x 140mm wood stud walls, R20+ fibreglass batt insulation, poly vapour barrier and gypsum board finish (or pre-finished metal panel finish as required by area use). 1,000 s.m. surface area.
