# RECAPP Facility Evaluation Report

Wild Rose School Div #66

**Maintenance Shop**

**Evaluation Company:** John Hull Architect  
**Evaluation Date:** November 4 2005  
**Evaluator Name:** Ms. Sherri Turpin

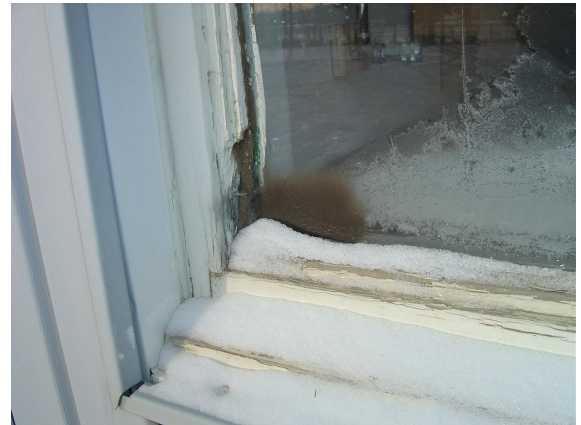
**B2020.01.01.05 Wood Windows (Glass & Frame)\*\***

(1976) double-glazed wood frame windows, awning on lower half.

<u>Rating</u>	<u>Installed</u>	<u>Design Life</u>	<u>Updated</u>
3 - Marginal	1976	35	NOV-05

Windows are aging, some frames are rotten.

Replace all six windows, approximately 16 s..m.
