TABLE OF CONTENTS

EXECUTIVE SUMMARY

Project Overview

In November 1999 the Alberta Infrastructure School Facilities Branch engaged Carruthers & Associates Architects Inc. to investigate and report on the physical condition of 10 schools in Calgary under the jurisdiction of the Calgary Board of Education. We are now pleased to present the results of our investigations, in the form of charts as specified by Alberta Infrastructure.

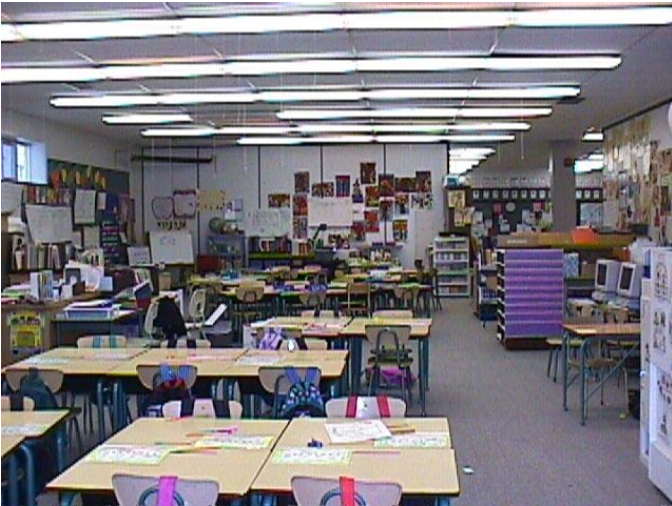
However, the open concept design has been found to be unsuitable for educational purposes. Sounds from each class are disruptive to neighbouring classes, despite obvious efforts by teachers and students to be quiet.

7. Open Classroom – Noise is a Concern

Further sound-dampening materials are needed throughout.

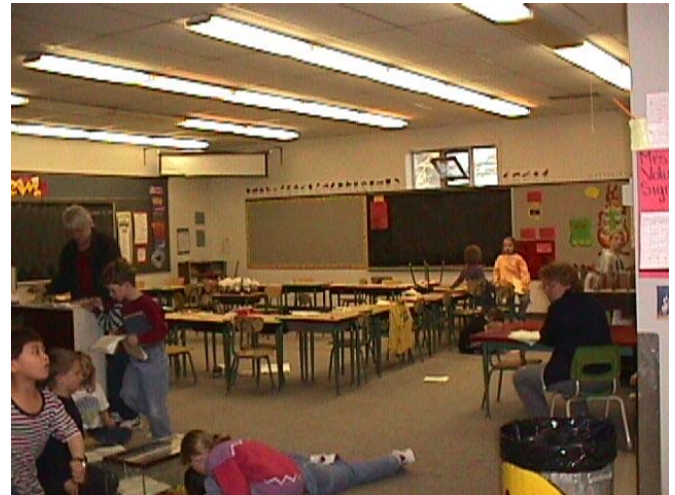
8. Open Classroom – Noise is a Concern

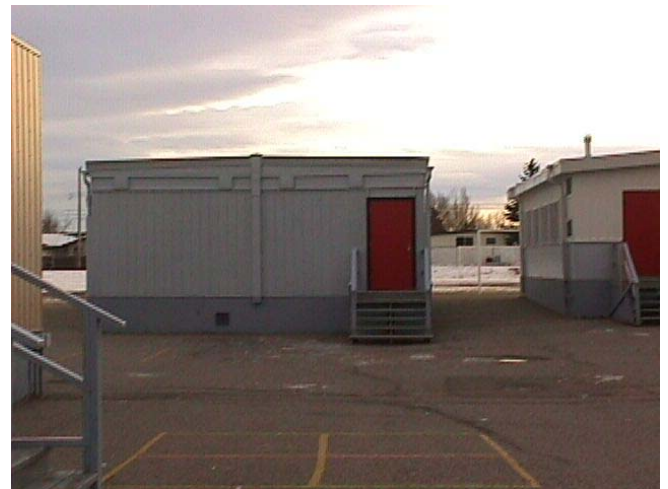
Portable classes are in poor to fair condition, with worn surfaces and a lack of storage and support services.

10. Portable Classroom

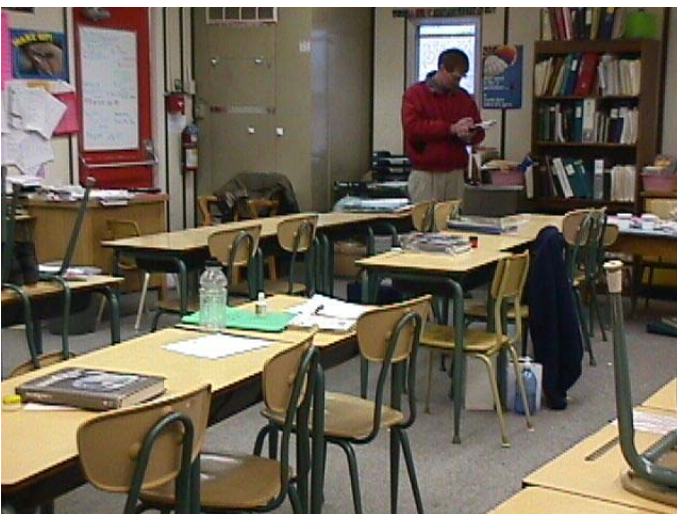
11. Portable Classroom (Interior)

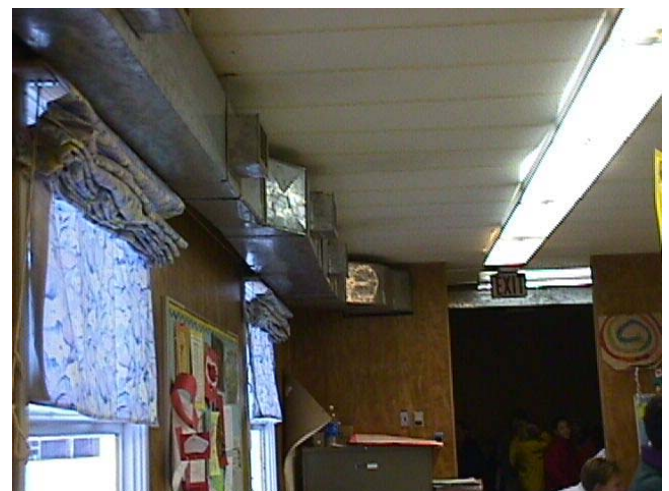
12. Portable Classroom (Interior)

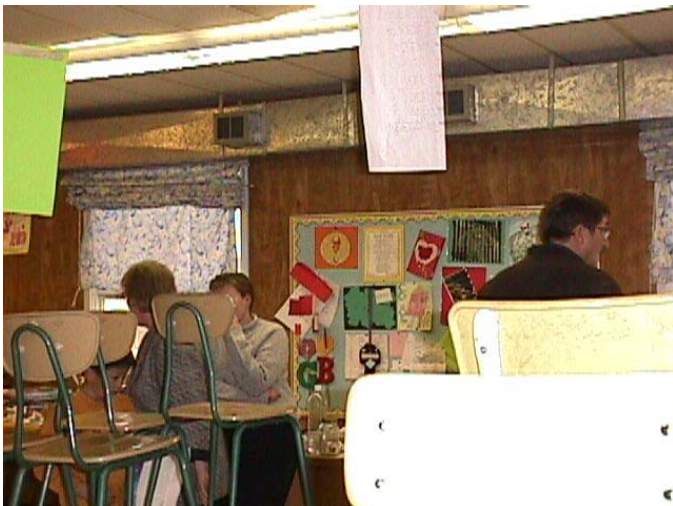
13. Portable Classroom (Interior)

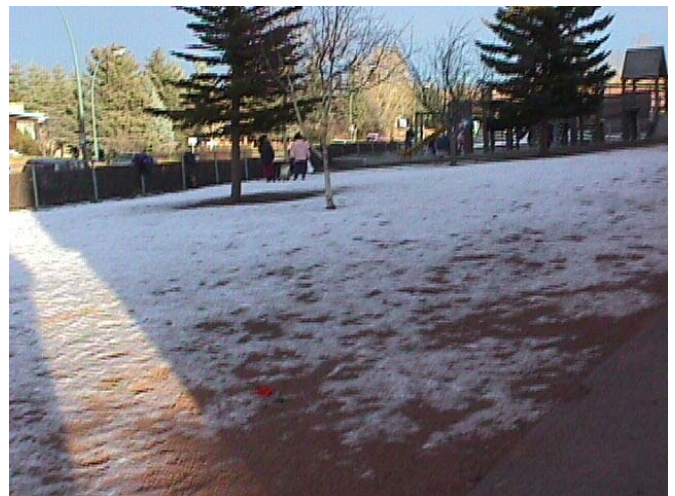
The site is too small. Turf areas are worn and need regrading and resodding.

14. Front Lawn Converted to Playground, grass and topsoil eroded

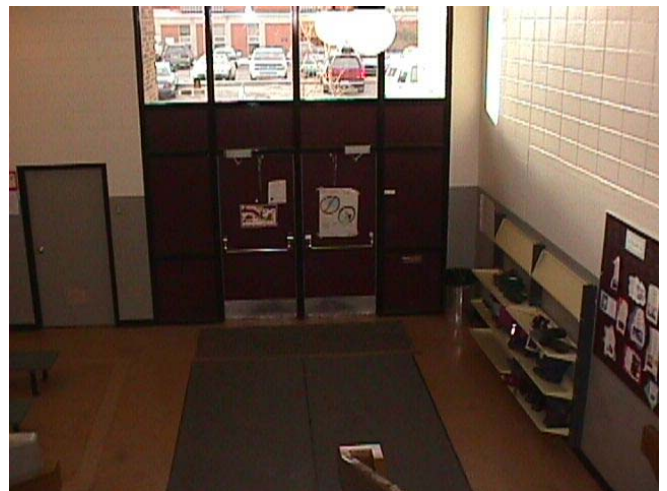
16. Main Entry Not Large Enough to accommodate big rush of surface

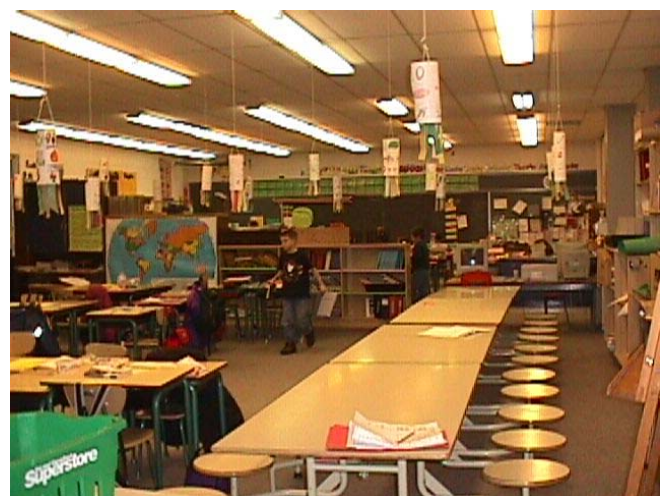
18. Open Classroom – High Noise Level
