RECAPP Facility Evaluation Report

Edmonton School Dist #7

McCauley Elementary / Junior High School

B3209A
Edmonton

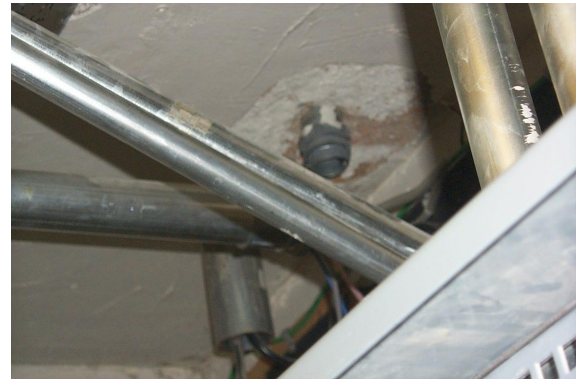
B1010.10 Floor Construction Firestopping*

1911 building -Unsealed penetrations (conduit, pipe, raceway) through floors / walls / ceilings in electrical room 011, mechanical room 003, main floor communications room 118.

<u>Rating</u>	<u>Installed</u>	<u>Design Life</u>	<u>Updated</u>
2	0	50	October 2004

Unsealed penetrations (conduit, pipe, raceway) through floors, walls and ceilings, compromise the fire separations.

Event: **Fill and seal the floor/wall/ceiling penetrations with firestopping material.**

Fill and seal the floor/wall/ceiling penetrations with firestopping material to meet code.

<u>Type</u>	<u>Year</u>	<u>Cost</u>	<u>Priority</u>
Code Repair	2004	\$6,000	High

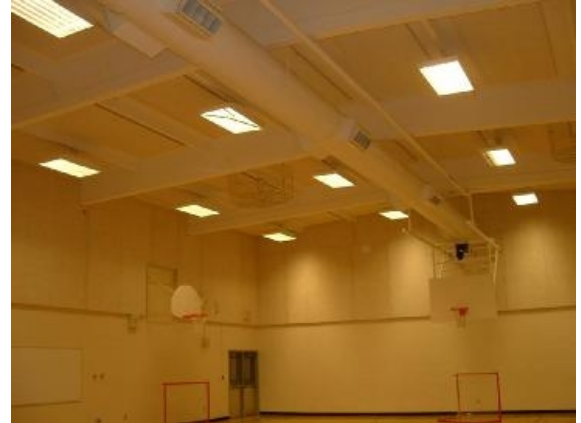
Acrylic Lenses on the Gymnasium 4'x3' light fixtures are loose and have fallen down. They are not protected by wire guards for the Gym activities and against vandalism.

Replace Acrylic Lenses with Wire guards. Total of 20 units.

<u>Type</u>	<u>Year</u>	<u>Cost</u>	<u>Priority</u>
Failure Replacement	2004	\$4,000	High

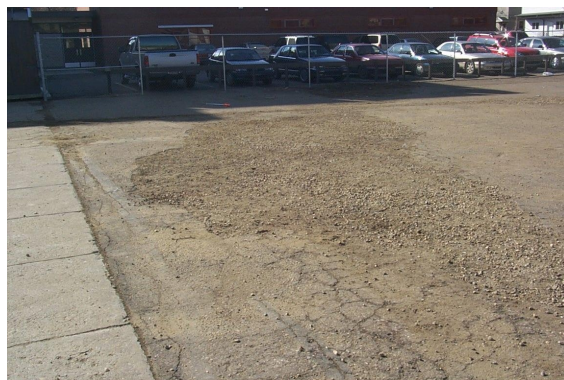
Pavement has cracks, holes and the surface has erroded.

<u>Type</u>	<u>Year</u>	<u>Cost</u>	<u>Priority</u>
Failure Replacement	2004	\$35,000	Medium
