RECAPP Facility Evaluation Report

McNally Composite High School

B3215A
Edmonton

Evaluation Company: Alberta Infrastructure
Evaluation Date: December 1 2004
Evaluator Name: John Grassick

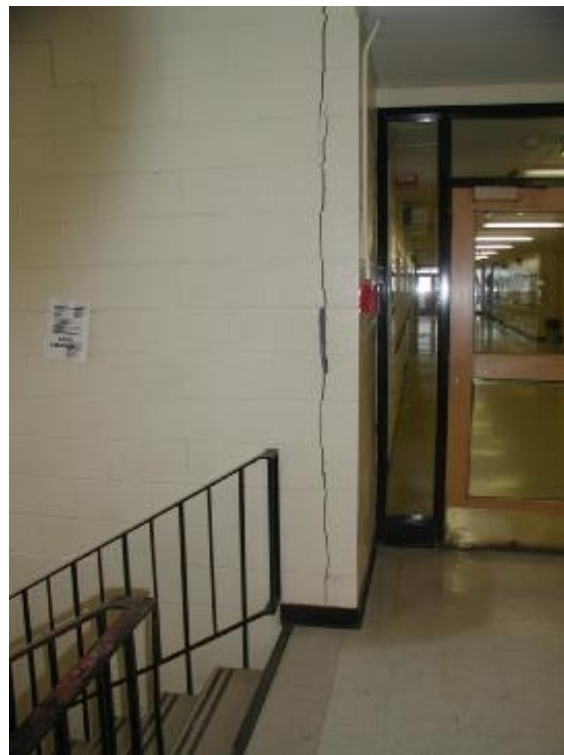
Event: Underpin Southcentral Stairshaft.

There is foundation settlement occurring at the south central stairshaft that is part of the original building, at the junction with the 1967 Academic addition. Foundation settlement is occurring and further movement is probable.

Underpin Southcentral Stairshaft and complete associated repairs to finishes.

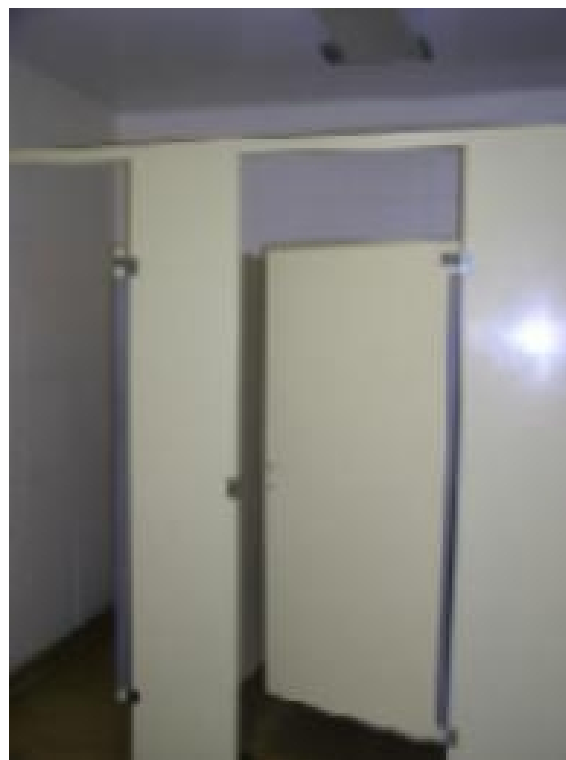
Event: **Repair damage locker room toilet partitons - 1963 section**

Damaged and showing rust

Repair or replace damage toilet partition

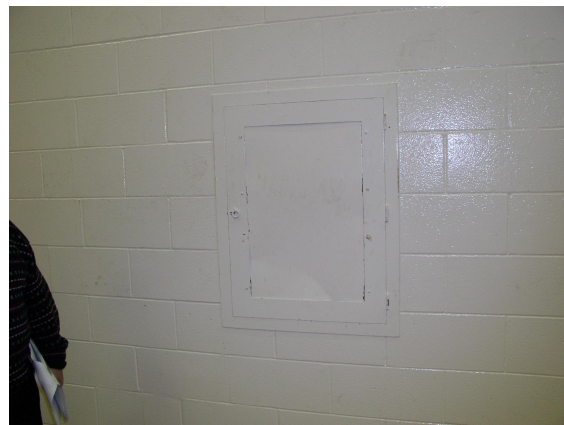
Event: Repair fire safety signage**Concern:**

Repair and update signage throughout school

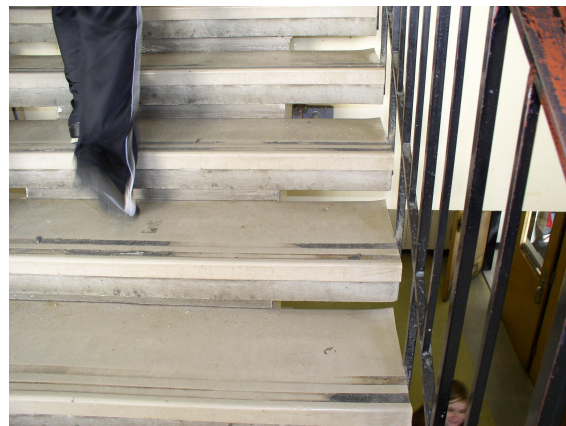
Event: Replace worn stair treads on all exterior stairwells**Concern:**

Non-slip nosing worn or missing and resilient material lifting

Replace nosing strips on 12 stair cases
