School Name:	Mount Carmel			School Code:	205	
	Location:	10524 - 76 avenue Edmonton, Alberta T6E 1L3			Facility Code:	2009	
	Region:	Central			Superintendent:	Dr. Dale W. Ripley	
	Jurisdiction:	Edmonton RCSSD No. 40			Contact Person:	Mr. Garnet McKee	
					Telephone:	(780) 453-4500 (Garnet)	
	Grades:	K-IX			School Capacity:	Total 540	
Building Section		Year of Compl.	No. of Floors	Gross Bldg Area (Sq.M.)	Type of Construction (i.e., structure, roof, cladding)	Description of Mechanical Systems (incl. major upgrades)	Comments/Notes
Original Building		1925	1	1110	Framed/Asphalt Shingles	Perimeter hot water heating; limited exhaust ventilation	System fed from new boiler installation in 1948 wing.
Additions/ Expansions		1948	1	840.0	Framed/B.U.R. T & G	1948, 1951: Perimeter hot water heating; limited exhaust ventilation 1968: Perimeter hot water heating and separate ventilation system.	
		1950	1	103.7	Framed/B.U.R. T & G

1951	2	678.0	Framed/B.U.R. T & G		
		1962	1	105.0	Framed/B.U.R.		
		1968	2	3095.1	Masonry/B.U.R.		
					Evaluator's Name:	Bill Vance	
					& Company:	Henderson Inglis Partridge

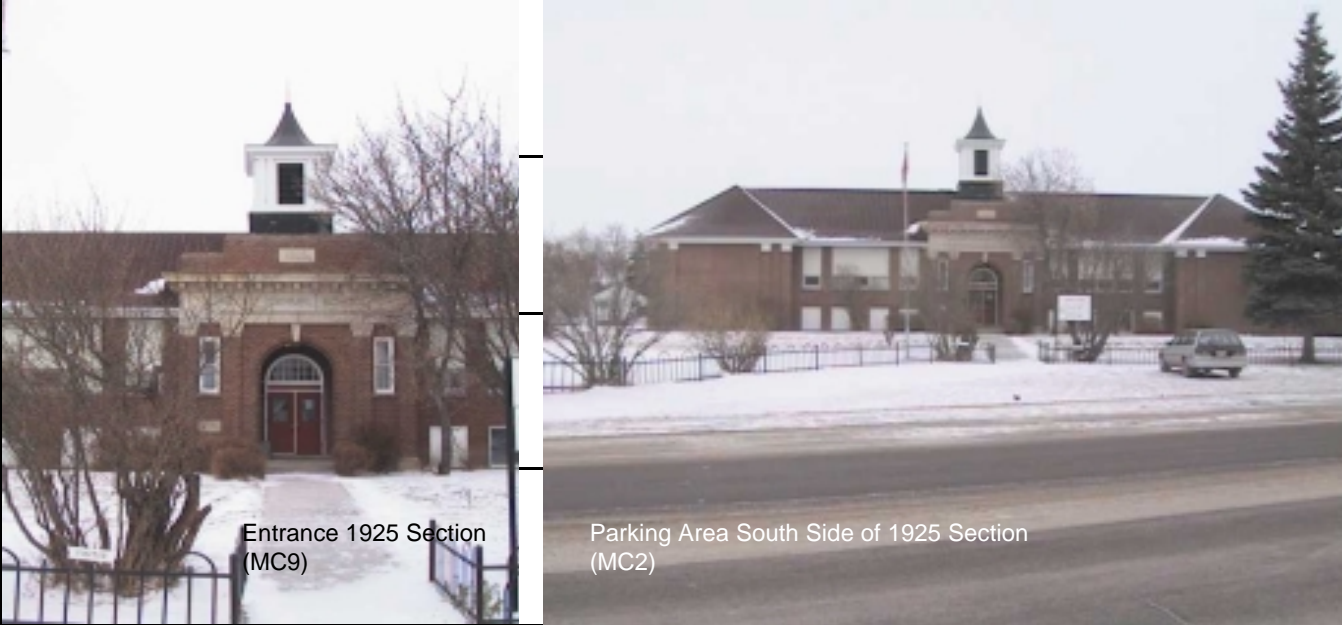
1.3.2	Layout and safety of parking lots.	3	South Side of school is somewhat unsafe in that parking forces cars to back onto fairly busy street. Cost identified would be cost to create new lot equivalent size in alternate location.	\$50,000

(MC9)	Entrance 1925 Section (MC9) General view of Main Entrance to School
(MC2)	Parking area which forces cars to back out onto relatively busy street.

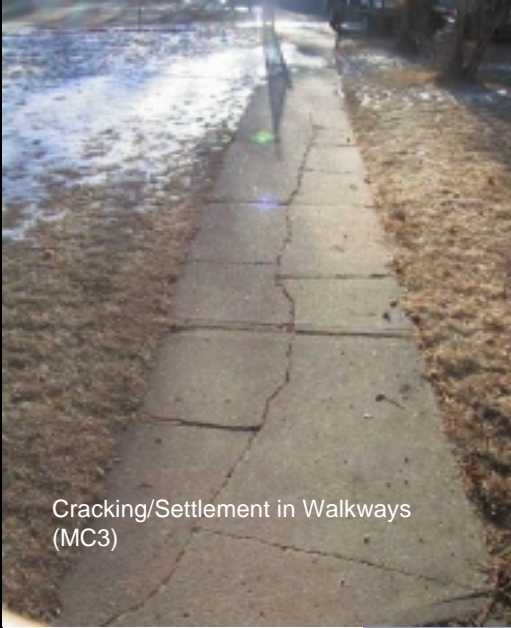
<p>Cracking/Settlement in Walkways (MC3)</p>

1.3.4	Layout and safety of sidewalks.	4		
1.3.5	Surfacing and drainage of sidewalks (note type of material).	3	Significant cracking/settlement in sidewalks, noted particularly at main entrance.	\$7,500

<p>Exterior Paint/Stucco Finish Deterioration (MC4)</p>
(MC3)	Exterior walkways are in need of repair some areas.	
(MC4)	Stucco finish in need of repair and repainting in some areas.

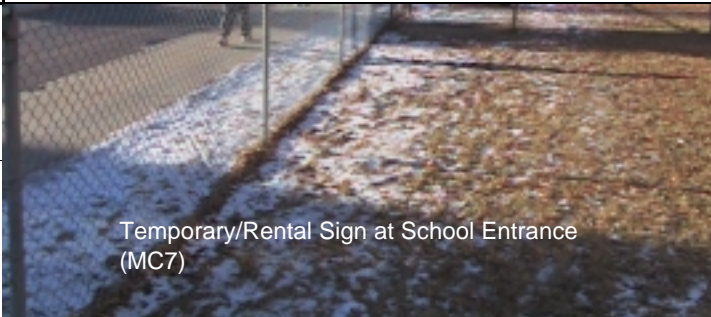
(MC7)	Temporary "Rental Sign" seems poor image for school.		
(MC8)	Suspended Ceiling systems are in need of replacement in many areas.

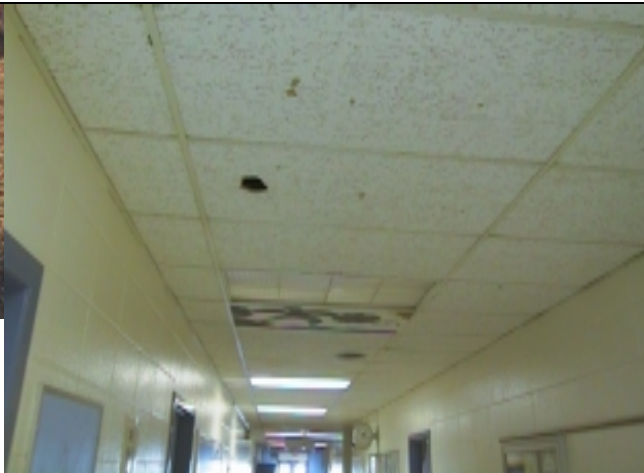
<p>Soiled/Worn/Damaged Ceiling Tiles (MC8)</p>

3.2.3	Ceiling materials and finishes.	3	1925 1948 1950 1951 1962 1968	T-Bar - Given mechanical and electrical upgrades and marg. state of ceilings, T-Bar, Adhered Acoustic tile - 100% non- 1968 replacement is budgeted Adhered Acoustic Tile/T-Bar - good T-Bar - Looks New Some Areas; Good in others T-Bar - good T-Bar, Spray Acoustic Fibre (Boiler Rm.) Replace T-Bar in corridors, washrooms and music rm.	\$103,000
