RECAPP Facility Evaluation Report

Edmonton School District No. 7

North Edmonton Elementary School

B3232A
Edmonton

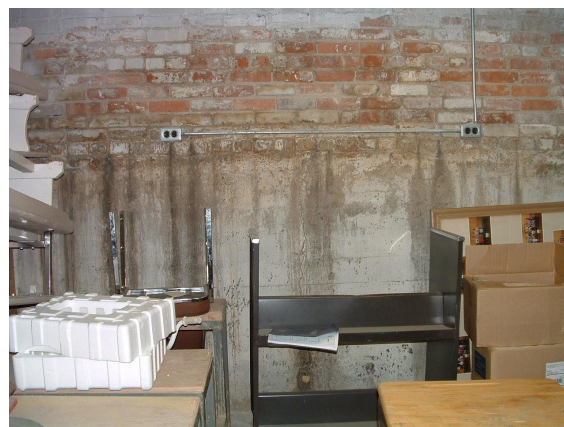
The concrete basement foundation walls of 1917 building have developed cracks and leak at many locations. The north wall is most affected. Basement keeps getting flooded, even after the downspouts were connected to the storm sewer and weeping tile drains were installed at north wall in 1993. Negative grades along building walls have contributed to the problem. A small one storey addition (for exit from basement) on the west side has separated from the main structure, creating large gaps which allow rain water inside.

Provide water proofing around basement walls of the 1917 building (bentonite or equal), complete with weeping tiles and drains. Seal cracks on basement walls by injecting expandable water proof sealant. Regrading included in site work - see site evaluation.

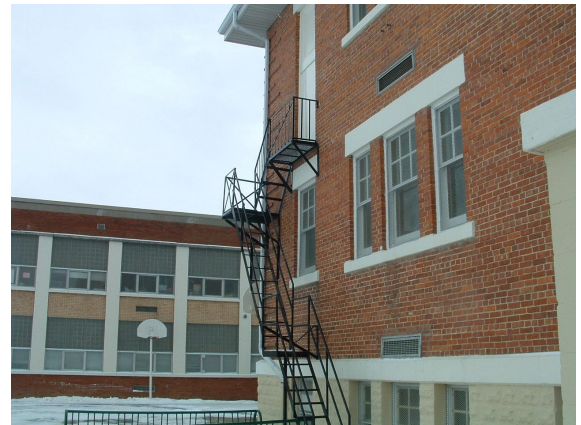
The fire escape has been contributing to vandalism in the building. Police and the Fire department have recommended it's removal.

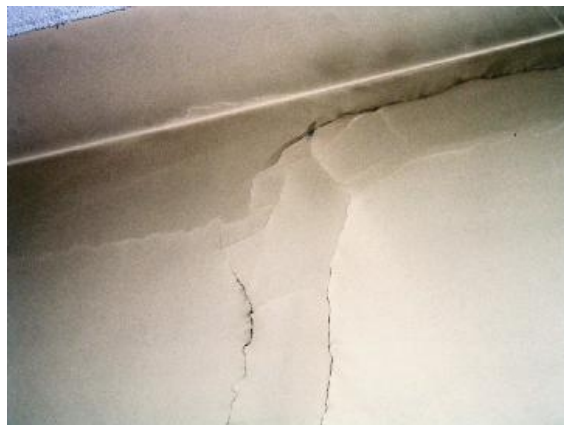
Solid brick walls are not insulated and there is no indication of air / vapor barrier on walls, except that the walls are plastered from inside. Paint peeling and cracking of plaster surfaces evident on the walls of the 1917 building.

Investigation in to the effects and the extent of cold air infiltration and condensation on the walls of the 1917 building should be investigated by a building envelope consultant, including thermography, as required. Solutions recommended should take in to consideration that the building has Class B historic designation.

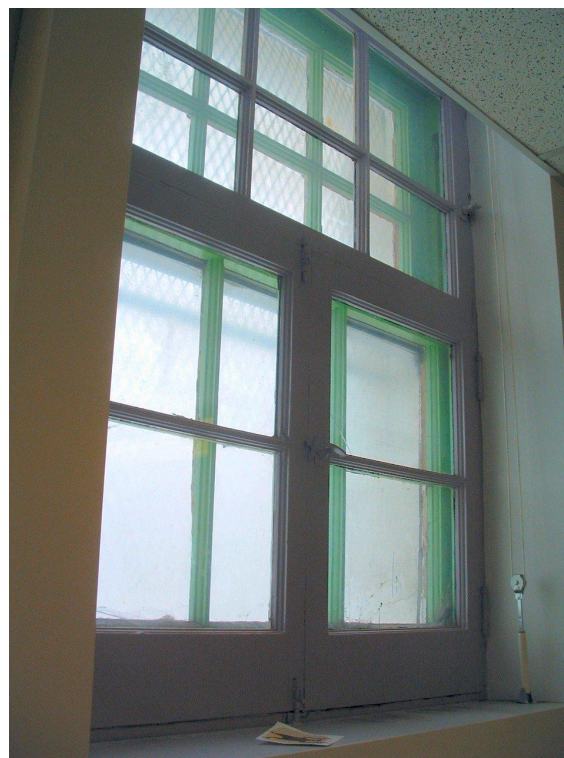
Windows are well past their service lives. Wood framing members have cracked and buckled. Sash and awning sections do not operate properly. Not energy efficient. Concrete sills have spalled in isolated areas.

Replace all windows in 1955 building with aluminum windows, complete with sealed double glazing and awning sections. Replace existing windows in 1917 building with new wood windows (profile to match existing) due to building's historic designation. Patch and repair concrete sills and caulk all perimeter of windows.

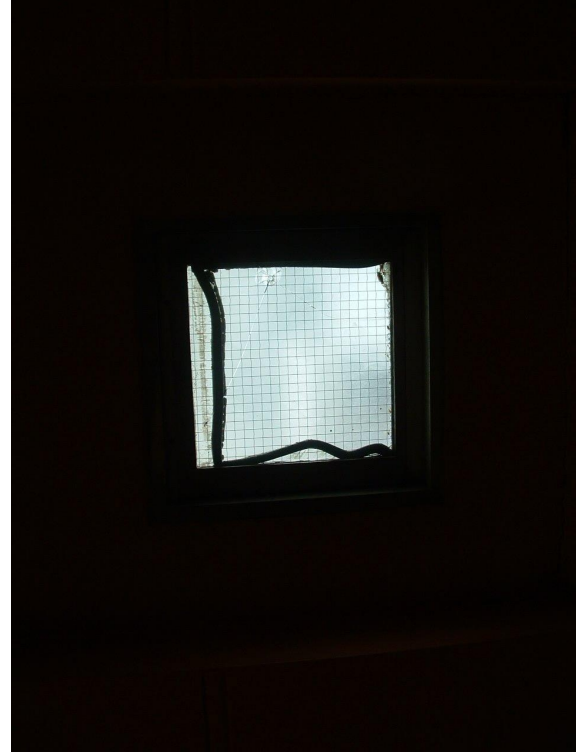
Hopper window inserts in glass block openings are in poor condition. Gaskets are loose and windows do not operate properly. Day lighting is limited. Air infiltration.
