RECAPP Facility Evaluation Report

Wetaskiwin Regional Div #11

Norwood Elementary School

B4250A
Wetaskiwin

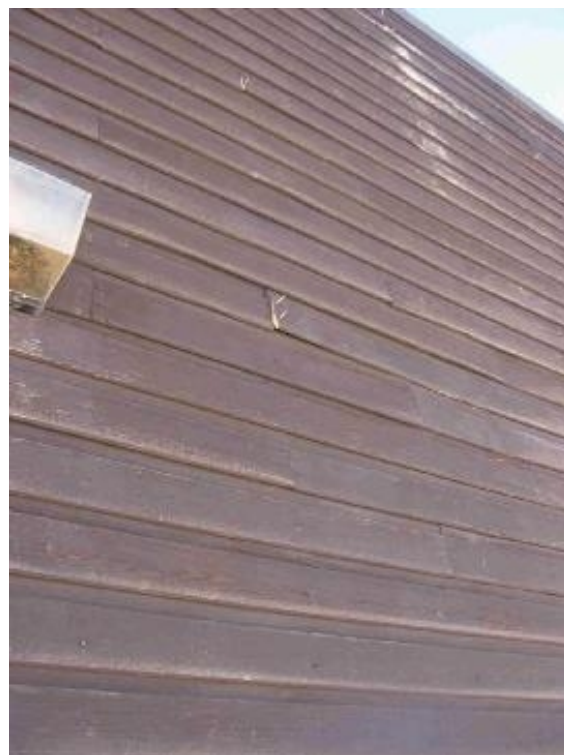
B2010.01.06.04 Wood Siding**

1981- Original stained cedar siding at fascias where not replaced with metal cladding.

<u>Rating</u>	<u>Installed</u>	<u>Design Life</u>	<u>Updated</u>
2 - Poor	0	40	FEB-06

Original cedar siding at fascias on east side of building damaged and requires stain.

Cedar siding will continue to deteriorate. Potential for water damage to exterior envelope.

Replace existing wood cladding with new pre-finished metal cladding at fascias at east side of building (approximately 40m²).

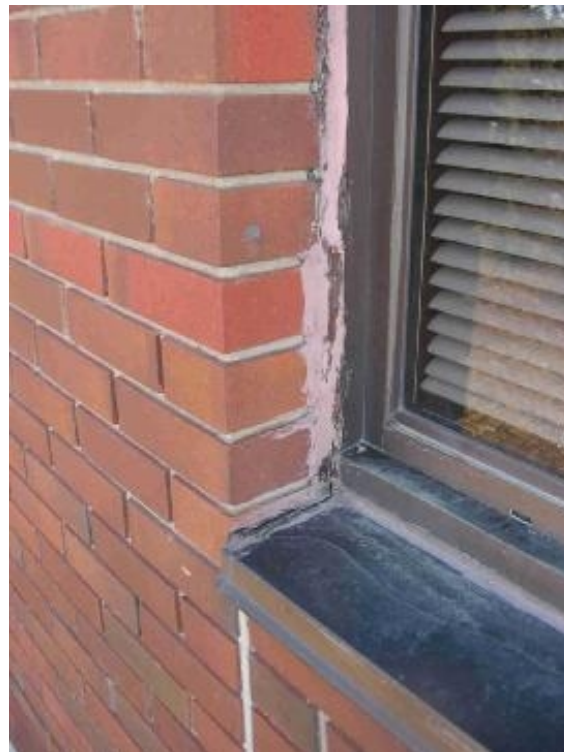
B2010.01.11 Joint Sealers (caulking): Ext. Wall**

1981- Sealant around all aluminum exterior windows and doors.

<u>Rating</u>	<u>Installed</u>	<u>Design Life</u>	<u>Updated</u>
2 - Poor	0	15	FEB-06

Caulking at existing aluminum window sills and window jambs has failed.

Water and outside air infiltration.

Remove existing caulking at all existing aluminum windows and replace with new caulking appropriate for substrate.

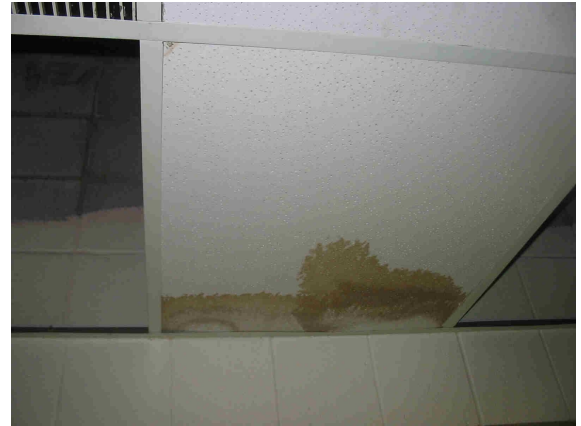
B3010.04.01 Built-up Bituminous Roofing (Asphalt & Gravel)**

1981- Original BUR roof system at low roof adjacent gymnasium over stage area. Balance of roof replaced with new 2 ply SBS (Modified) roof system since 2000.

<u>Rating</u>	<u>Installed</u>	<u>Design Life</u>	<u>Updated</u>
3 - Marginal	0	25	JUN-06

Original BUR roof replaced with new 2 ply SBS throughout except approximately 100m² adjacent gymnasium over stage area.

Roof will fail similar to low roof area at west side of gymnasium before replacement.

Replace original BUR roof with new SBS (Modified) roof system including metal flashing at low roof adjacent gymnasium (approximately 100m²).

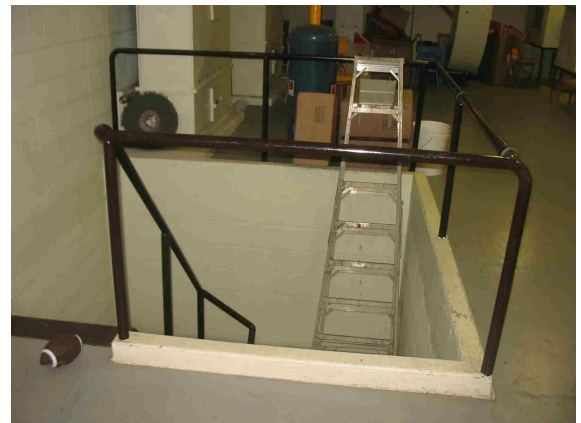
**C2010 Stair Construction***

1981- painted steel stair to mechanical mezzanine c/w metal pans and steel channel stringers.

Potential hazard.

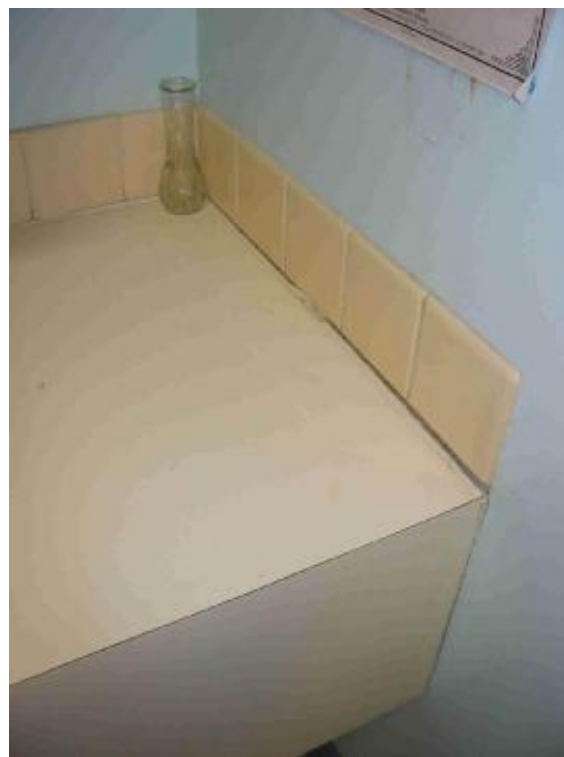
Event: Replace plastic laminate clad vanities and chrome supports.**Concern:**

Washroom vanities at student washrooms in poor condition, seams between horizontal surface and backing wall and chrome supports rusted. Chrome supports rusted at staff washrooms.

Replace plastic laminate clad vanities student washrooms (approximately 6M.) Provide one barrier free lavatory in student washrooms c/w fittings as per ABC 1997. Replace chrome supports at staff washrooms (2 required). Replace ceramic tile backsplash as required.

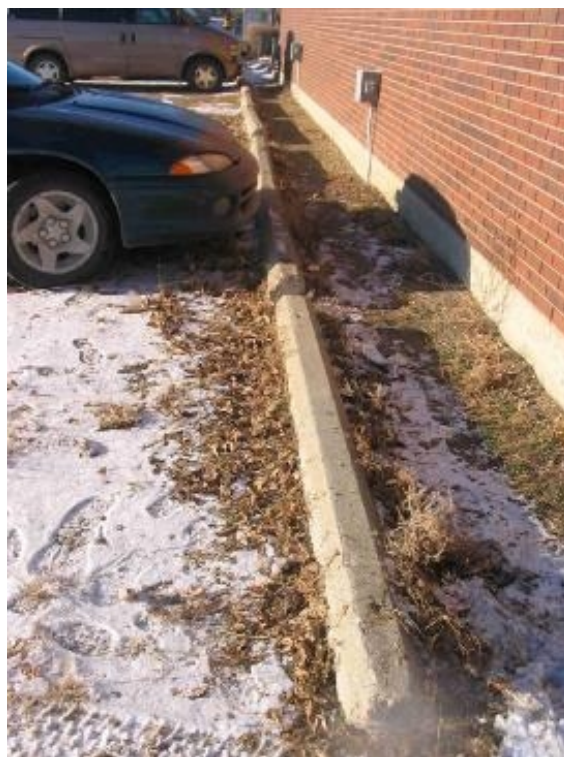
25 on-site parking stalls are provided for staff to the south of the building. The parking lot is gravel with drainage to a catch basin. The existing parking lot was assessed as too soft and paving was recommended in 2000.

Poor surface drainage and continued deterioration.

Soft subgrade areas to be excavated and replaced with suitable compacted soil. Re-grade, provide suitable granular base and sub-base. Install asphalt paving at staff parking lot at south side of building (approximately 1200m²).
