RECAPP Facility Evaluation Report

Calgary School District #19

Ogden Elementary School

Evaluation Company: Marshall Tittlemore Architect
Evaluation Date: November 4 2005
Evaluator Name: Mr. Tom Tittlemore

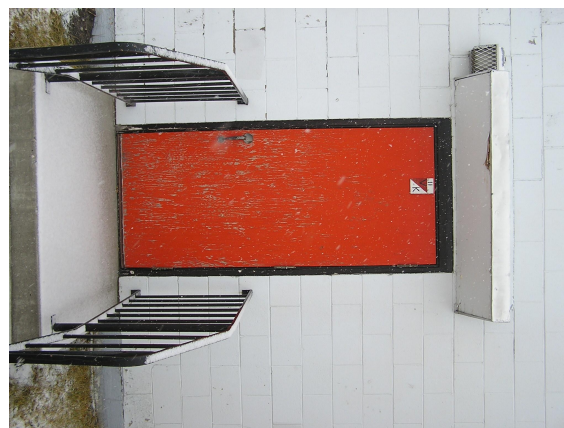
B2010.01.13 Paints (& Stains): Exterior Wall**

<u>Rating</u>	<u>Installed</u>	<u>Design Life</u>	<u>Updated</u>
2 - Poor	0	15	NOV-05

Event: Painted finish to exterior concrete block firewalls, grilles, concrete foundation base, some wood exit doors.

Painted finishes to these exterior building components are peeling and require refinishing.

Repaint these components.

<u>Type</u>	<u>Year</u>	<u>Cost</u>	<u>Priority</u>
Failure Replacement	2006	\$64,200	Medium

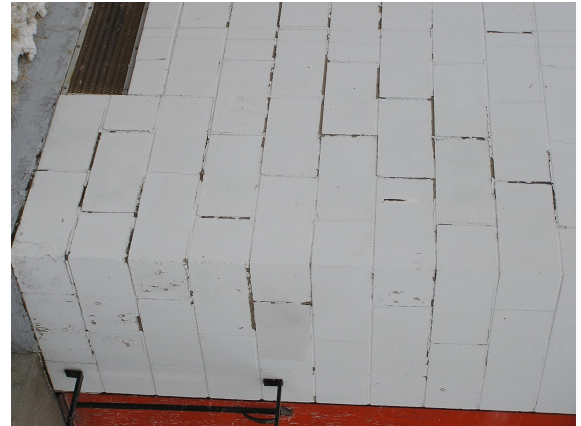
Apart from evidence of structural failure along the masonry joints of the exterior masonry walls in the school's north west corner, the school's structural system is in good condition.

B2010.02.03 Masonry Units: Ext. Wall Const.*

<u>Rating</u>	<u>Installed</u>	<u>Design Life</u>	<u>Updated</u>
2 - Poor	0	100	NOV-05

Event: Concrete masonry veneer , 1960 Wing

Deterioration of mortar joints in the concrete block veneer in the north west corner of the 1960 wing is evidence of some structural failure.

Undertake remedial action to the concrete block veneer. A structural analysis is recommended beforehand.

<u>Type</u>	<u>Year</u>	<u>Cost</u>	<u>Priority</u>
Repair	2006	\$85,600	Medium
