RECAPP Facility Evaluation Report

Parkdale Elementary / Junior High School

B3245A
Edmonton

December 2005

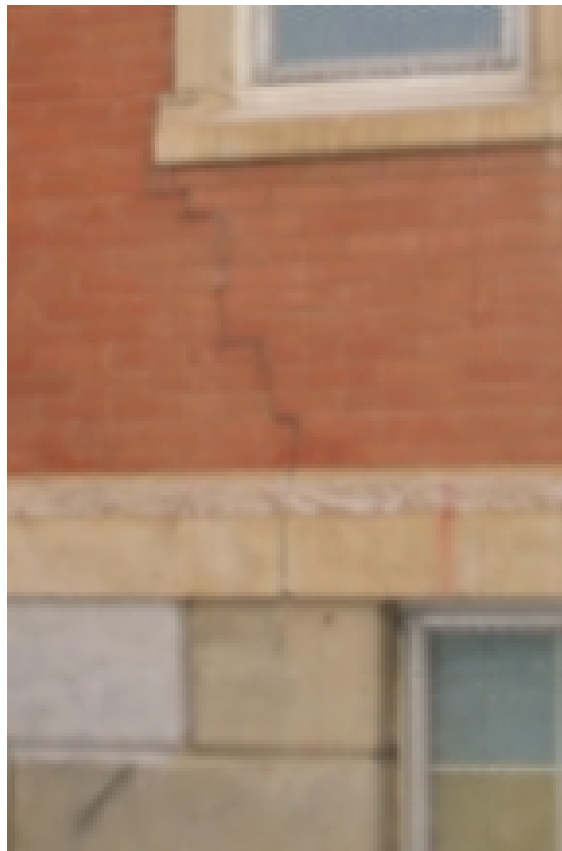
The exterior brick work has cracked and requires repair.

Replace exterior brick work.

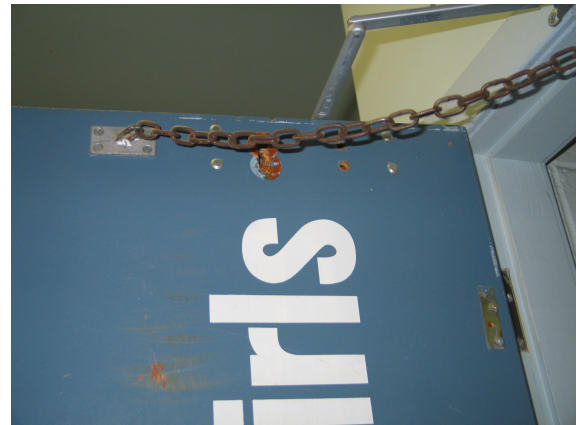
Interior doors and frames are damaged due to the action of a chain door stop.

Replace damaged interior wood doors.

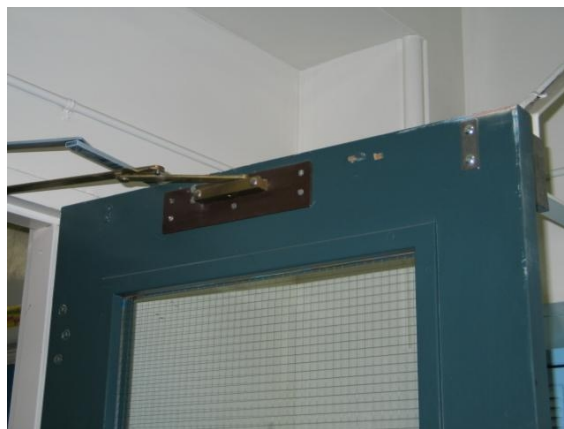
Fire doors to the stairs in the school have been fitted with different hardware over the years and are damaged.

Replace fire doors including hardware tied into the fire alarm system.

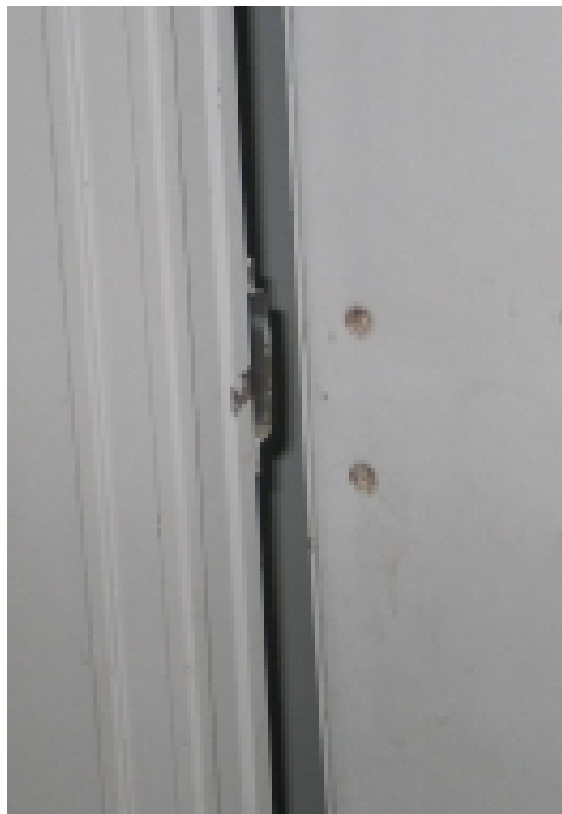
The steel toilet partitions and doors are damaged, are not lockable and require replacement.

Replace damaged steel toilet partitions and doors.

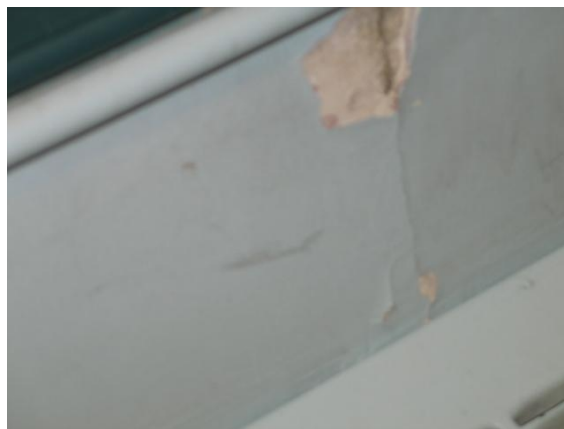
There are damaged plaster walls throughout the school which are unsightly and require repair.

Patch and paint damaged plaster walls.

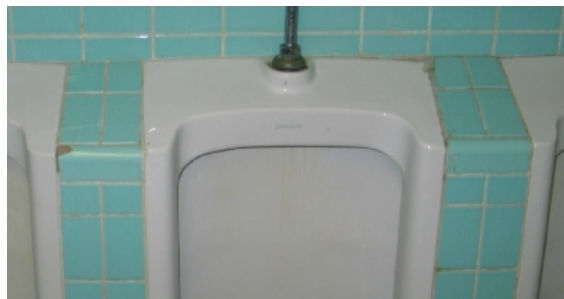
Glazed tile walls in the student washrooms are damaged, unsightly and require replacement.

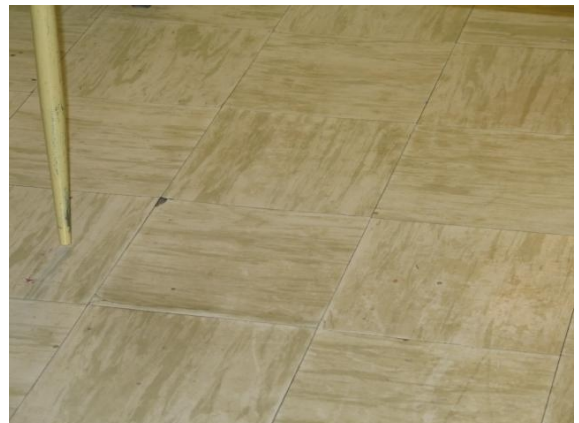
Vinyl tiles in the basement lunch room are damaged and unsightly.

Replace vinyl tiles in lunch room.

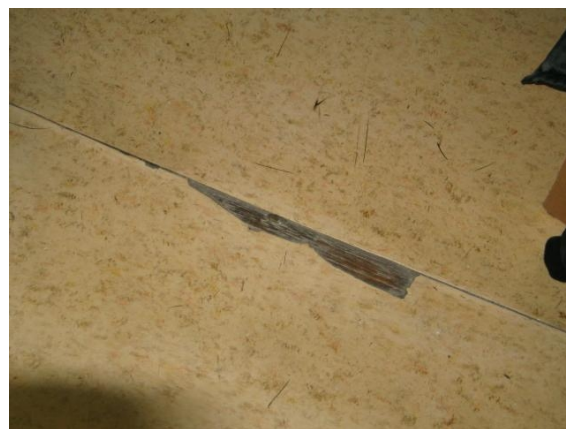
The lino floor is split in several locations throughout the school and requires replacement.

Replace sections of deteriorated linoleum.

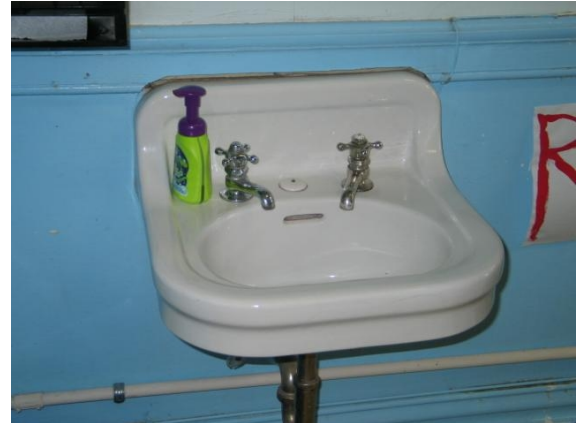
Enamel finish on wall hung lavatories is worn. There are a variety of faucet configurations. Some have individual hot and cold taps that could lead to scalding conditions. One has had the cold water tap replaced with a bubbler.

Replace lavatories in 1957 gymnasium addition.

The estimate is based on replacing 6 lavatories with stainless steel lavatories with self-closing or sensor actuated mixing faucets mounted in laminated vanities.

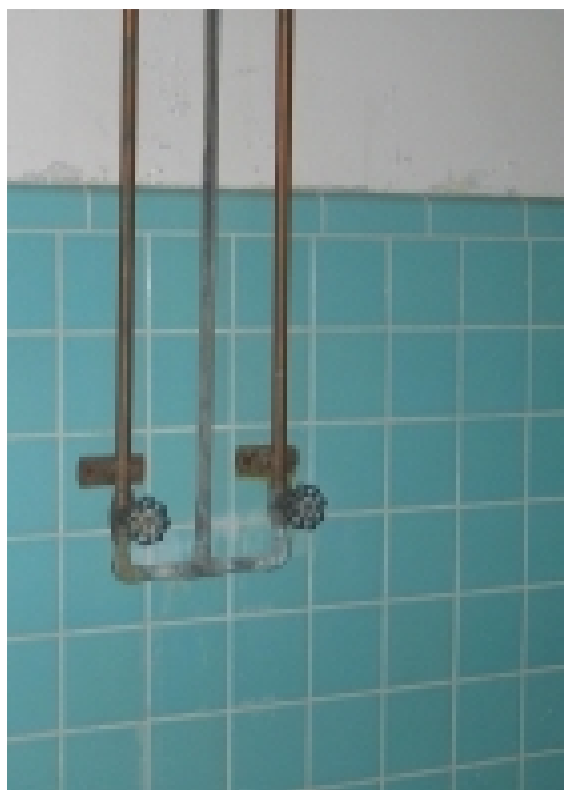
The surface mounted piping in the showers is corroded and damaged. Inappropriate globe valves are used for hot and cold water taps.

Replace shower assemblies.

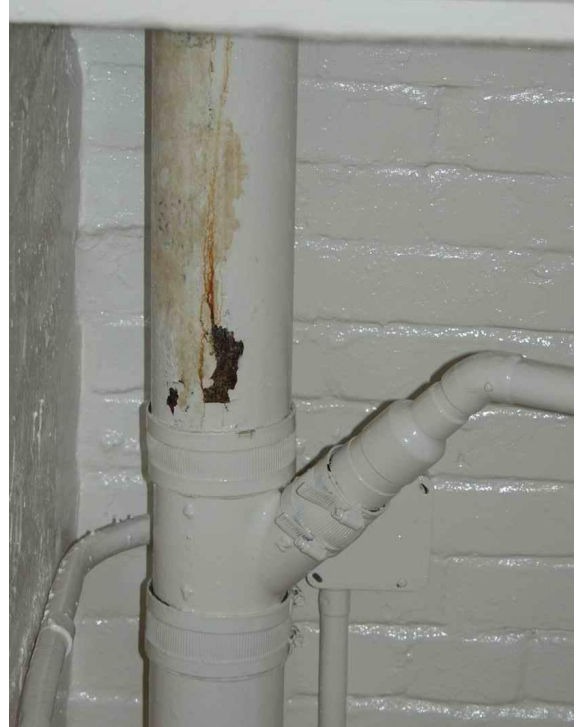
Some sections of the piping has been repaired. There is evidence of leaks and damage in a number of areas. Piping is brittle and worn

Replace sanitary piping in the mechanical room and all piping serving original 1912 buildings. Remove asbestos wrap and insulation if present. Repair finishes.

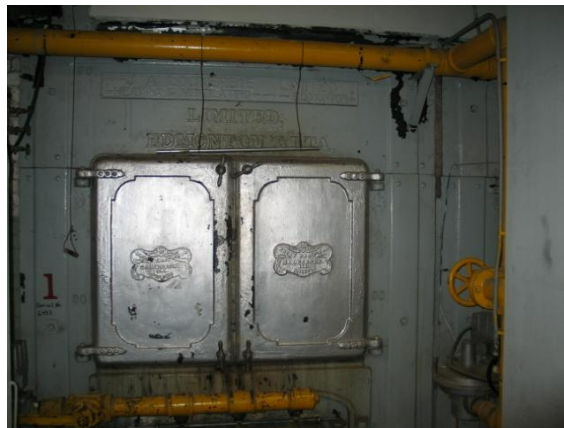
The boilers are over 90 years old. They are idifficult to control and inefficient . Temperature complaints have been ongoing for years. The boilers are often manually shut down when space heating conditions get to hot.

Replace the heating boilers

The estimate is based on two 880 kW induced draft hot water heating boilers and primary circulating pumps. (see also D3040.02, Steam Distribution System)

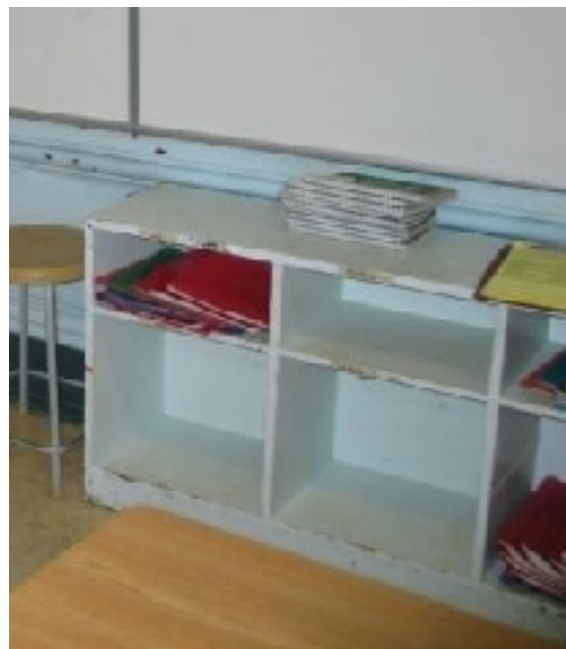
The casework in the classrooms is damaged and requires replacement.

Replace damaged classroom casework.

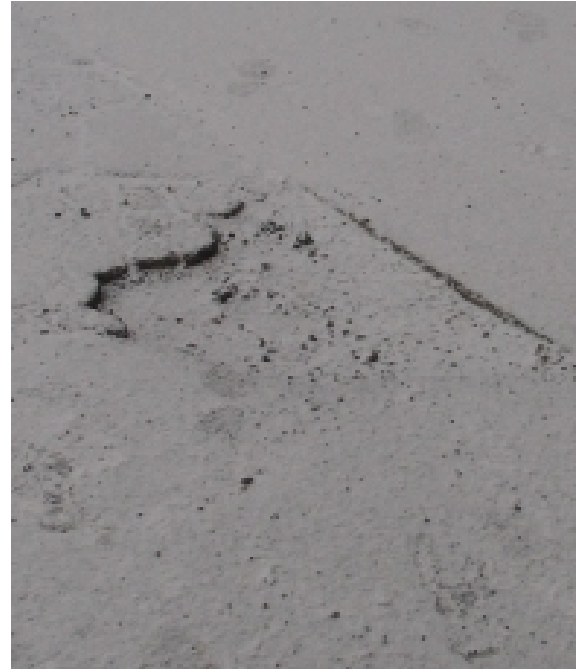
The asphalt roadway on to the site has deteriorated and requires resurfacing.
