RECAPP Facility Evaluation Report

Parkland Village School

B4053A
Spruce Grove

Evaluation Company: Stephens Kozak Carr and Brown
Evaluation Date: December 1 2004
Evaluator Name: Mr. Eric Lumley

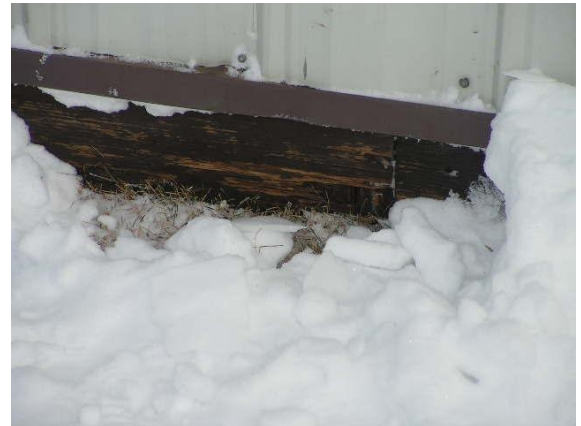
Event: **Replace rotted skirting with cement board, to one portable. Provide crawlspace ventilation with "window" wells.**

Replace rotted skirting with non-organic material such as cement board. Provide undefloor ventilation by introducing vent grilles in "window" wells.
