RECAPP Facility Evaluation Report

Prince Charles Elementary School

B3251A
Edmonton

Evaluation Company: Koliger Schmidt
Evaluation Date: December 1 2004
Evaluator Name: Mr. Mario Macchione

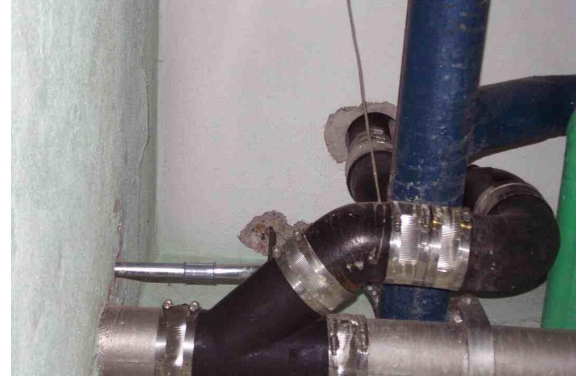
Unsealed penetrations (conduit and pipe) through ceiling and walls compromising fire separations.

Fill and seal ceiling and wall penetrations with firestopping material to meet code.

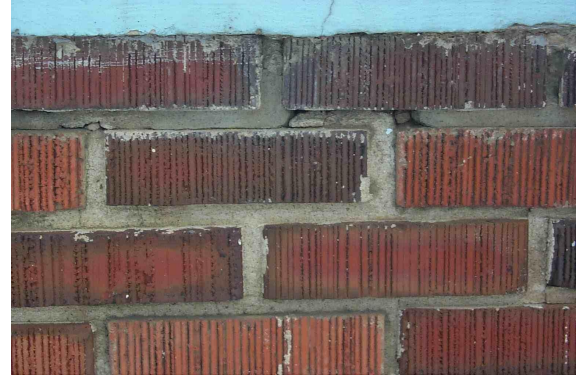
Brick has cracked and deteriorated joints allowing water to penetrate inside, possibly causing future problems

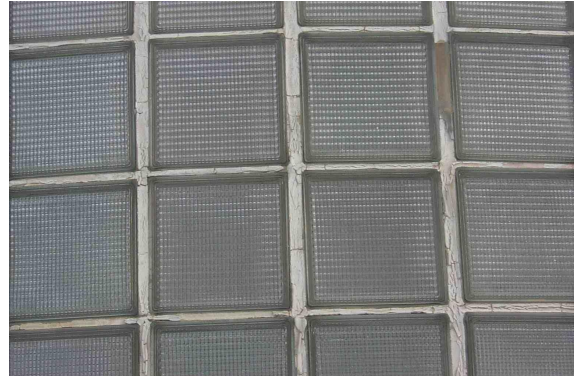
Glass block seals are cracked and discolored.

Repair and reseal glass on exterior and interior side of block.

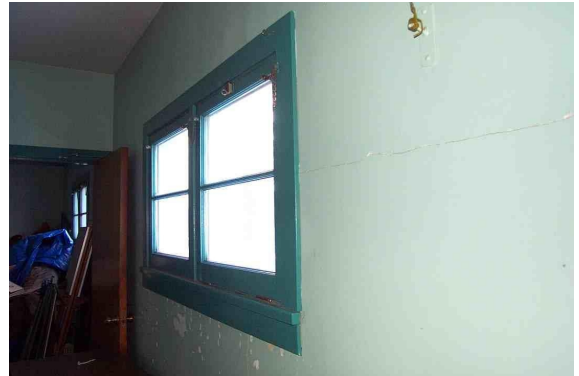
Original wood windows haven't been replaced and area is cool and drafty. Window are showing signs of rotting and major deterioration.

Replace windows with vinyl windows. 3 sets of double windows.

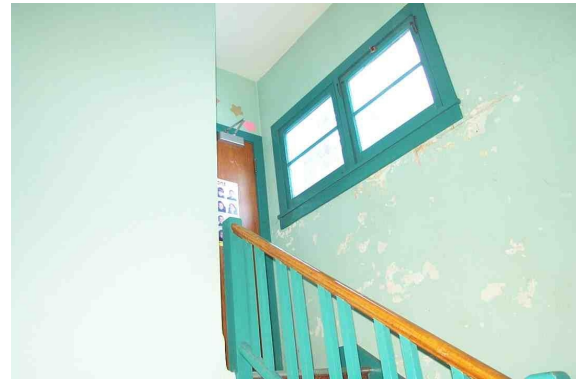
Gym storage area with staircase up to projection room (which is used for storage now) has walls with crack and holes in the gypsum, also it's paint is peeling.

Patch, repair and repaint walls in staircase area, projection room and upper storage room. If this area is going to be a permanent storage facility then provide shelves for better use of space. Coordinate with replacement of windows in B2020.01.01.05. (approx. 140m²)

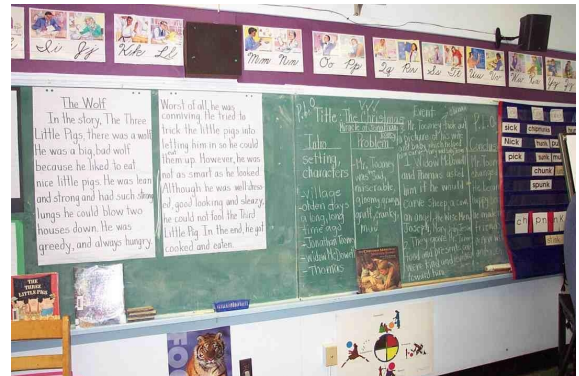
Some children are allergic to chalk and also causes a mess with chalk residue on floors and walls.

Replace 5 chalkboards with whiteboards. Repair walls as needed.

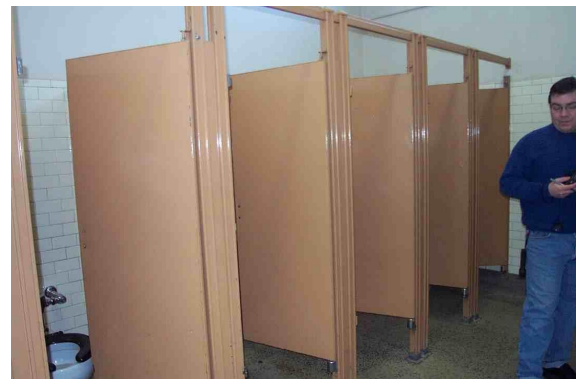
Old, rusted, stained and paint is peeling off. Hardware is also old and probably original.

Remove existing partitions and hardware and replace with new. (8 in total 1 in each washroom should be barrier free)

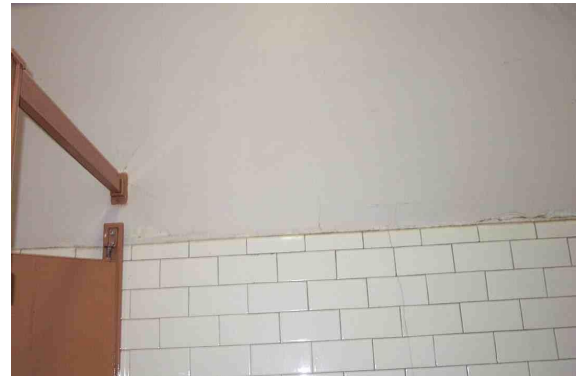
Tiles are old, cracked and discolored with stained grout. If a modernization is taking place and most of the finishes in these 2 washrooms need to be upgraded then the tiles should be as well. Boys washroom has a newer type of tile on most walls except urinal wall.

Replace wall tiles.(approx 40m² in total both washrooms)
Match tiles in boys washroom on urinal wall to the rest of the tiles in the room. Schedule following mechanical event to replace old floor urinals to wall mounted. D2010.02 Repair and paint top portion of boys and girls walls after all construction has been completed.

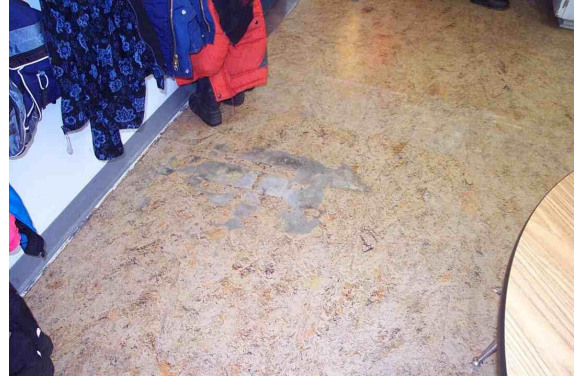
1954 building- Original sheet flooring in classrooms; Old, stained and in some classrooms is worn down.

Replace all sheet flooring with VCT and install new rubber base where needed. (Approx. 873.6m²)

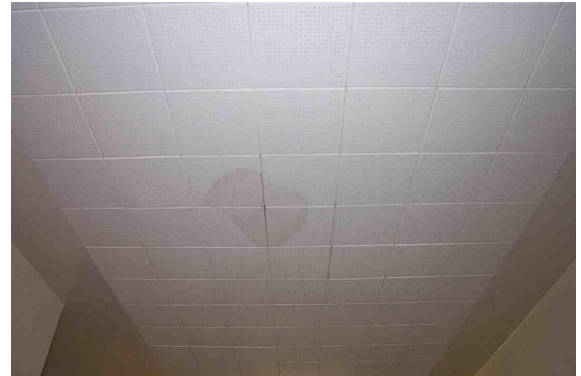
Tiles stained, cracked and missing from ceilings.

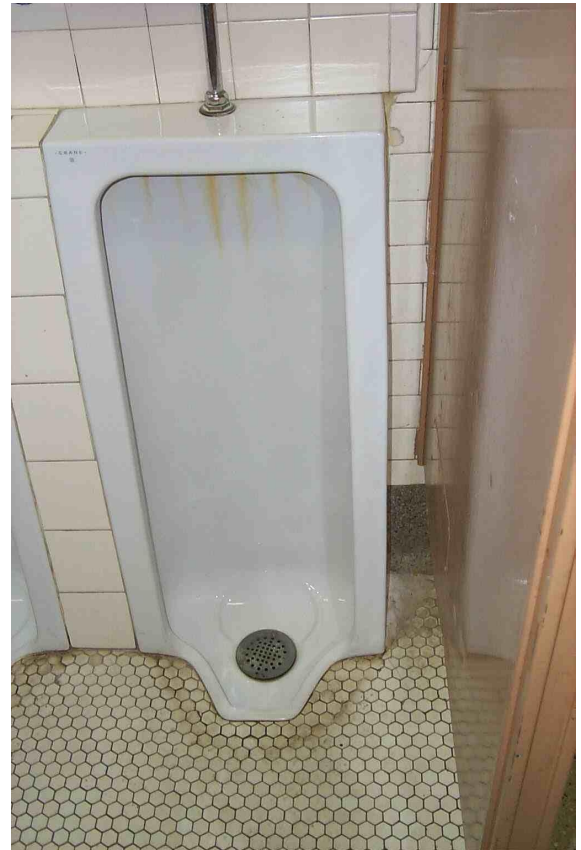
Urinals are stained and discolored.

Replace 5 urinals with new wall hung units. Replace tile around urinals (Arch C3010.06)

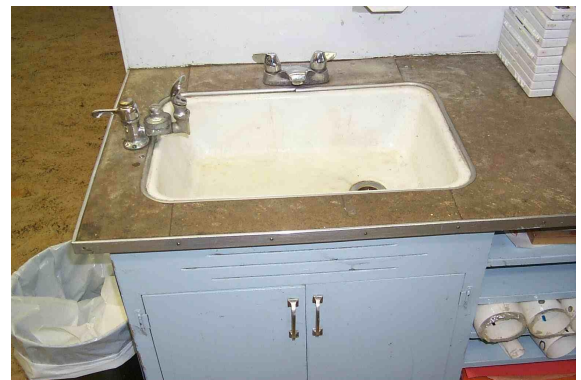
Sinks in classrooms are stained, parts for trim unavailable.

Replace 11 sinks with stainless steel ones and install new trim.

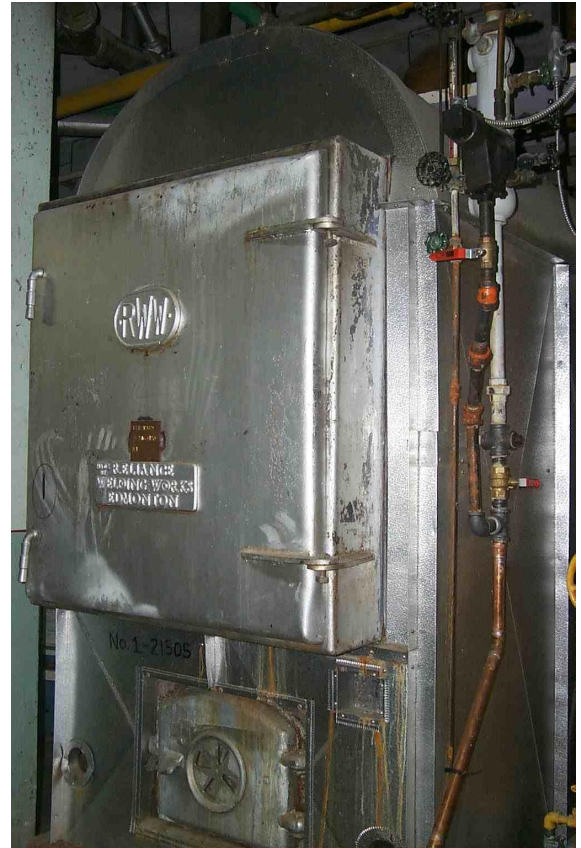
Existing steam boilers are inefficient. Components of the steam system are rusting and degraded.

Upgrade steam system to hot water boiler system. Replace boilers, install new hot water coils for ventilations systems, install new fin radiation in classrooms and at entrances. Install new chimney and combustion air. This should be completed as part of a school modernization.

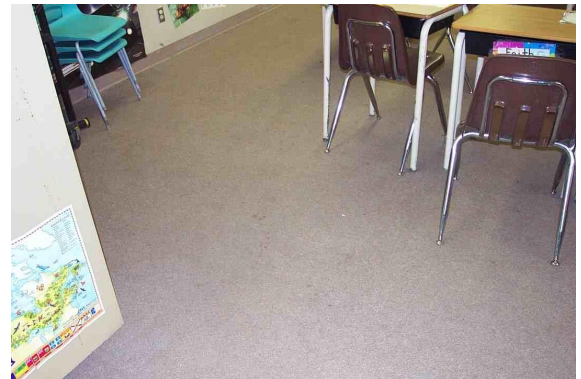
Carpet is stained and worn and the blinds are discolored and coming apart.

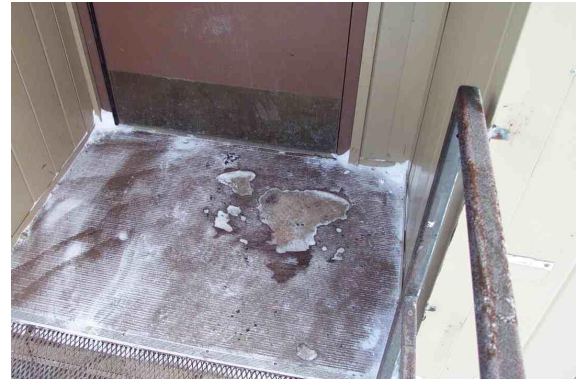
Existing carpet is worn and has large holes in it and is causing a huge tripping hazard.

Remove carpet on stair landing and replace with a slip material thin enough for door to pass.

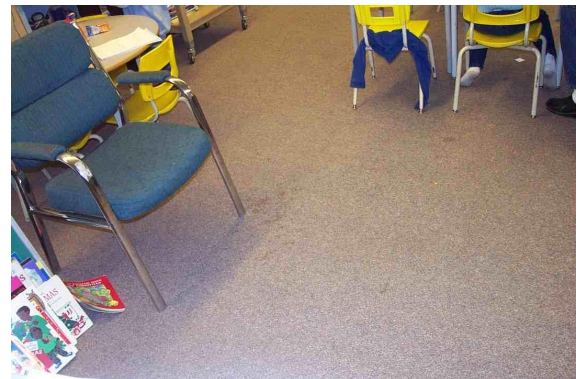
Carpet is stained and worn and the blinds are discolored and coming apart.

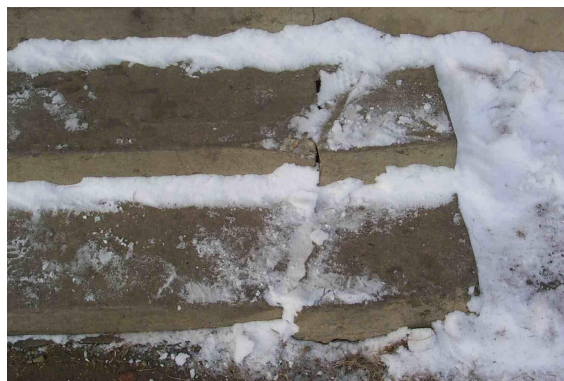
Concrete stairs are cracked.

Replace exterior stairs on boys side. (4 m²)
