RECAPP Facility Evaluation Report

Queen Elizabeth School

B3728A

Lloydminster (Alta)

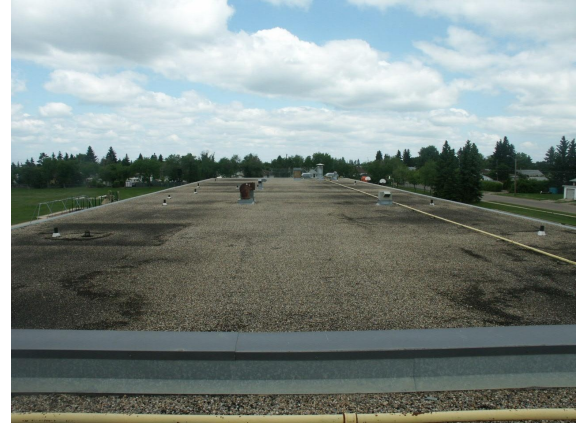
Roof on 1954 building replaced during 1982 modernization. 2003 roof inspection report notes few current problems, but at 23 years old it is recommending replacement in 2009.

<u>Rating</u>	<u>Installed</u>	<u>Design Life</u>	<u>Updated</u>
3 - Marginal	0	25	APR-99

Evidence of ponding on 1954 phase.

Replace BUR throughout (2,745 sq m).

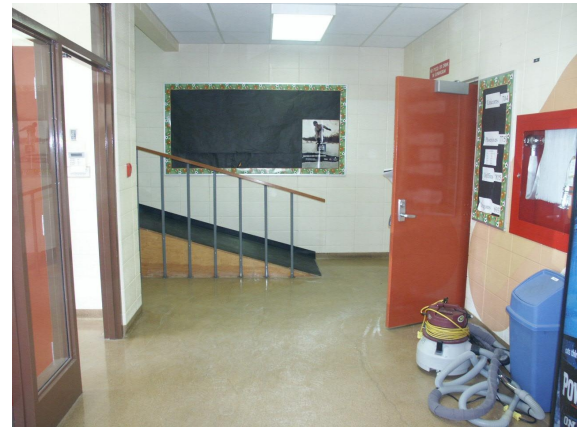
Access good to all areas except stage and conversation pit.

Recommendation:

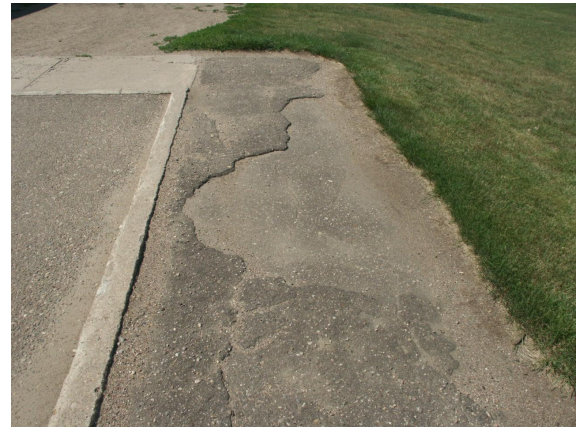
Asphalt sidewalk is deteriorated and delaminating in several areas.

Recommendation:

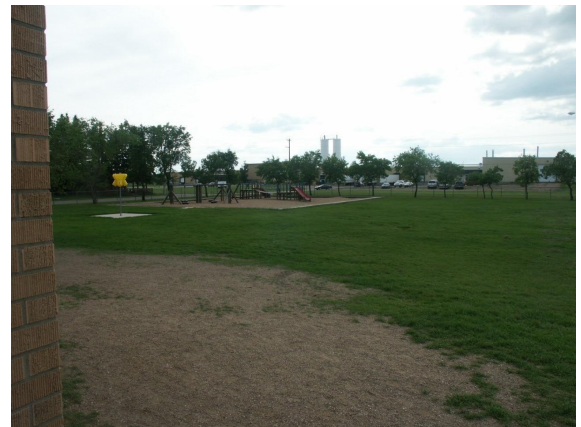
Lawn area worn bare by pedestrians.

Recommendation:

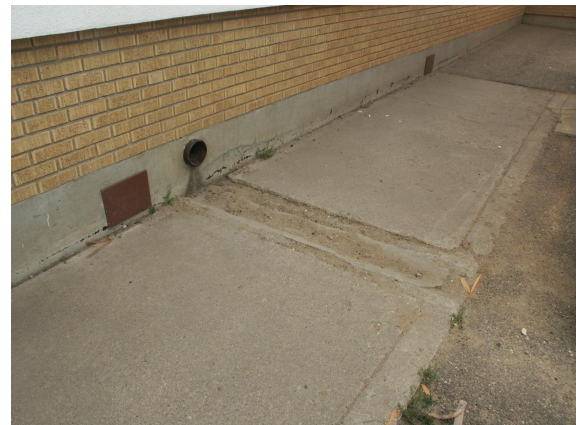
Concrete sidewalk on west side of 1954 phase is cracked and spalled. Settlement +/- 100mm.

Replace concrete sidewalk on west side of 1954 phase (60 sq m).
