RECAPP Facility Evaluation Report

Edmonton School District No. 7

R. J. Scott Elementary School

Evaluation Company: Lotus Architecture
Evaluation Date: December 1 2004
Evaluator Name: Tonu Mitra

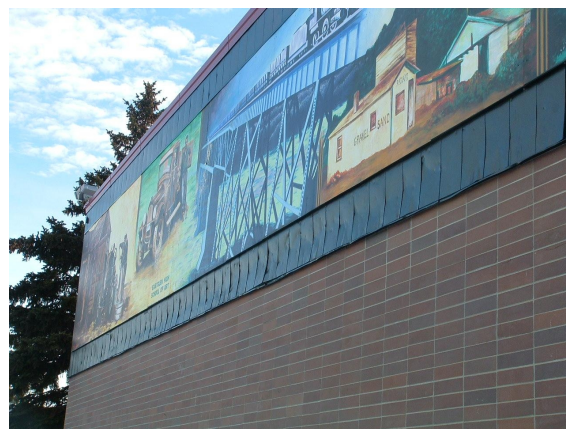
<u>Rating</u>	<u>Installed</u>	<u>Design Life</u>	<u>Updated</u>
2 - Poor	0	40	DEC-04

Vertical metal siding in upper portions of the north and east Gymnasium walls is of thin gauge and in poor condition. Defects include missing and bent metal panels, mostly due to vandalism. Large sections of painted plywood have been installed to cover missing panels and to secure loose panels. Hazard warnings have been issued related to falling metal panel sections and the panels are being riveted to hold them together temporarily. Water may be entering the cavity wall system from the damaged / missing areas of metal panels and contributing to efflorescence on brick surfaces.

Replace metal siding in upper portions of Gymnasium walls with brick or other durable siding material, complete with air barrier, rigid insulation and new flashing designed to shed water away from the cavity wall system. Actual design and detailing should be based on the study, recommended in B2010.01.02.01 Brick Masonry: Ext. Wall Skin.
