RECAPP Facility Evaluation Report

Edmonton School District No. 7

Sherwood Elementary School

B3273A
Edmonton

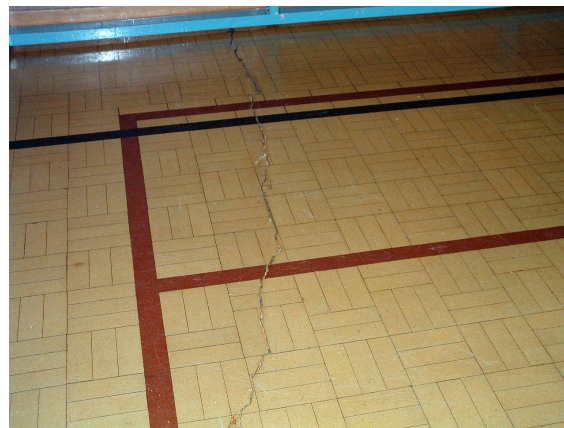
Gymnasium floor has developed a long crack parallel to the south walls in SW portion and the slab has sunk towards the south wall. The hallway floor, just outside the Gymnasium door has also sunk towards south. Settlements appear to be directly related to water entering under slabs on grades.

<u>Type</u>	<u>Year</u>	<u>Cost</u>	<u>Priority</u>
Repair	2007	\$20,000	Low

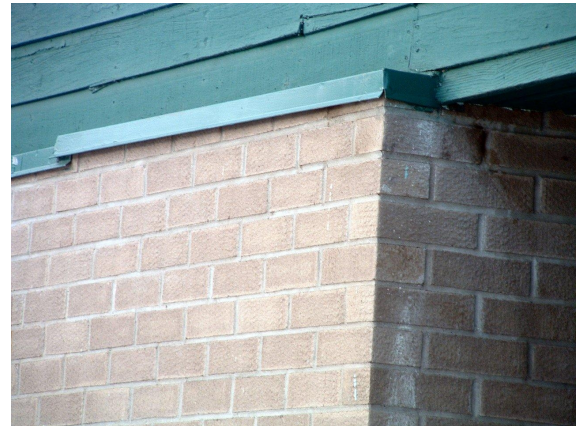
Cedar boards have warped, cracked and contain wide gaps at joints. Although all cedar surfaces were stained recently, they appear poor and dated. Paint peeling on bottom flashing. High maintenance. At SW entrance canopy, water or interior moisture leak is causing salt build up on brick. Bottom flashing is also bent.

Replace cedar boards in fascias and below windows with prefinished metal, complete with new bottom and top flashing. During this work, repair to the corner of SW entrance canopy with air barrier and proper flashing detail should be completed.

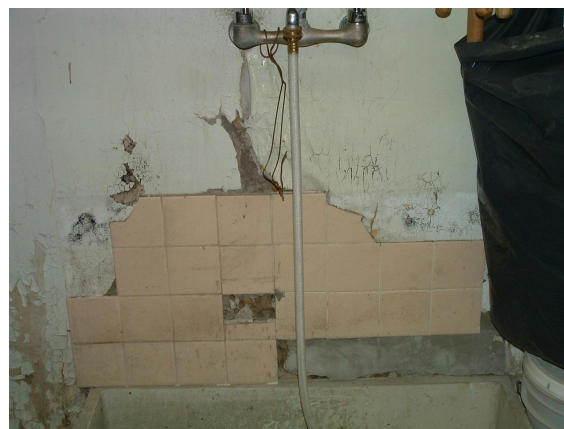
In Custodian's Room, the walls and floor around janitor sink has deteriorated. Wall ceramic tiles have fallen. Wall surfaces are wet and in poor condition. Mould is suspected on the wall surface.

In Staff Room sink cabinet, small traces of mould is suspected. Leaky sink trap may have created wet conditions.

Presence of mould on the wall should be verified by an expert. Following an appropriate remedial action, the wall and the floor surfaces should be repaired.

The Edmonton Public School staff will review and rectify mould in the sink cabinet.
