Evaluation Components	Summary Assessment	Estim. Cost
1	Site Conditions	Overall site conditions appear to be adequate with exception of the asphalt paving. Resurface parking lot and drive.	\$20,500
2	Building Exterior	A wide variety of materials on the exterior creates a somewhat incongruous appearance. Replace metal siding	\$4,000
3	Building Interior	Original millwork nearing end of life-expectancy. Gradual room by room replacement. New flooring on second floor.	\$172,000
4	Mechanical Systems	Install perimeter hot water heating to all classrooms and occupied spaces. Replace air handling equipment; clean existing ductwork that is reused; replace furnaces in portables with units that have adequate capacity for ventilation.	\$307,000
5	Electrical Systems	Generally, the school is operating adequately. No major electrical items. Recommend a preventative maintenance program being implemented. Replace broken receptacles, clean and vacuum out all electrical equipment and tighten panel feeder lugs.	\$84,450

Section 1	Site Conditions	Rating	Comments/Concerns	Estim. Cost
1.1	General Site Conditions			\$500
1.1.1	Overall site size.	4	Long narrow site is not ideal for visibility and supervisio

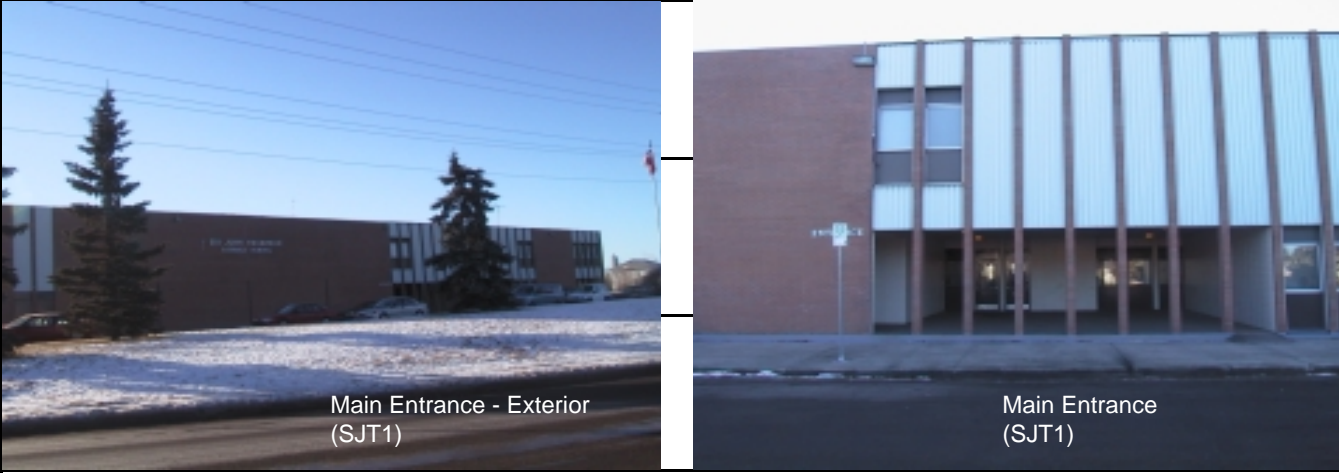
<div data-bbox="905 1089 1163 1146">Main Entrance - Exterior (SJT1)</div> <div data-bbox="1570 1089 1724 1146">Main Entrance (SJT1)</div>	
	The main entrance to the school is oriented towards a main arterial roadway which curves as it passes the school. This makes the school highly visible from both the east and west approaches. A semi-circular drive at the main entrance acts as a drop-off for students and visitors while also providing additional parking.

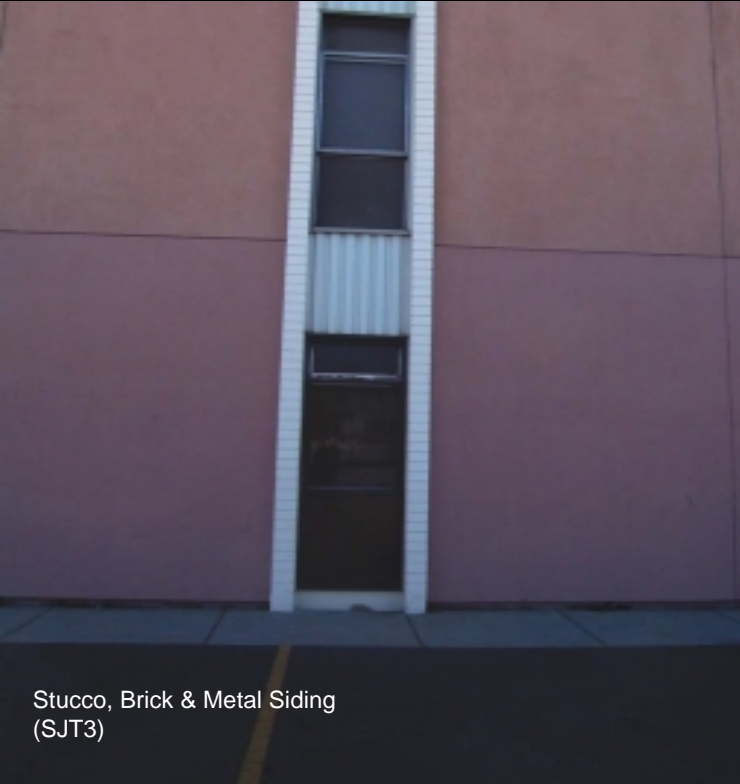
Section 2	Building Exterior	Rating	Comments/Concerns		Estim. Cost
2.3	Exterior Walls/Building Envelope		Bldg. Section	Description/Condition	\$500
2.3.1	Exterior wall finishes (i.e., signs of deterioration, cracks, brick spalling, effluorescence, water stains).	4	68/69	A mix of finishes which includes face brick, painted jumbo brick, vertical metal siding, vertical wood siding, horizontal wood shiplap siding and acrylic stucco are all generally in good condition. There are some signs of abuse at outside corners where bricks are chipped and broken. Replacement of the metal & wood siding with another material such as acrylic stucco would improve the overall appearance of the building as well as the overall unity of finishes.

<p>Stucco, Brick & Metal Siding (SJT3)</p> <p>Exterior Windows (SJT4)</p>
Exterior Wall Finishes	<p>A mix of finishes which includes face brick, painted jumbo brick, vertical metal siding, vertical wood siding, horizontal wood shiplap siding and acrylic stucco (SJT3) are all generally in good condition. There are some signs of abuse at outside corners where bricks are chipped and broken. Replacement of the metal & wood siding with another material such as acrylic stucco would improve the overall appearance of the building as well as the overall unity of finishes. There are signs of minor damage and/or weathering of the aluminum window frames (SJT4), but not sufficient to warrant replacement.</p>
Wall Materials & Finishes.	<p>Painted concrete block is the main wall finish throughout and is in reasonable condition. Painted gypsum board will require painting in the next five years or sooner. Some areas have been patched with sheets of painted plywood mounted over the existing gypsum board (SJT5). This appears to be a temporary solution and may in fact contravene code requirements for fire separations. Washroom walls with ceramic tile finish are in reasonable condition.</p>

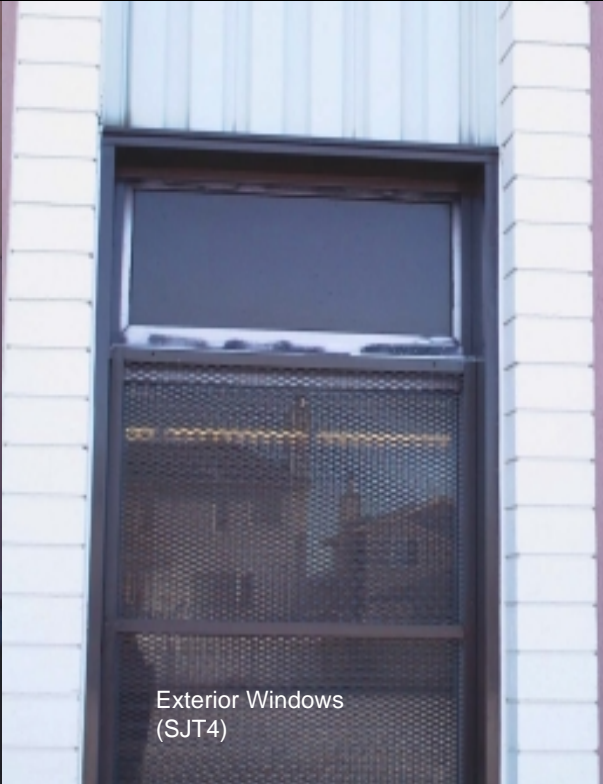
2.4.3	Exit door hardware (i.e., safety and/or code concerns).	4	68/69	No problems noted.	
2.4.4	Windows (i.e., signs of deterioration, rusting metal, glass cracks, peeling paint, damaged seals, sealed unit failure).	4	68/69	Double-glazed aluminum windows with internal venetian blinds.

2.4.5	Window accessories (i.e., latches, hardware, screens, locks, alarms, holders, closers, security devices).	3	68	Internal blinds difficult to operate - controls jam or do not function smoothly. Some broken hardware noticed throughout.	\$2,000

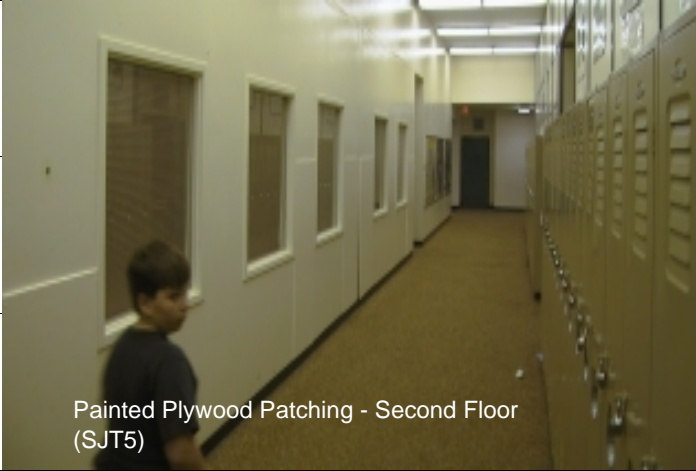
<p>Painted Plywood Patching - Second Floor (SJT5)</p>

3.2.2	Wall materials and finishes.	3	68 / 69	Painted concrete block is the main wall finish throughout and is in reasonable condition. Painted gypsum board will require painting in the next five years or sooner. Some areas have been patched with sheets of painted plywood mounted over the existing gypsum board. This appears to be a temporary solution and may in fact contravene code requirements for fire separations. Washroom walls with ceramic tile finish are in reasonable condition.	\$15,000

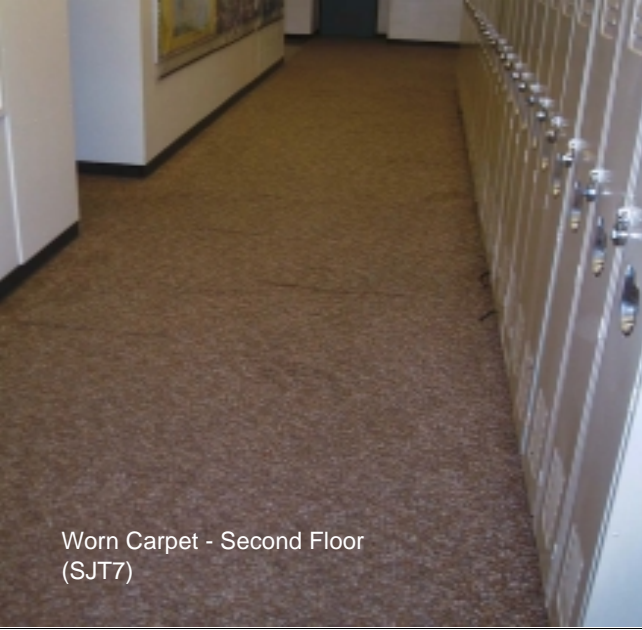
3.2.1	Floor materials and finishes.	3	68 / 69	A mix of VA tile, VC tile, ceramic tile, carpet and resilient sheet flooring are generally in good condition with exception of the carpeting on the second floor which is showing signs of age and wear. A better quality commercial grade carpet or resilient sheet flooring would lower maintenance costs as well as improve the appearance of these spaces. The hardwood flooring on the gymnasium stage is gouged & worn. Replacement of this floor recommended.	\$53,000

<p>Worn Carpet - Second Floor (SJT7)</p>
		<p>A mix of VA tile, VC tile, ceramic tile, carpet and resilient sheet flooring are generally in good condition with exception of the carpeting on the second floor which is showing signs of age and wear (SJT7). A better quality commercial grade carpet or resilient sheet flooring would lower maintenance costs as well as improve the appearance of these spaces. The hardwood flooring on the gymnasium stage is gouged & worn. Replacement of this floor recommended. Further investigation required to determine whether existing vinyl tile is of the asbestos or composite type.</p>
<p>Floor materials and finishes.</p>
