# RECAPP Facility Evaluation Report

## Sir William Van Horne High School

B2852A  
Calgary

<b>Evaluation Details</b>	
<b>Evaluation Company:</b>	Marshall Tittlemore
<b>Evaluation Date:</b>	December 1 2004
<b>Evaluator Name:</b>	Mr. Tom Tittlemore

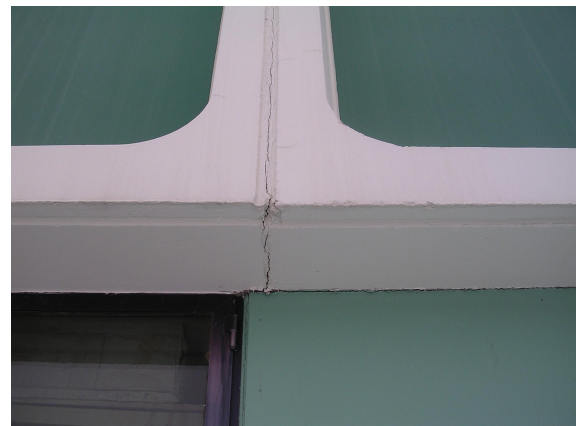
**Event:** Caulk joint failure at precast connections.

Caulk joints have failed.

Recaulk precast connections.
