School Name:	St. Michael				School Code:	222
Location:	10545 - 92 street Edmonton, Alberta T5H 1V1				Facility Code:	2026
Region:	Central				Superintendent:	Dr. Dale W. Ripley
Jurisdiction:	Edmonton RCSSD No. 40				Contact Person:	Mr. Garnet McKee
					Telephone:	(780) 453-4500 (Garnet)
Grades:	K-VI				School Capacity:	Total 450
Building Section	Year of Compl.	No. of Floors	Gross Bldg Area (Sq.M.)	Type of Construction (i.e., structure, roof, cladding)	Description of Mechanical Systems (incl. major upgrades)	Comments/Notes
Original Building	1946	1	1277.6	Framed/B.U.R. T & G	Steam heating system; exhaust ventilation heating & ventilation serves gym	Boilers recently replaced.
Additions/ Expansions	1949 1953 1957 1962 1970	1 1 1 1 1	177.6 177.6 1192.0 500.7 187.1	Framed/B.U.R. T & G Framed/B.U.R. T & G Framed/B.U.R. T & G Framed/B.U.R. Framed/B.U.R.	1949; 1958; 1968: Steam heating; exhaust ventilation. 1970: Roof top (gas-fired) heating & ventilation to serve library

Evaluator's Name:	Bill Vance
					& Company:	Henderson Inglis Partridge

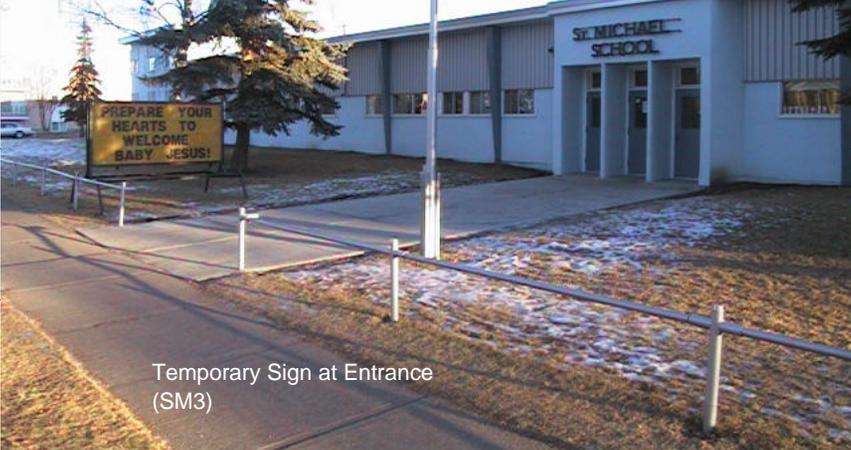
1.2.5	Signage.	3	Fixed signage in good condition. School currently uses what we assume is a portable rented sign to provide community information. Fixed sign would be more appropriate.	\$5,000
Other

(SM3)	<p>Temporary Sign at Entrance (SM3)</p> <p>Temporary/Rental Sign seems inappropriate</p>
(SM2)	<p>Bent railings at front of school.</p>

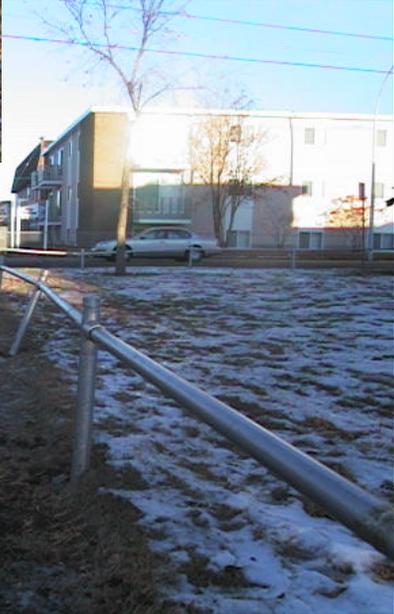
1.1.4	Site landscaping.	4	As per 1.1.2	
1.1.5	Site accessories (i.e., perimeter and other fencing, guard rails, bike stands, flag poles).	3	Bent railings along 92nd street.	\$2,500

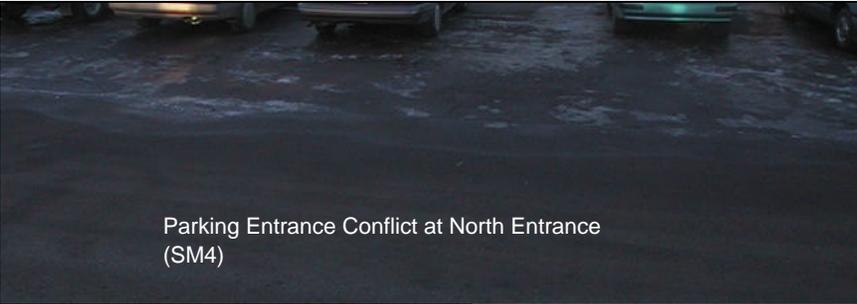
1.3.2	Layout and safety of parking lots.	3	Conflict with bus drop off & school pedestrian access layout forces backing out onto City of Edmonton streets. Costs have been identified in 1.2.1	Refer to 1.2.1

Evaluation Component/ Sub-Component	Additional Notes and Comments	
(SM4) Entrance/Exit feeds directly into parking without buffer.

<p>Parking Entrance Conflict at North Entrance (SM4)</p>

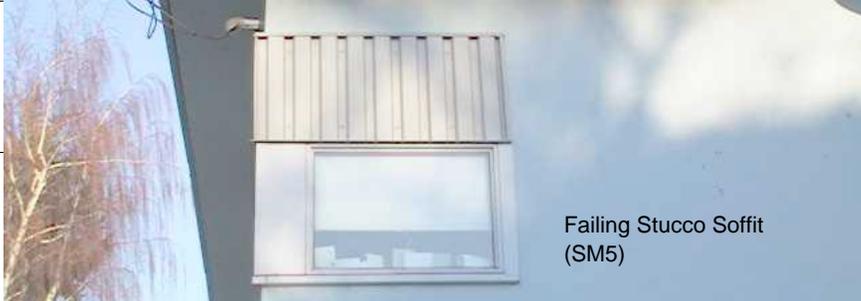
2.3.2	Fascias, soffits, parapets (i.e., signs of looseness, stains, rust, peeling paint).	3	1946 all others	Stucco soffit southwest corner appears to be coming loose. Generally other sections good.	\$5,000

<p>(SM5) Stucco soffit appears to be failing</p>
		<p>Failing Stucco Soffit (SM5)</p>
(SM6)	<p>Many floor finishes are original and tired/dated.</p>
