School Facility Evaluation Project
Part IV - Additional Notes and Comments

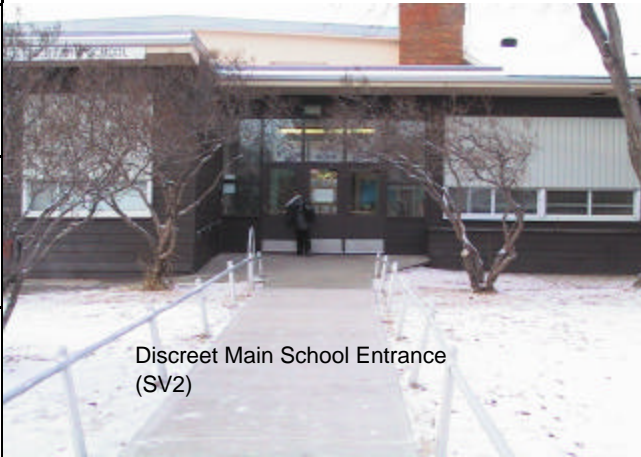
Section 1	Site Conditions	Rating	Comments/Concerns	Estim. Cost
1.2	Access/Drop-Off Areas/Roadways/Bus Lanes			\$18,000
1.2.1	Vehicular and pedestrian access points (i.e., size, number, visibility, safety).	3	Most active part of the school from a visual point of view is not actual front entrance which leads to some confusion. Entrance needs better identity.	\$15,000

<p>Discreet Main School Entrance (SV2)</p>
(SV2)	Main school entrance is difficult to identify particularly from main vehicular access on 105 Avenue

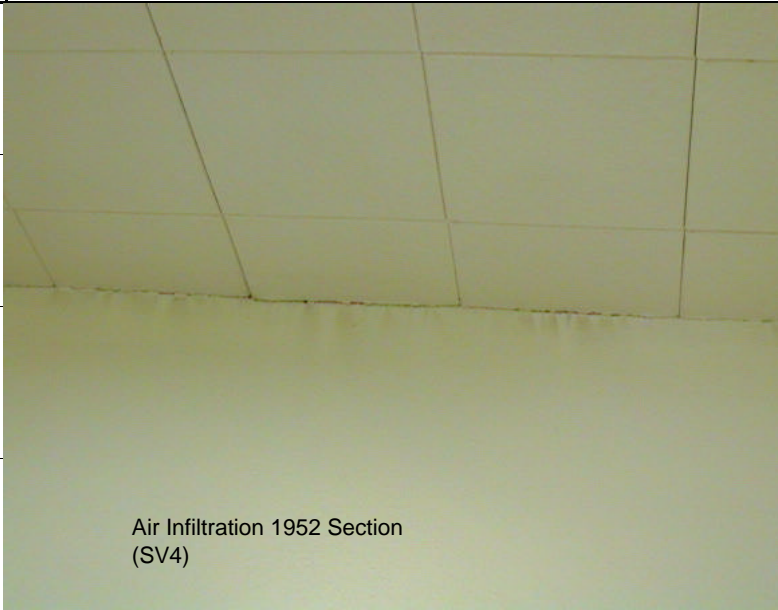
1.3.4	Layout and safety of sidewalks.	4	Layout appears satisfactory.	
1.3.5	Surfacing and drainage of sidewalks (note type of material).	3	Asphalt surface west side of 1952/1953 requires replacing.	\$10,000

Air Infiltration 1952 Section (SV4)	Deteriorating Asphalt Play Area (SV3)
(SV3)	Asphalt play area in need of repairs on West side of 1952 - 1953 Addition.	
(SV4)	Staining on ceiling tiles suggests there may be some air movement above the ceiling space.

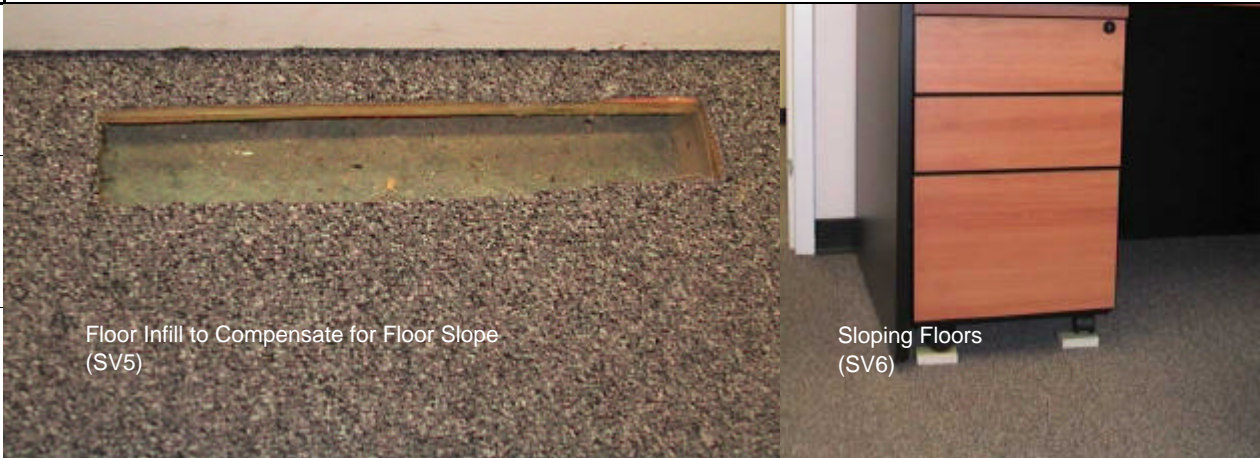
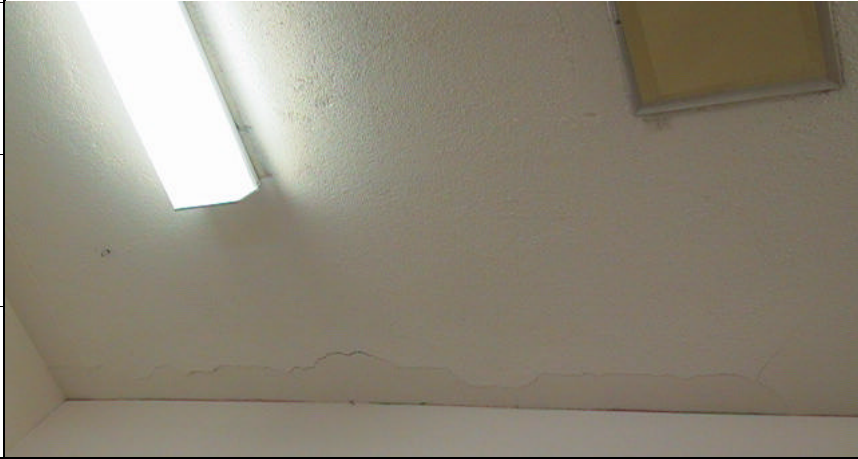
Section 2	Building Exterior	Rating	Comments/Concerns		Estim. Cost
2.1	Overall Structure		Bldg. Section	Description/Condition	\$0
2.1.1	Floor structure and beams (i.e., signs of bending, cracking, heaving, settlement, voids, rust, stains).	F.I.	1952 1953 1955 1969	O.K. considering age of structure Evidence of movement at South End which may be linked to 1955 addition condition. Rest O.K. Potentially significant signs of movement east side O.K. Heaving/sloping floors as one would expect in linked frame structures of this age. No apparent structural problems with the exception of settlement primarily East side of 1955 but some evidence there is an effect on the 1953 section.

3.1.2	Floors (i.e., signs of cracks, heaving, settlement).	F.I.	1955 1952-1960 1969	Signs of potentially significant problem. False floor created to compensate for drop at perimeter Generally O.K. although humps and unevenness as one would expect for wd. structure this age. Good	
Other

(SV5)(SV6)	1955 section shows signs of significant settlement at perimeter resulting in the need for a raised leveling floor to provide a useable floor surface.

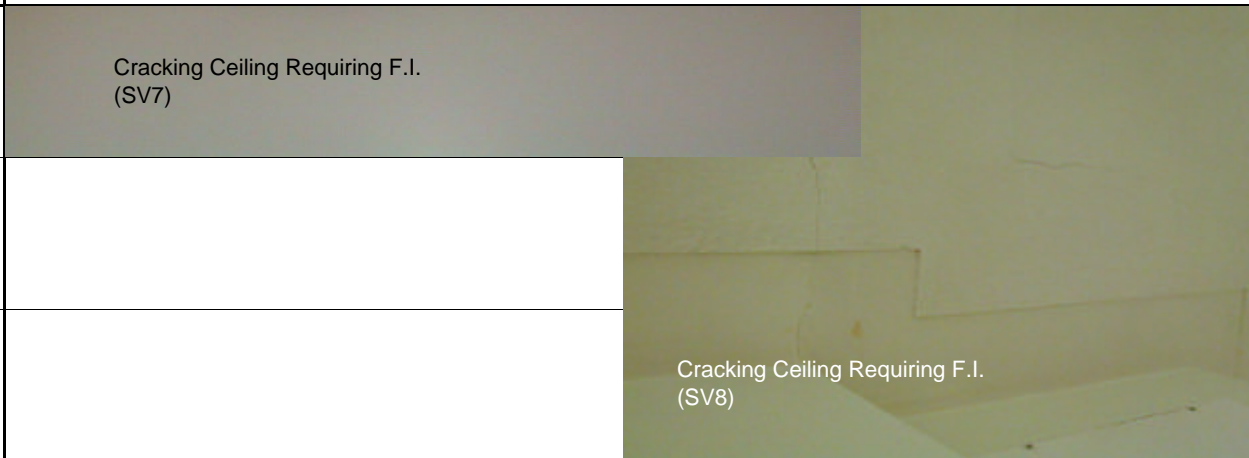
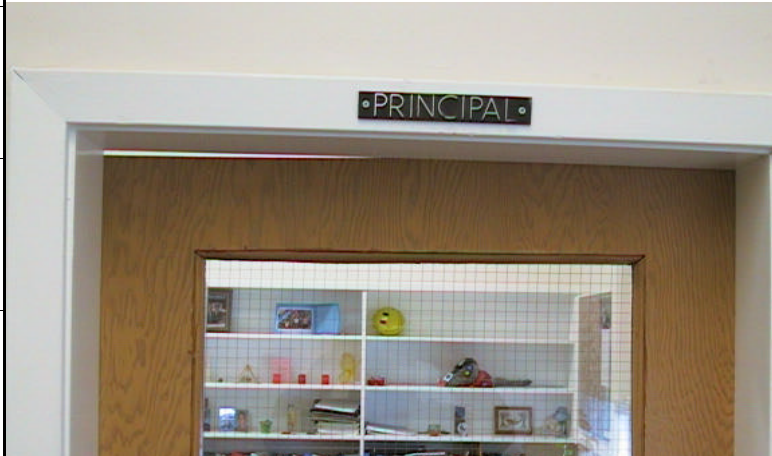
Evaluation Component/ Sub-Component	Additional Notes and Comments	
	Cracking Ceiling Requiring F.I. (SV7)

3.2.3	Ceiling materials and finishes.	3	1952-1960 1969	mixture of T-Bar (corridor) and adhered acoustic ceiling tile, some plaster. Some cracking noted. Materials show age. Possible asbestos content in ceiling tiles. T-Bar marginal condition - definitely due for replacement particularly in corridor areas. Allowance is for 20% building area replacement T- Bar Mechanical and electrical upgrades make replacement of ceilings necessary. 35% non 1969 plus	\$35,000

(SV7)(SV8)	Cracking in ceilings may be the result of building movement in 1952 - 1955 sections.

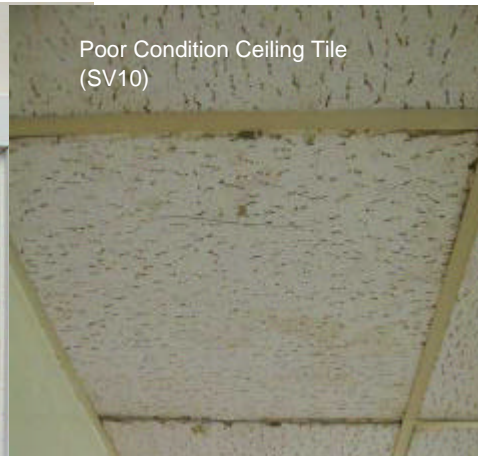
Poor Condition Ceiling Tile (SV10)

(SV9)	1955 section shows signs of significant settlement at perimeter resulting in the need for a raised leveling floor to provide a useable floor surface.		
(SV10)(SV11)	Ceilings in poor condition in high traffic areas in 1969 section.

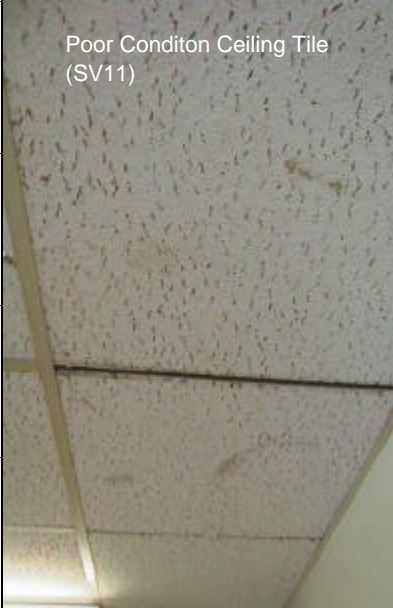
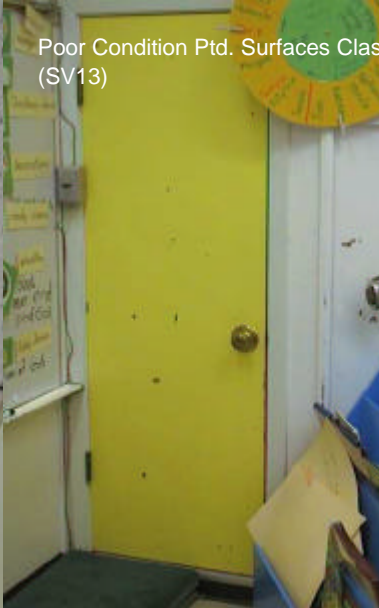
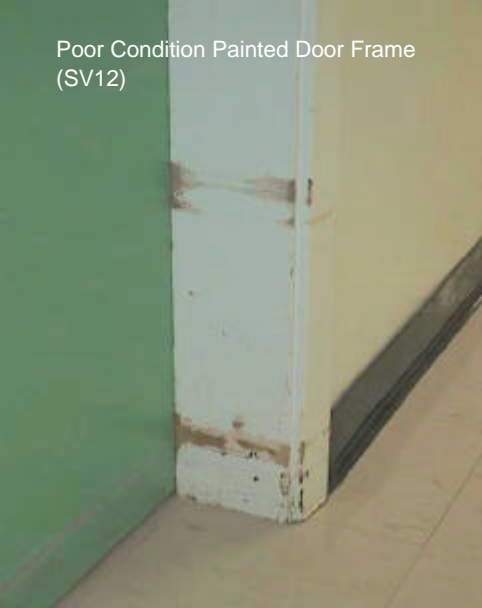
Evaluation Component/ Sub-Component	Additional Notes and Comments
(SV12)(SV13)	Repainting required as many surfaces are chipped and marked.
List of Reports/ Supplementary Information	<p> Educational Facilities Master Plan 2007 Edmonton Catholic Schools March 1998 Inventory of Core School Buildings – Edmonton Catholic School District Summary From Alberta Education School Buildings Service Areas in m2 Roofing Projects Revised July 22, 1999 1997 B.Q.R.P. 1998 B.Q.R.P. 1996 B.Q.R.P. 1995 B.Q.R.P. 1993 B.Q.R.P. Heating, Ventilation and Air Conditioning Systems Portable Classroom Locations – Edmonton Catholic Schools Edmonton Catholic Schools Fire Alarm Systems Consultants for School Facilities Edmonton Catholic Schools – Legal Description December 01, 1998 Inventory of School Buildings – Edmonton Catholic Schools November 05, 1999 Edmonton Catholic Schools – Gymnasium Inventory Edmonton Catholic Schools – 1999/2000 Summary of Minor Modernization Projects From 1990 through to 1999 Major Modernizations and Additions Summary of Alternately Funded Renovation Projects Standard Assessment and Utilization Report 0018 Edmonton RCS REG DIV #40 </p> <p>Data Sheets</p> <p>St. Vincent School March 1980</p> <p>Mini-Plans</p> <p>St. Vincent School March 1980</p>
