RECAPP Facility Evaluation Report

St. Augustine Elementary / Jr. High School

B2791A

Evaluation Company: Quinn Young Architects Ltd.
Evaluation Date: October 30 2006
Evaluator Name: Barry McCallum

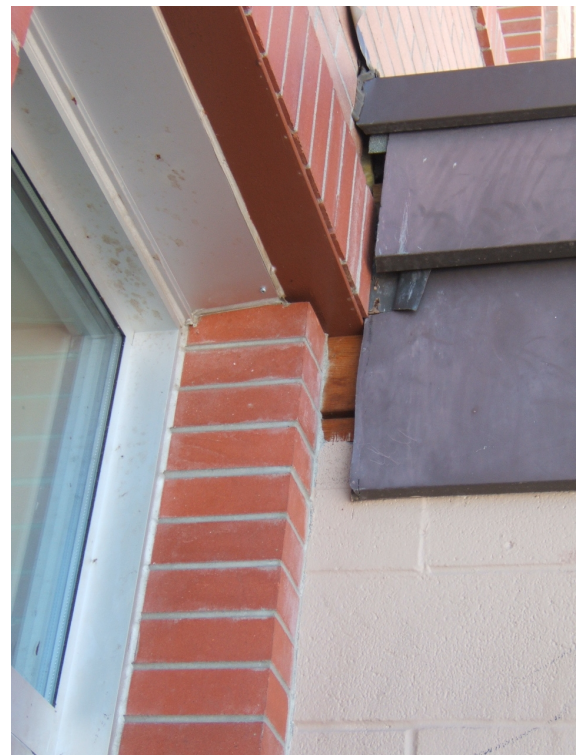
Moisture penetration and insect infestation into wall cavity

Replace portion of fascia as required to cover exposed substrate and seal to corner with appropriate caulking

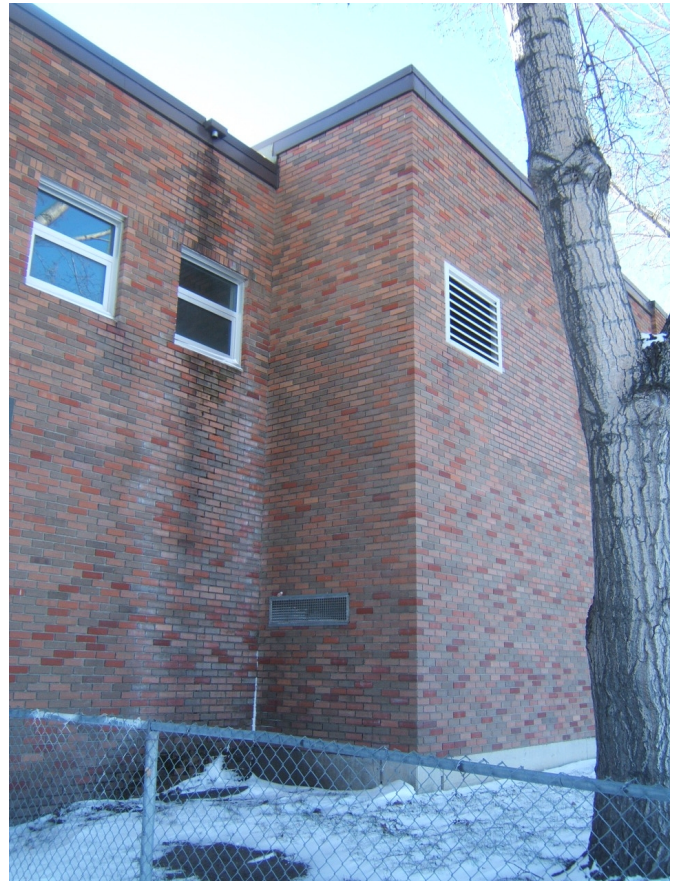
Overflow scuppers around perimeter of roof. Overflow scupper on north face at 1961 classroom block appears to have flooded frequently

Overflow scupper appears to have flooded wall numerous times. Wall is dirty, water runs across window and leaks may occur, efflorescence is evident on lower wall

Damage to wall, water penetration at window and into cavity, poor appearance.

Add heavy duty downspout or change roof slopes and clear drain to prevent damage to wall

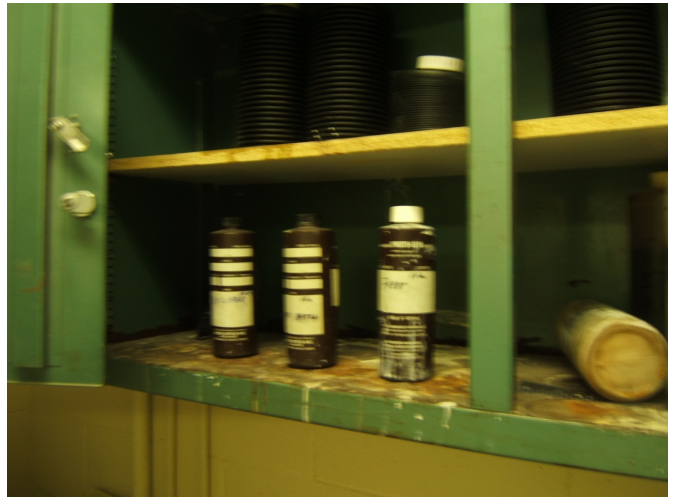
Dark room in Industrial Arts area. Refer to E3010.02 for casework replacement

<u>Rating</u>	<u>Installed</u>	<u>Design Life</u>	<u>Updated</u>
3 - Marginal	1965	50	MAR-07
