RECAPP Facility Evaluation Report

Edmonton RCSSD #7

St. Benedict Catholic Elementary School

B3284A
Edmonton

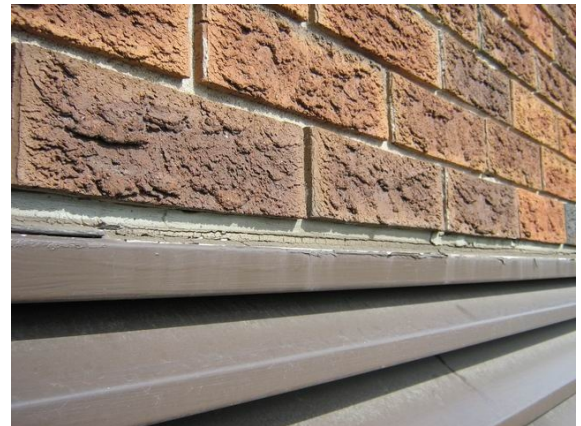
Concern:

Failed sections of sealant noted on window and louver perimeters.

Consequences of Deferral:

Potential for water entry into wall assembly and increases air leakage.

Recommendation:

Replace all failed sections of sealant - 100 m @ \$15/m.

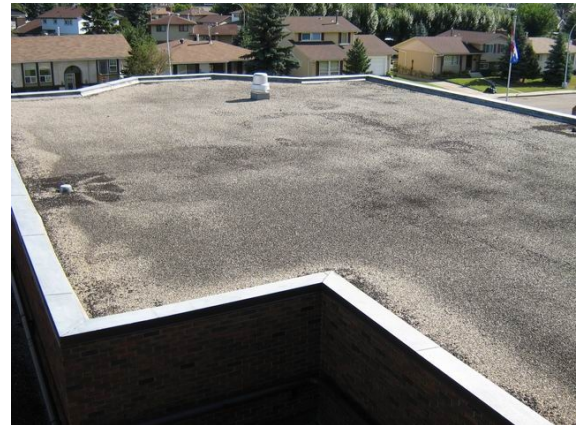
Concern:

Roof blisters, past repairs, wind scouring, evidence of ponding water and "spongy" insulation noted during review. Also numerous reports of roof leakage.

Consequences of Deferral:

Continued roof leakage can damage interior finishes and result in mould growth.

Recommendation:

Replace conventional built up roofing system. 2660 m2 @ \$80/m2.

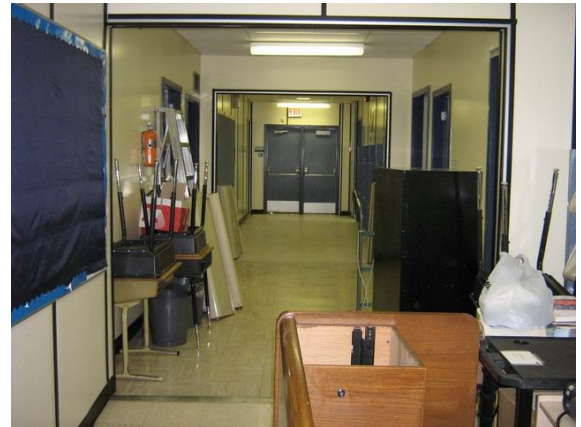
Concern:

Wood doors at portable emergency exits have experienced varying degrees of physical and water damage (marginal condition).

Recommendation:

Replace wooden portable doors - 7 doors @ \$1,000.

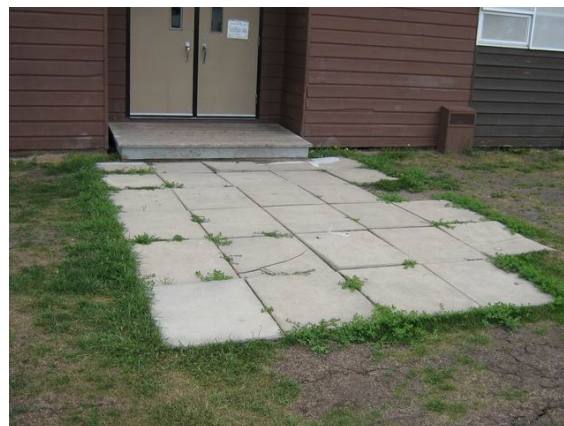
Precast concrete paver walk at south portable has settled / displaced. Also broken pavers.

Uneven walking surface, potential tripping hazard.

Recommendation:

Relevel / reset precast concrete paver walkway. Replace broken pavers.

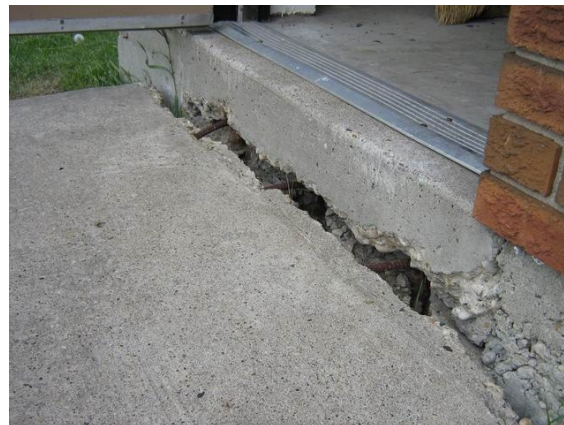
Cracks, surface deterioration and settlement noted on cast-in-place concrete walkways at numerous locations.

Consequences of Deferral:

Potential tripping hazards.

Recommendation:

Replace deteriorated and settled walkway sections - allow 100 m² @ \$200/m².
