RECAPP Facility Evaluation Report

Regional School Board

St. Elizabeth Seton School

B3950A
Red Deer

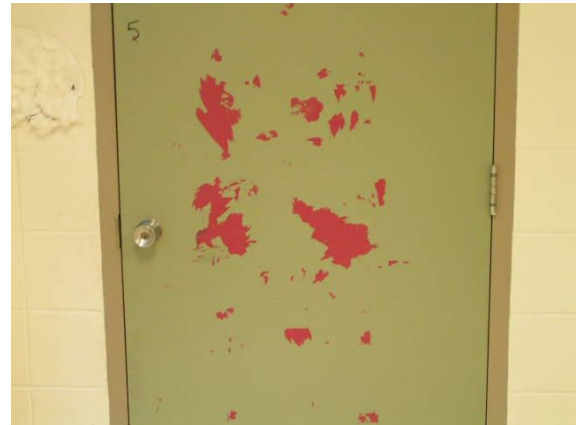
<u>Rating</u>	<u>Installed</u>	<u>Design Life</u>	<u>Updated</u>
3	0	40	October 2004

14 of the original doors are peeling badly. Acrylic paint was put over oil, without being back-primed.

Refinish 14 interior doors.

<u>Type</u>	<u>Year</u>	<u>Cost</u>	<u>Priority</u>
Repair	2004	\$3,500	Low
